**Äspö Hard Rock Laboratory**

**Äspö Pillar Stability Experiment,  
Final report**

**Rock mass response to coupled  
mechanical thermal loading**

January 2007

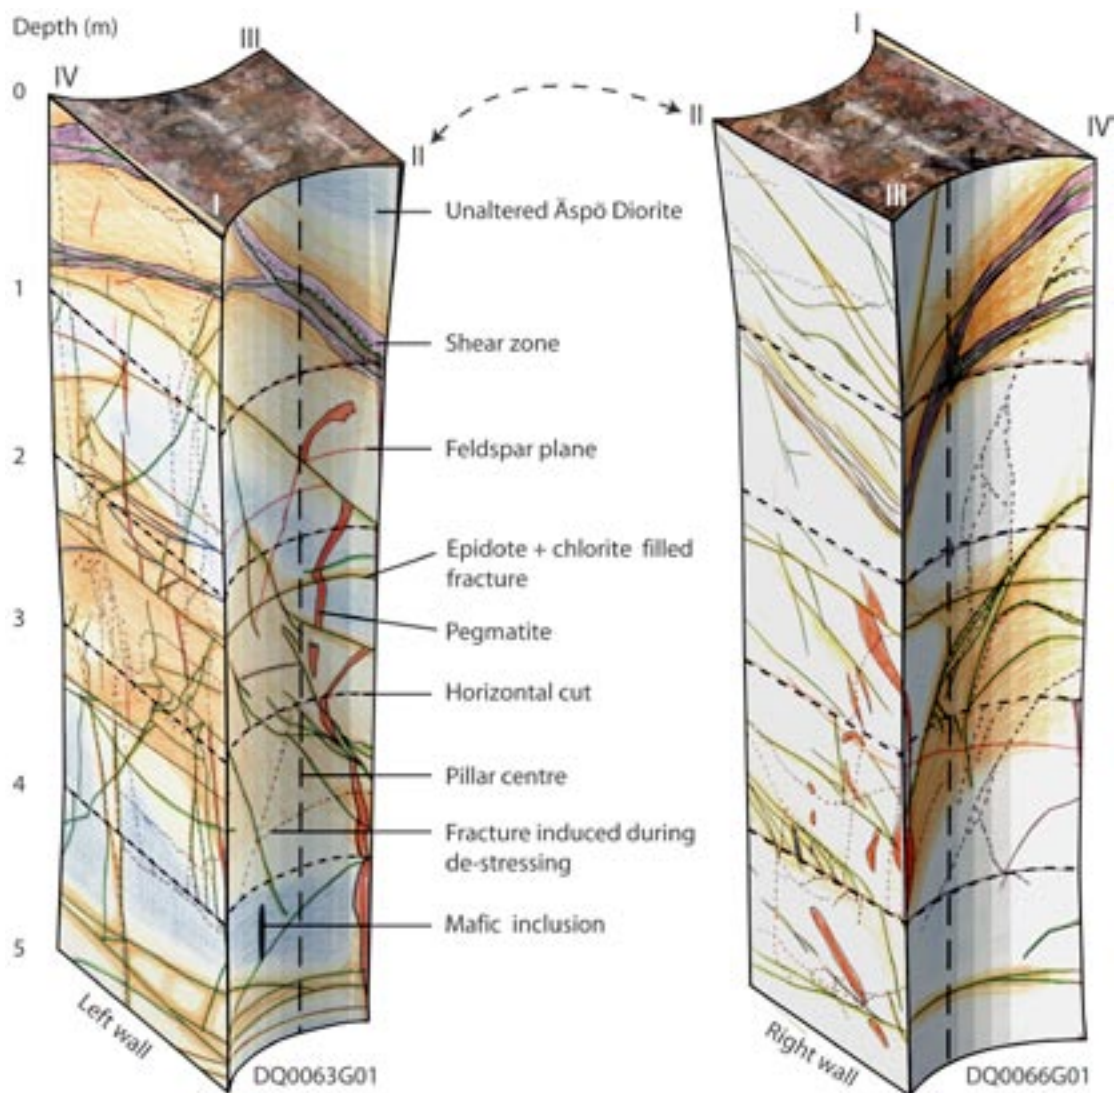
**Figure 2-2.** *Compilation of the geological mapping of the five pillar blocks.*

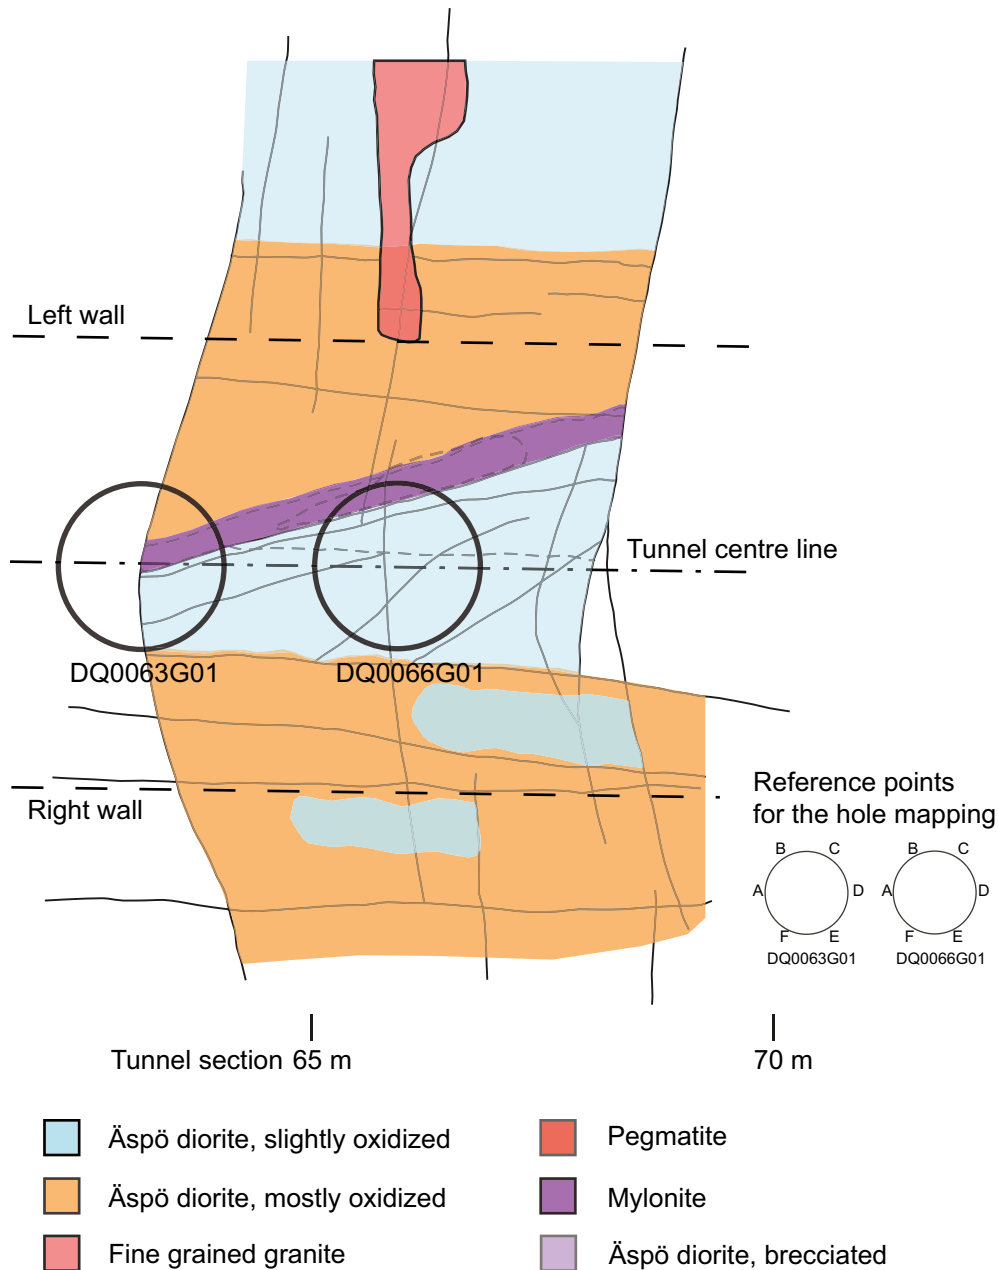
**Figure 2-3.** Geological mapping of the tunnel floor at the pillar location. The large-diameter holes and the reference points A to F used during the mapping of the hole walls are indicated in the figure.

The geological mapping of the tunnel floor, the large-diameter boreholes and the pillar walls is presented in greater detail in Figure 2-3 to Figure 2-7.

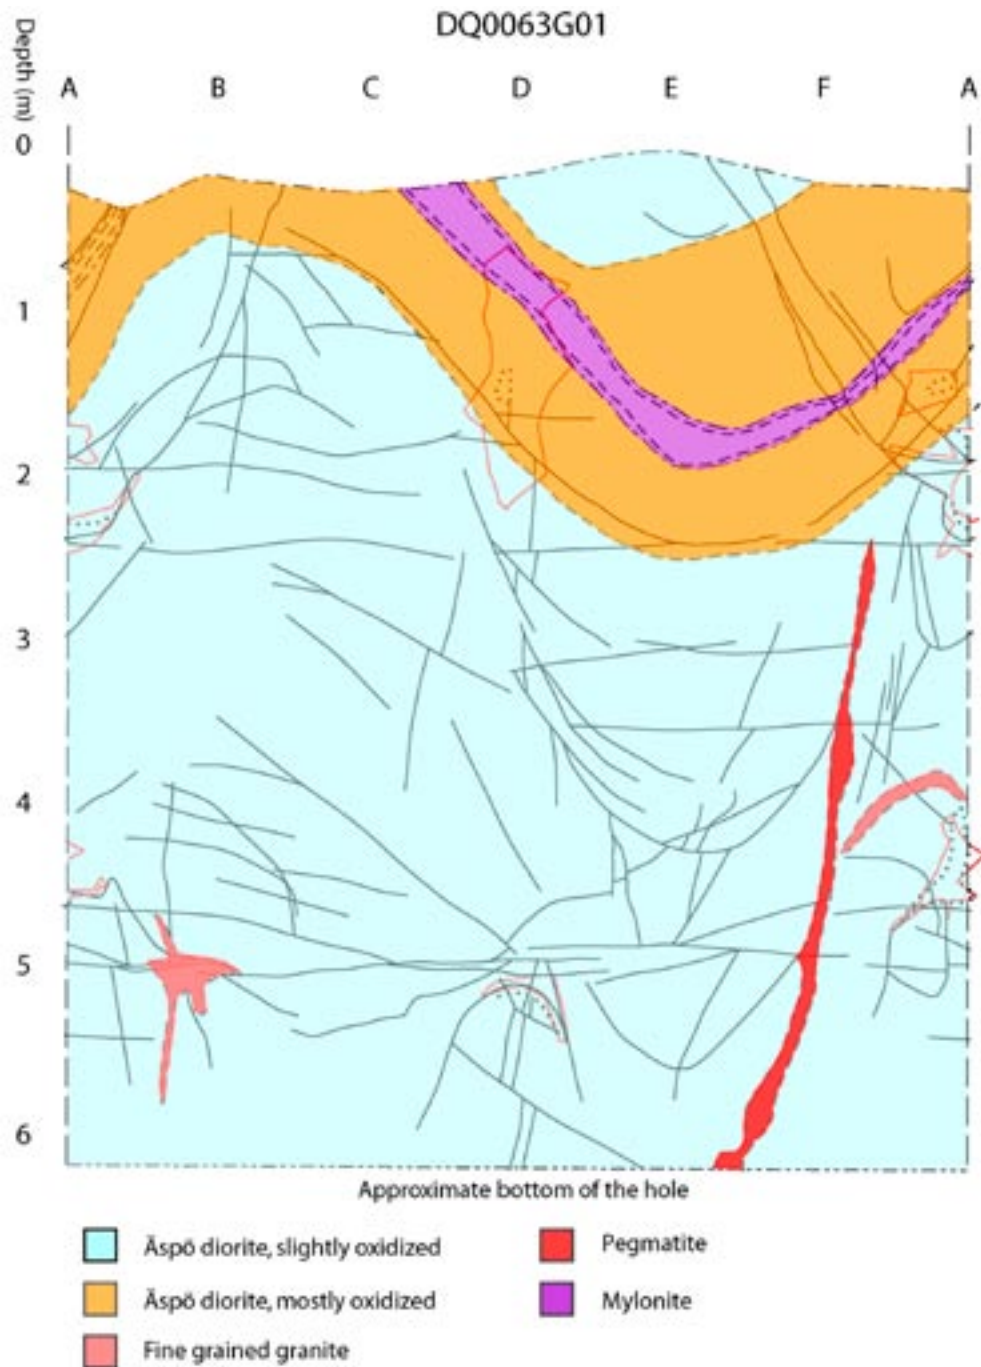
**Figure 2-4.** Geological mapping of large-diameter hole DQ0063G01. All mapped fractures are included (both sealed and open).

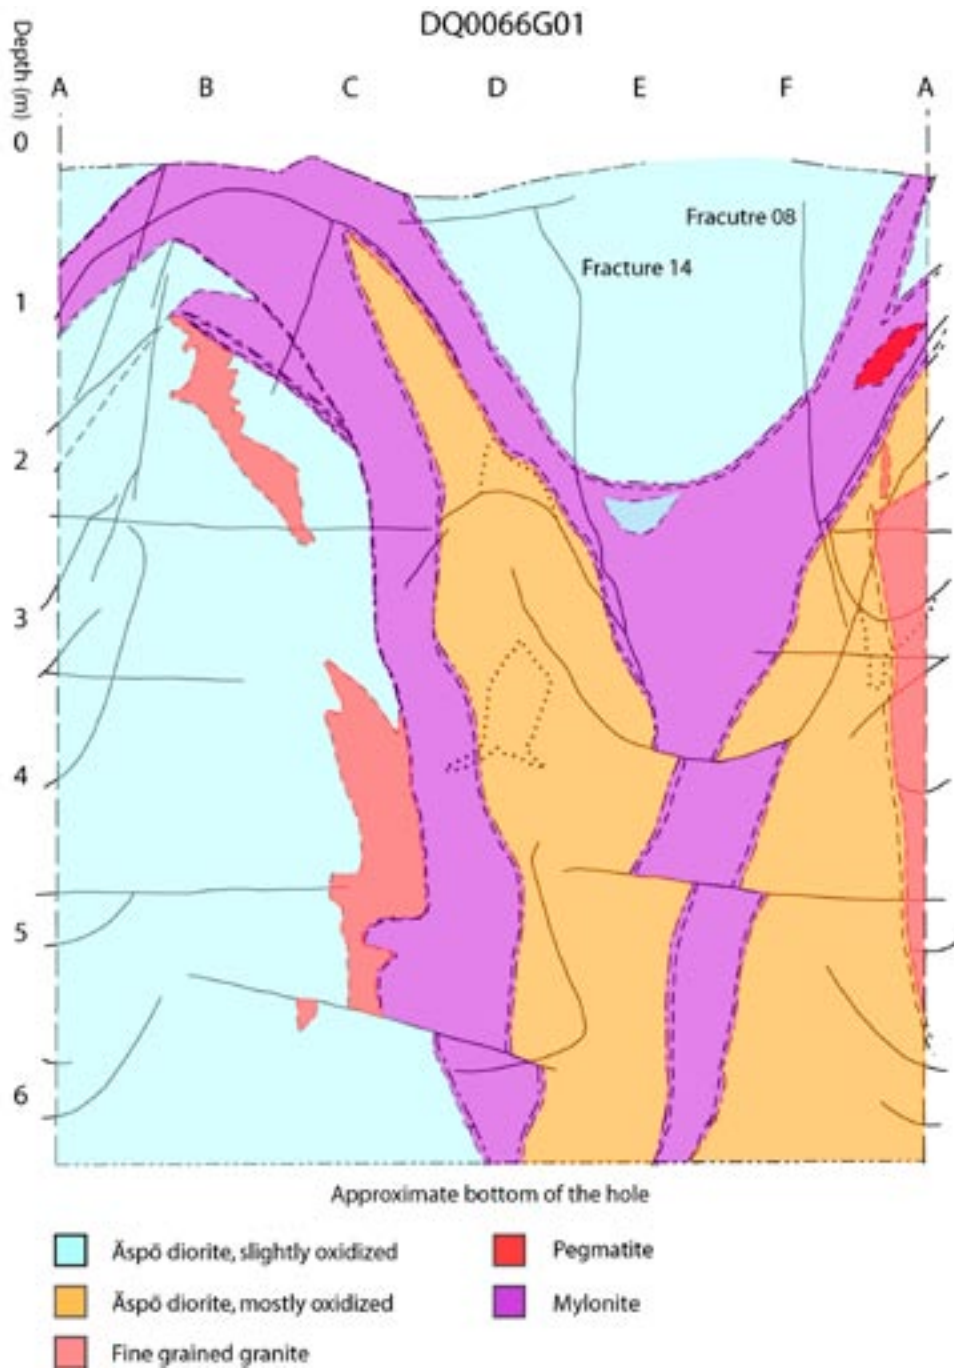
**Figure 2-5.** Geological mapping of large-diameter hole DQ0066G01. Fractures 08 and 14 are indicated in the figure. All mapped fractures are included (both sealed and open).

fracture 14, was that they could displace (shear) during the different phases of the experiment. Displacements could re-distribute the stress field in the pillar. Accurate back calculations of the actual stresses in the pillar during the different phases of the experiment would then become difficult to perform. The AE system was used to keep track of displacements of this kind, and a detailed study of fracture 08 is presented in Appendix 2f.

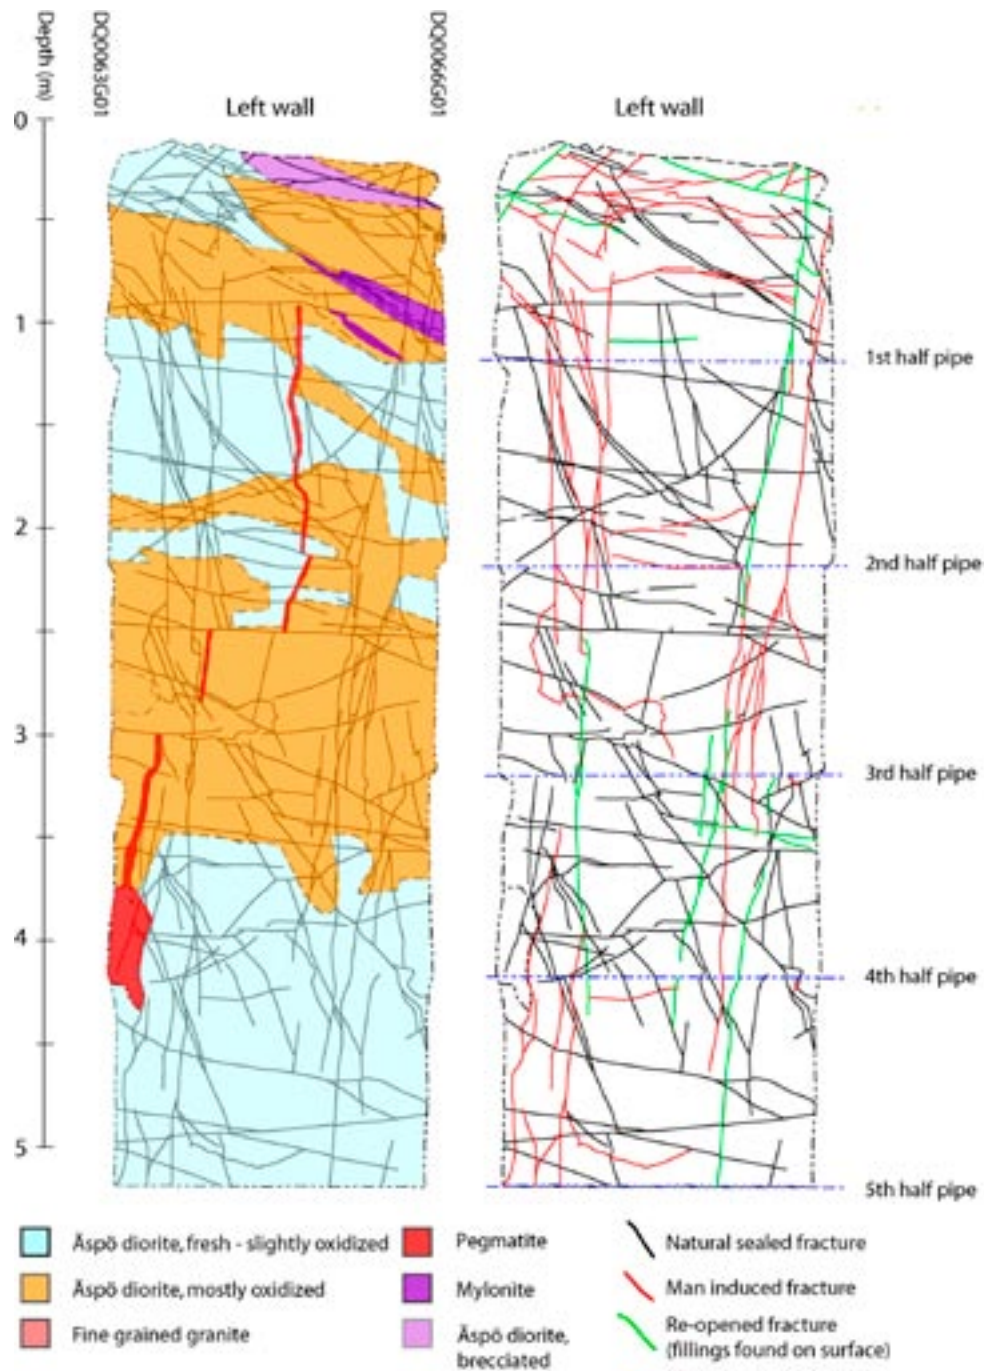
**Figure 2-6.** Geological mapping of the left pillar wall (A-wall). The half pipes originate from the boreholes used for the wire sawing (Chapter 10).

The mapping of the pillar walls (Figure 2-6 and Figure 2-7) was done with a cut-off length of approximately 0.1 to 0.5 m. The figures also present the mapped fractures separately. As described in Chapter 10, fracturing was induced in the pillar as the pillar blocks were excavated, and these fractures are highlighted in the figures. Fracture 08 (Figure 2-5) is of particular interest for the outcome of the experiment, since it was one of the few open water-bearing fractures close to the pillar. It was evident that fracture 08 would intersect the pillar. A concern with fracture 08, but also

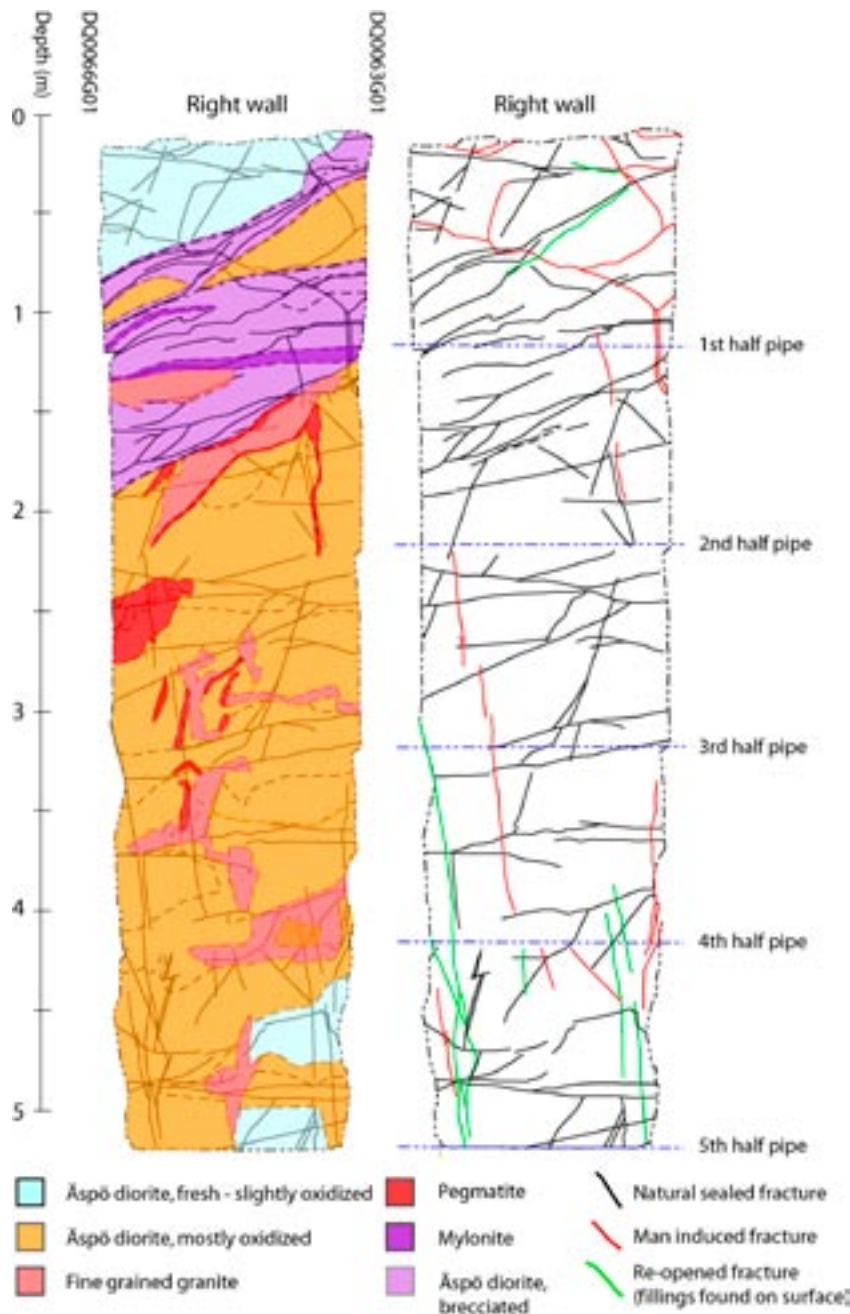
*Figure 2-7. Geological mapping of the right pillar wall (B-wall).*

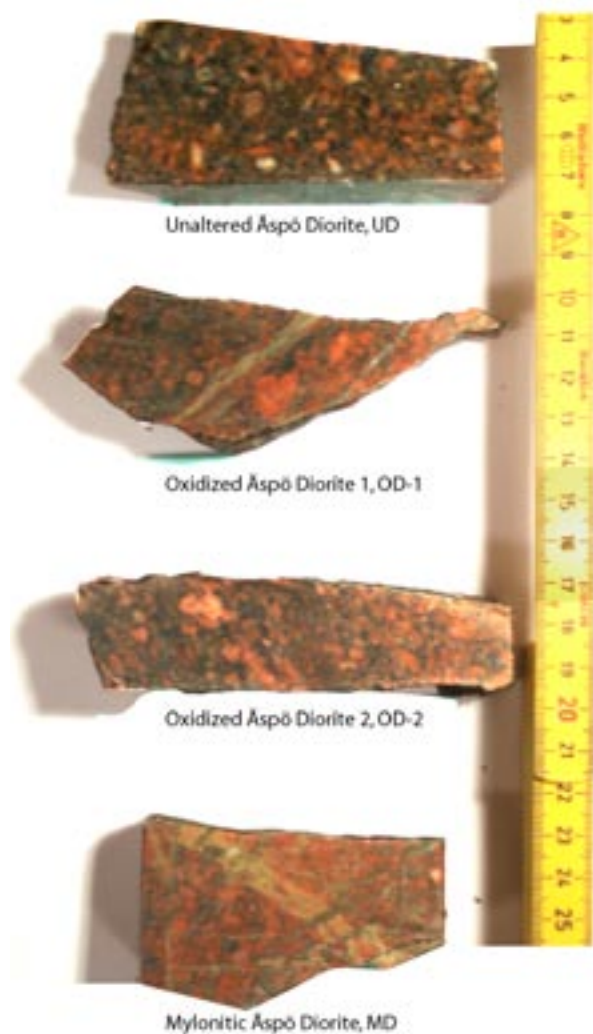
*Figure 2-8. Photographs of the rock samples used to make the thin samples.*

Four rock samples with varying degrees of oxidation were selected for making thin sections. The slabs were stored in boxes and organized into ~ 0.5- to 0.6-m sections. In other words, all the slabs removed between 2.7 and 3.3 m are stored together (Appendix 2e). The location of the samples for making the thin sections is therefore only known to within which approximately half-metre section it belongs to. In Table 2-3, the samples and their ID (Figure 2-8) are listed together with the

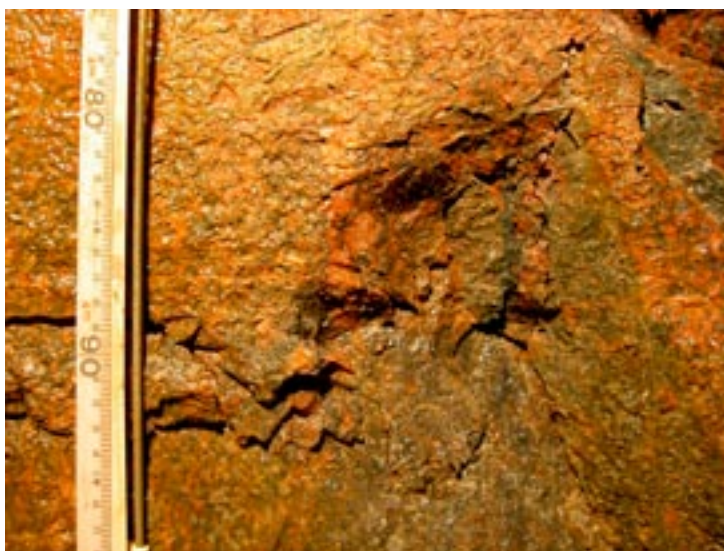
**Figure 2-10.** The approximate location of sample MD at a depth of 4.9 m. Note the strong oxidation.

The MD sample was selected to represent mylonitized diorite purely on the basis of its textural appearance, not its depth level. The sample has all the qualities of a mylonite: extreme oxidation, dense epidote vein network and massive-like grain size. However, the hole depth level, 4.90 m, from which the sample is presumably taken is not mapped as a mylonitic zone. Nevertheless, the rock at that depth is extremely oxidized diorite and is in many ways similar to “real” mylonite. The location of sample MD is shown in Figure 2-10.

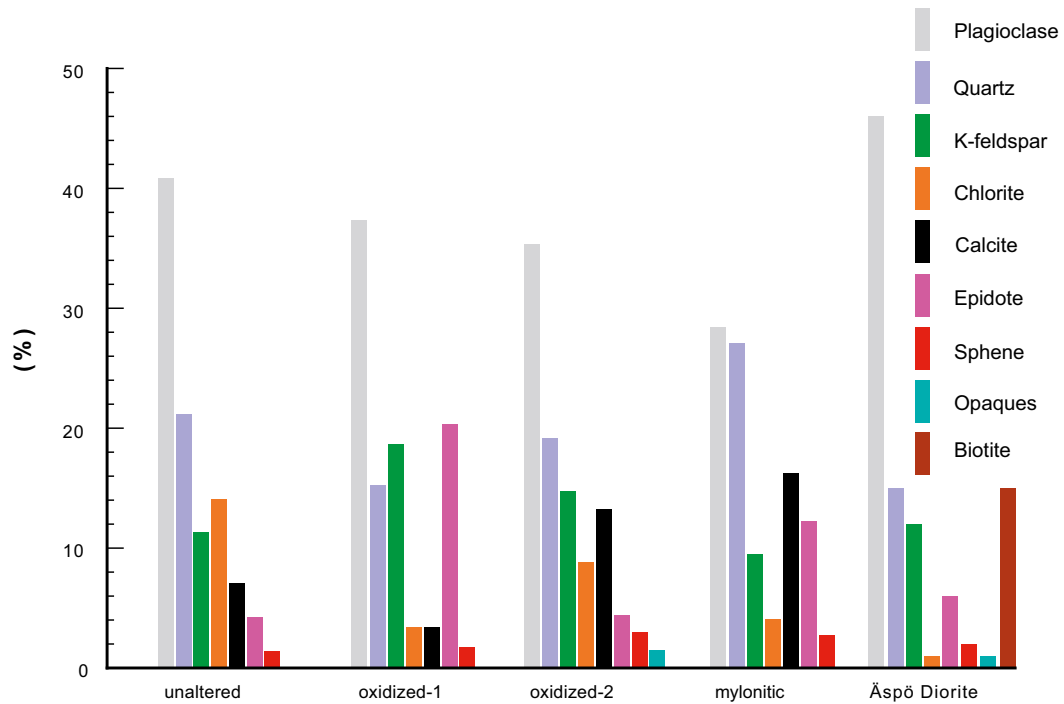
**Figure 2-11.** Distribution of different minerals in the thin sections.

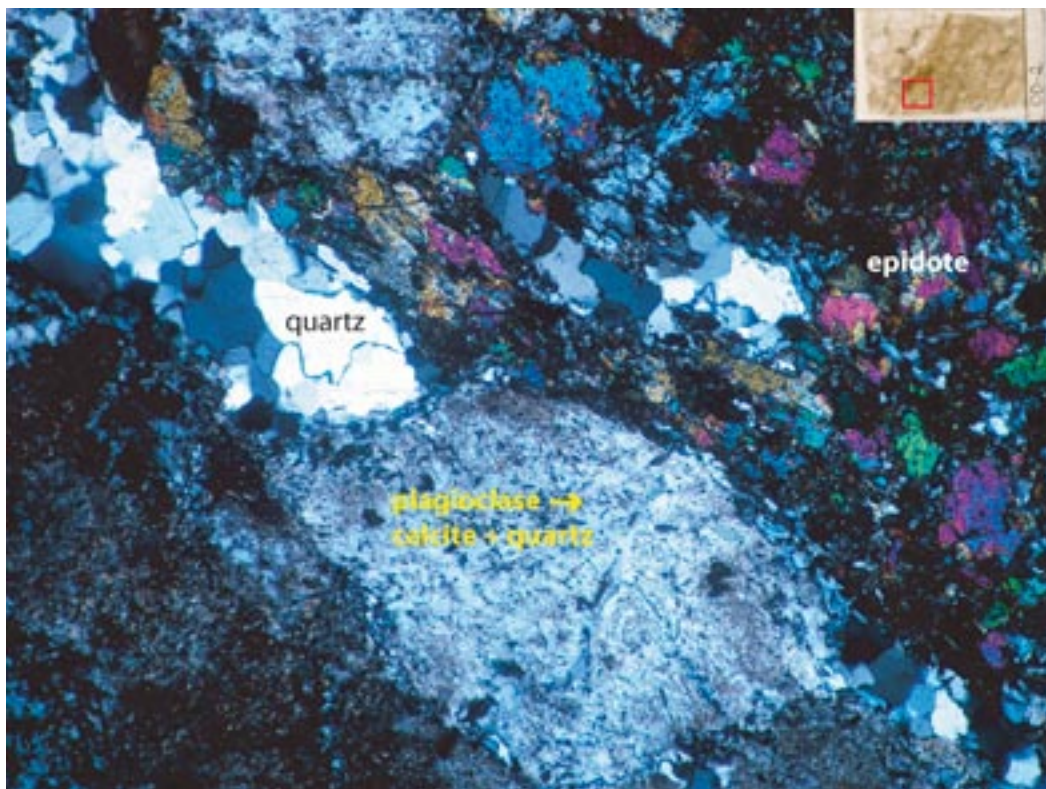
**Figure 2-12.** Microscope image of sample OD-2 in polarized light. Altered plagioclase crystals and quartz porphyroclasts. The image width is 4 mm.

It seems that plagioclase has been altered even in the least altered pillar rock sample, OD-2 (Figure 2-12). No biotite, which has presumably all been altered to chlorite, was found in the thin sections. The alteration of the plagioclase and the absence of biotite indicate that the alteration may be greater and more dispersed than is reported in /Magnor 2004/, at least in the pillar rock volume.

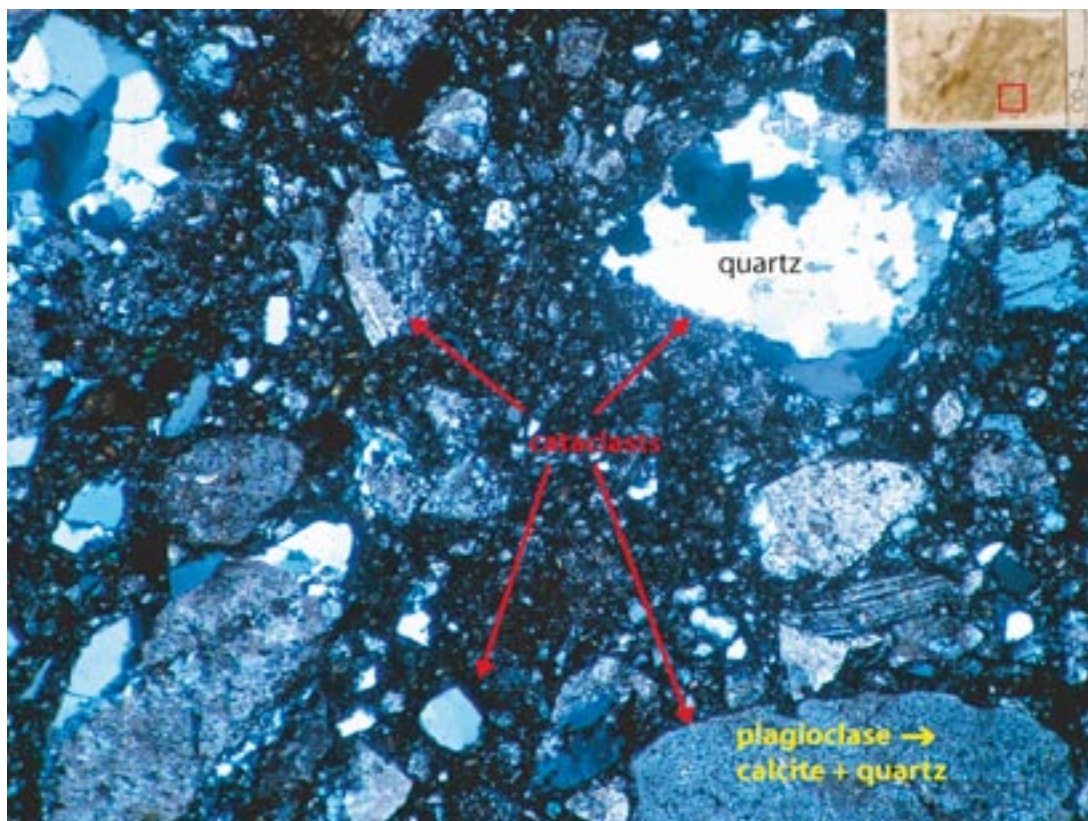
**Figure 2-13.** Microscope image of sample OD-2 in polarized light. Cataclastic shear band with brecciated matrix and sharp porphyroclasts. Some twinning in the altered plagioclase grains. The image width is 4 mm.

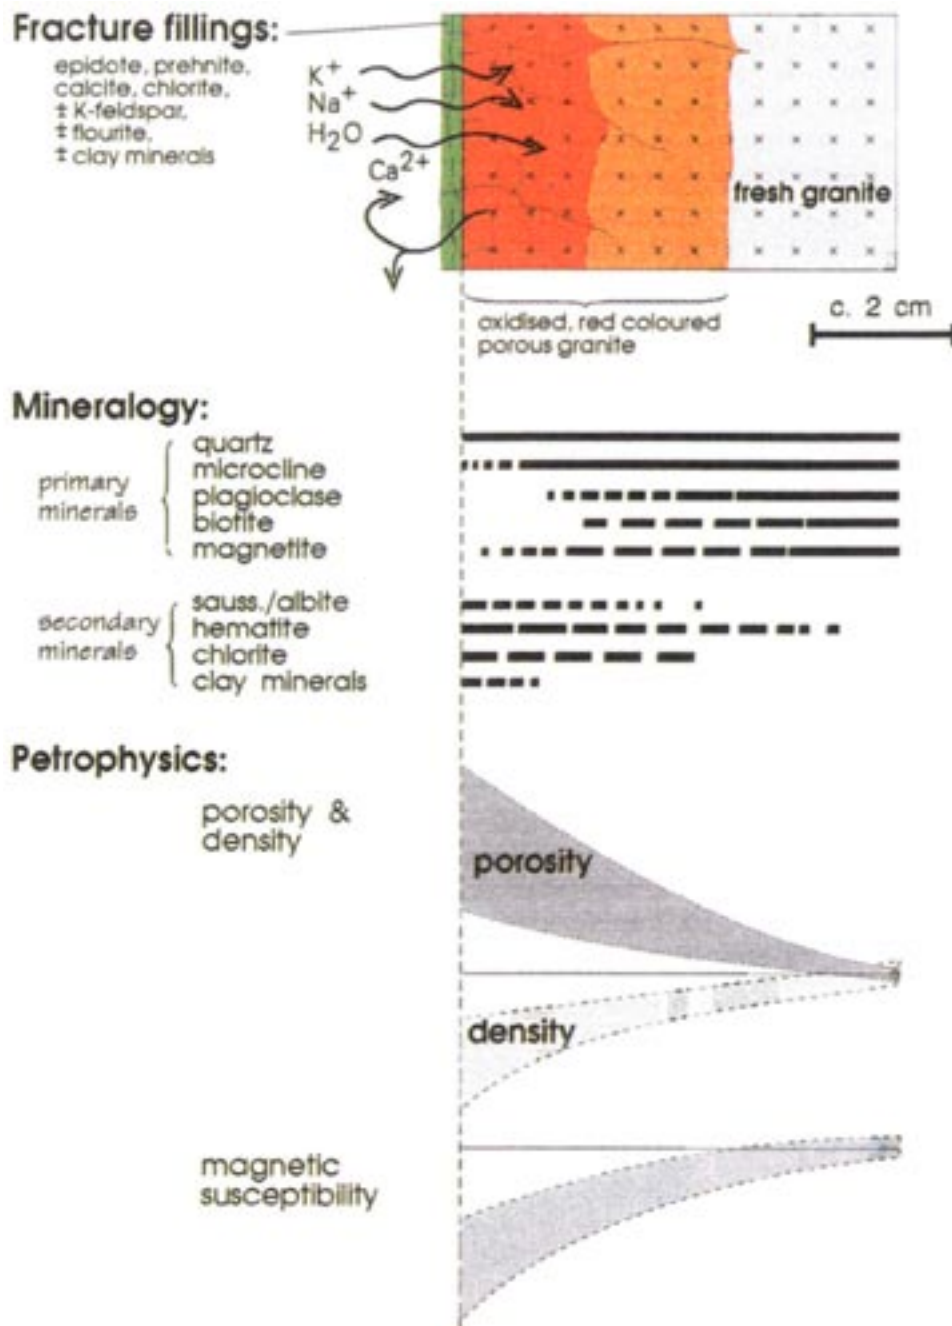
**Figure 2-14.** Schematic illustration of the most important alteration features in the red colouring along fractures in the Äspö diorite. Modified from /Eliasson 1993/.

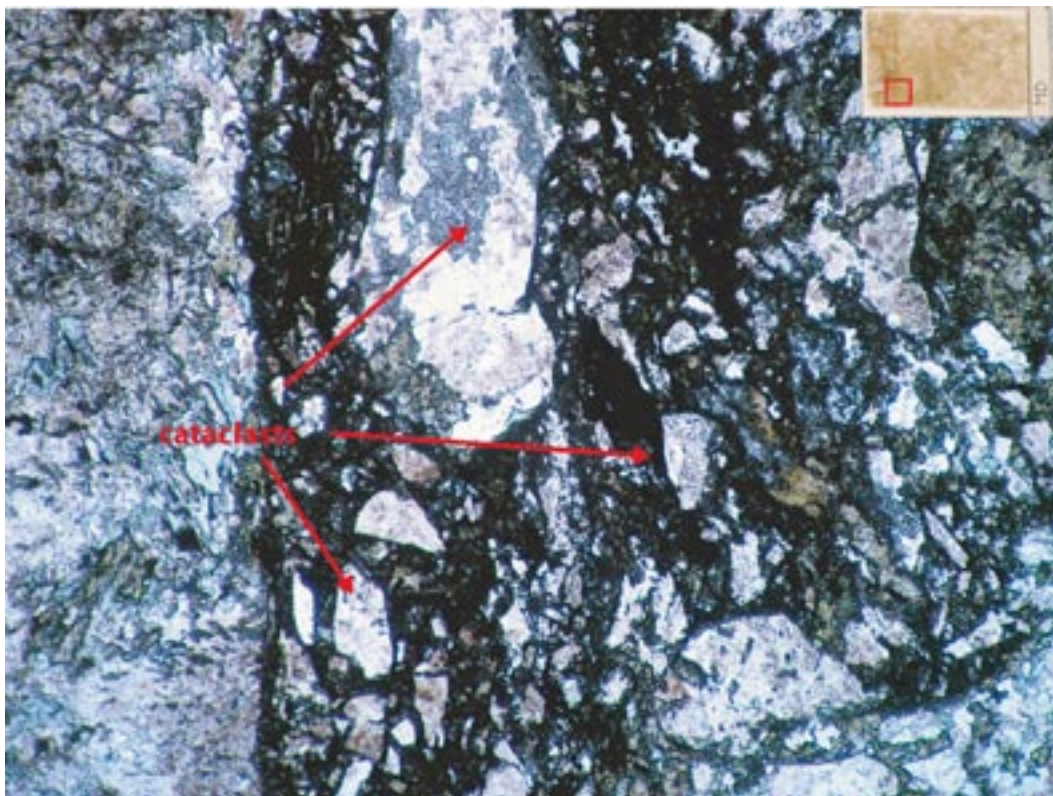
**Figure 2-16.** Microscope image of sample MD in normal light showing an epidote vein which is actually a microscopic cataclastic shear zone. The image width is 4 mm.

The grain size of the minerals does not seem to be affected by the degree of alteration of the sample. This can be noted from the mineral grain size charts in Figure 2-15. The grain size variation in the unaltered (UD) thin section and in both of the oxidized ones (OD-1 and OD-2) is very similar. The only exception is the mylonite sample (MD), which lacks large K-feldspar porphyroclasts. This change in mineral grain size is probably related only to the brittle shearing that has brecciated the rock. Alteration itself doesn't seem to break minerals and thereby reduce grain size. Changes in mineral size seem in this case to be purely related to shear structures. The brecciated minerals (cataclasts) within the epidote veins can be seen in the microscope images in Figure 2-16.

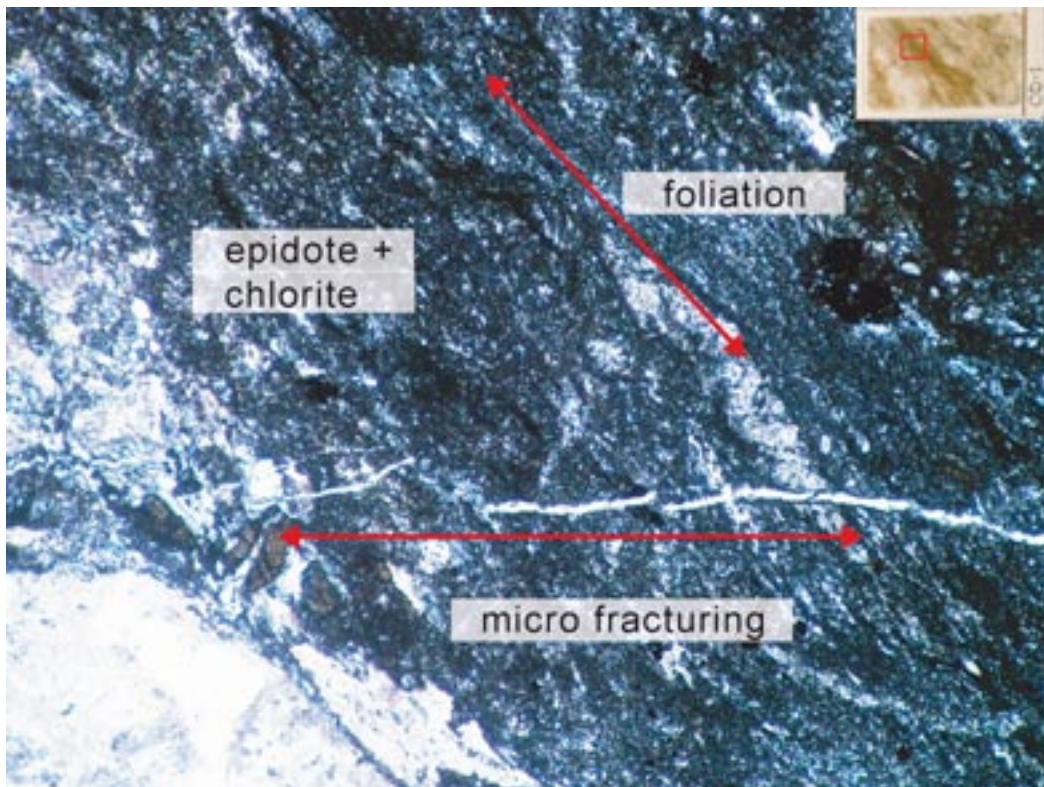
**Figure 2-17.** Microscope image of sample OD-1 in normal light. Microfracturing in the epidote and chlorite vein with a geometry that can be anticipated for the spalling-related fracturing. The image width is 4 mm.

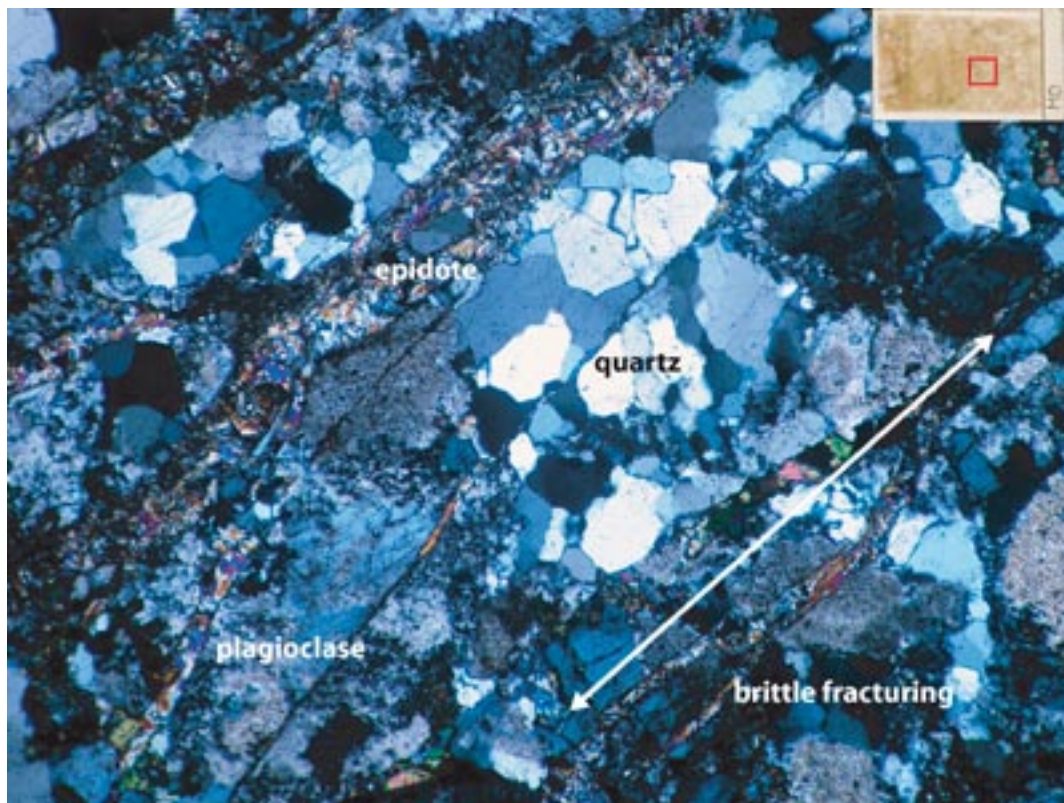
**Figure 2-18.** Microscope image of sample MD in polarized light. Altered feldspars, quartz and intensive brittle fracturing filled with epidote. The image width is 4 mm.

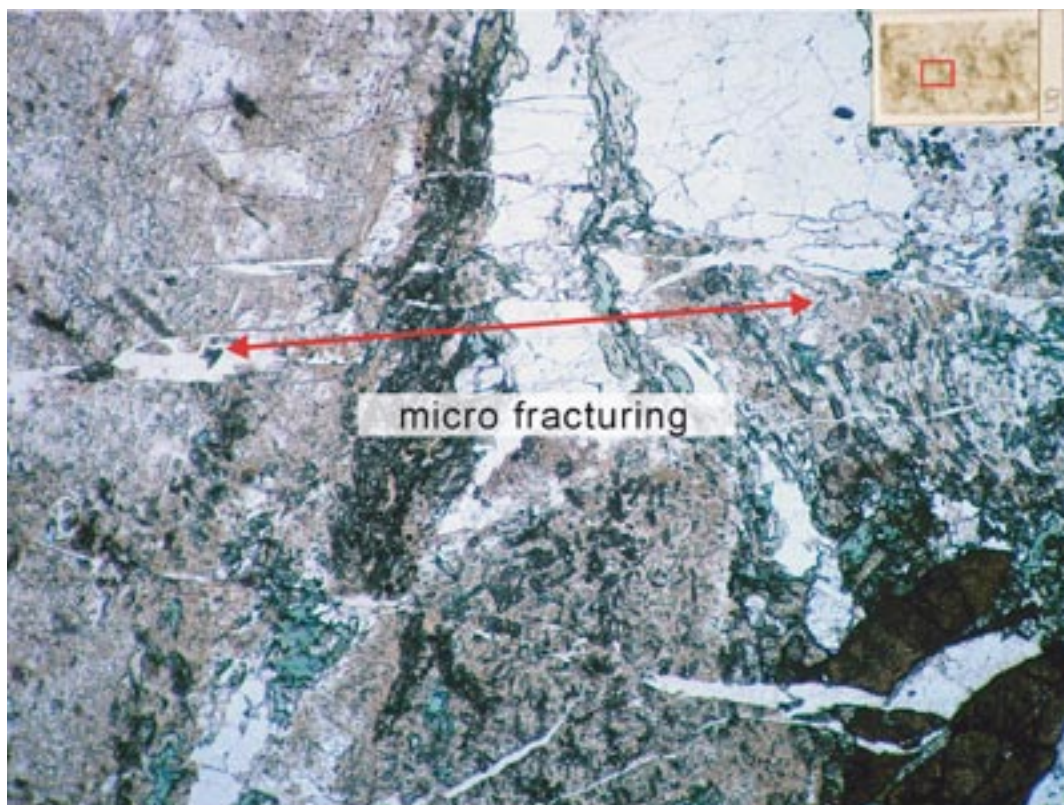
**Figure 2-19.** Microscope image of sample UD in normal light. Fractures that could be induced during the yielding of the pillar. The orientation of the sample is unknown and the origin of the fractures is not certain.

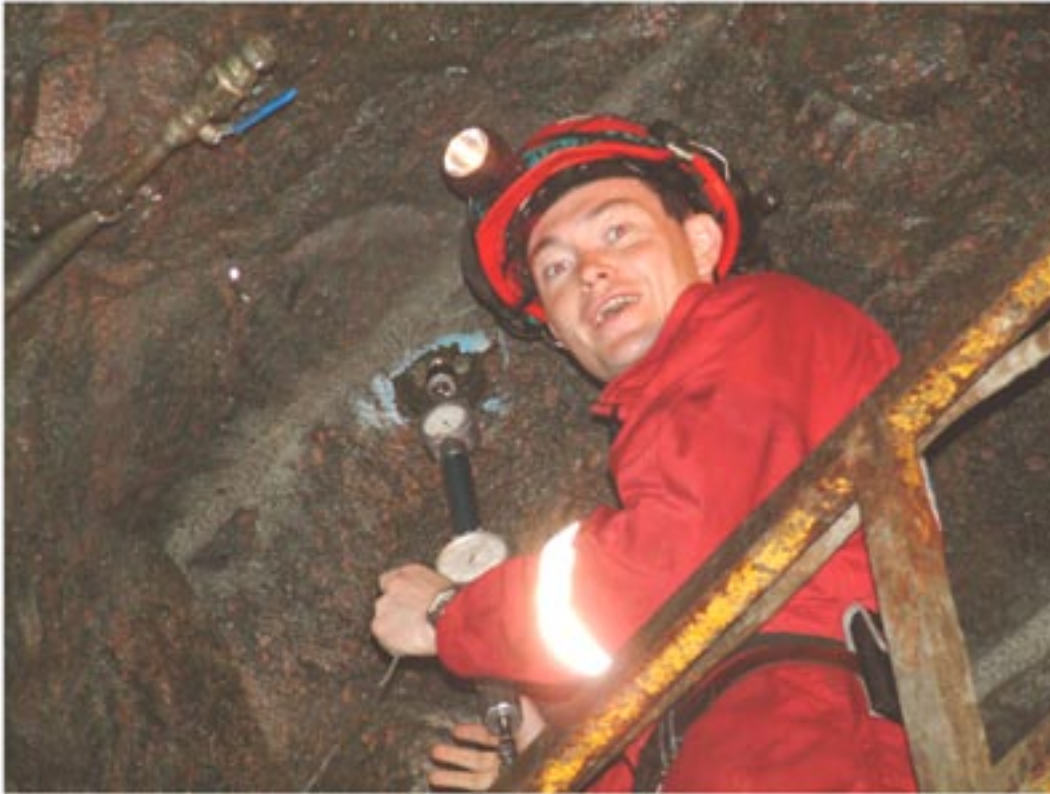
**Figure 2-21.** The convergence was measured with a Kern Distometer. The convergence pins were installed approximately 0.5 m behind the face.

To verify the stress tensor in Table 2-6, back analysis of convergence measurements was performed during the excavation of the experiment drift, /Andersson and Martin 2003, Staub et al. 2004/ using the boundary element code Examine3D /Rocscience/. At a section located 39 m into the drift, seven convergence pins were installed 0.3 to 0.5 m behind the face (Figure 2-20). The pins, which were approximately 700 mm long, were grouted into boreholes and read using a Kern Distometer (Figure 2-21) with an approximate accuracy of  $\pm 0.05\text{--}0.1$  mm. During the excavation of the pilot drift, the convergence in sections 1-4, 1-7, 3-2, 3-4, 3-7, 5-4, 5-6, 7-4, 4-5, 4-3 and 4-1 was measured five different times: (I) the first reading 0.5 m behind the face, (II) the second after the first 2 m round, (III) the third after the second 2 m round, (IV) the fourth after the third 2 m round, and (V) the fifth after the fourth round, which was 4 m in length.

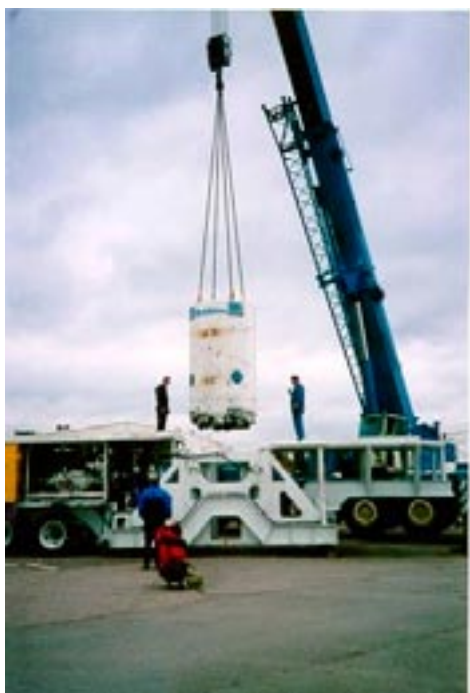
**Figure 3-3.** *Fitting of the cutter head into the frame. The converted TBM machine used for the excavation of the 1.75-m-diameter holes.*

The large 1.75-m-diameter boreholes were excavated with a TBM machine converted for vertical drilling. Figure 3-3 shows the cutter head being fitted into the frame on the surface. The large-diameter boreholes do not have exactly the same depth. The inner hole, DQ0066G01, which was confined, was bored to a depth of 6.5 m. The outer open, instrumented hole, DQ0063G01, was bored to 6.2 m. The reason for this was that the boring machine did not work very well towards the end of the boring due to technical problems and the penetration rate was very low. An elastic 3D model of the stress distribution between the two holes indicated that the effect of a 0.3 m difference in hole length was small and only evident at the bottom of the pillar. To save time it was therefore decided to stop the boring at 6.2 m. The mean diameter of the large-diameter holes is approximately 1.75 m. The centre-to-centre distance between the two holes at 0.5 m below the tunnel floor is 2.78 m, which gives an actual pillar width of 1.03 m. The pillar width was surveyed at certain depths, and the results are presented in Table 3-1.

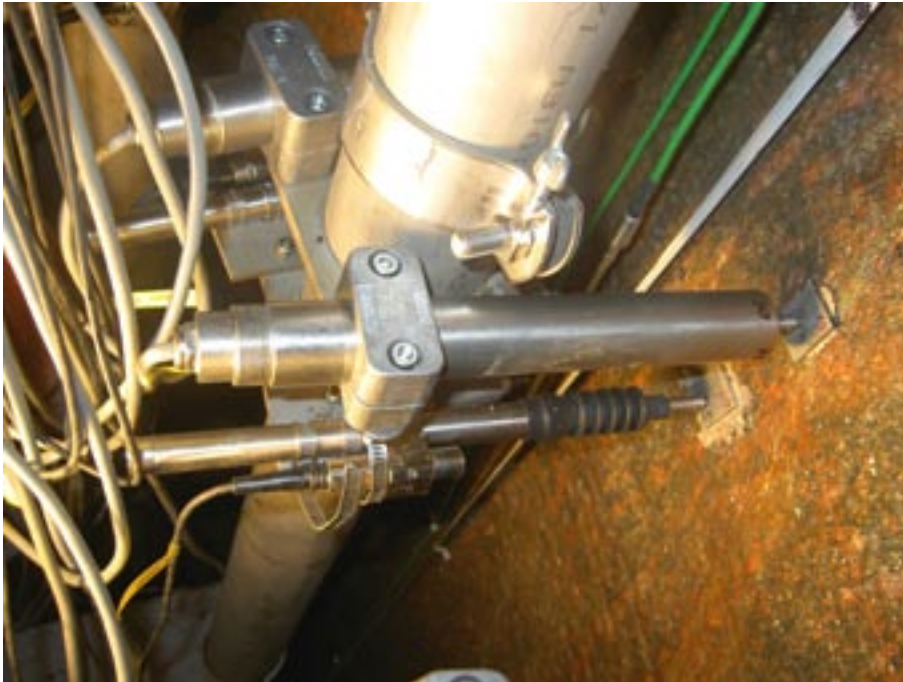
**Figure 4-3.** LVDTs mounted on a steel pipe in the open hole. The upper LVDT is of the short-range type and the lower of the wide-range type.

The LVDTs were mounted on steel pipes as illustrated in Figure 4-3 and Figure 4-4. One additional short-range LVDT was mounted directly on the rock wall parallel to the shear zone (Figure 4-5).

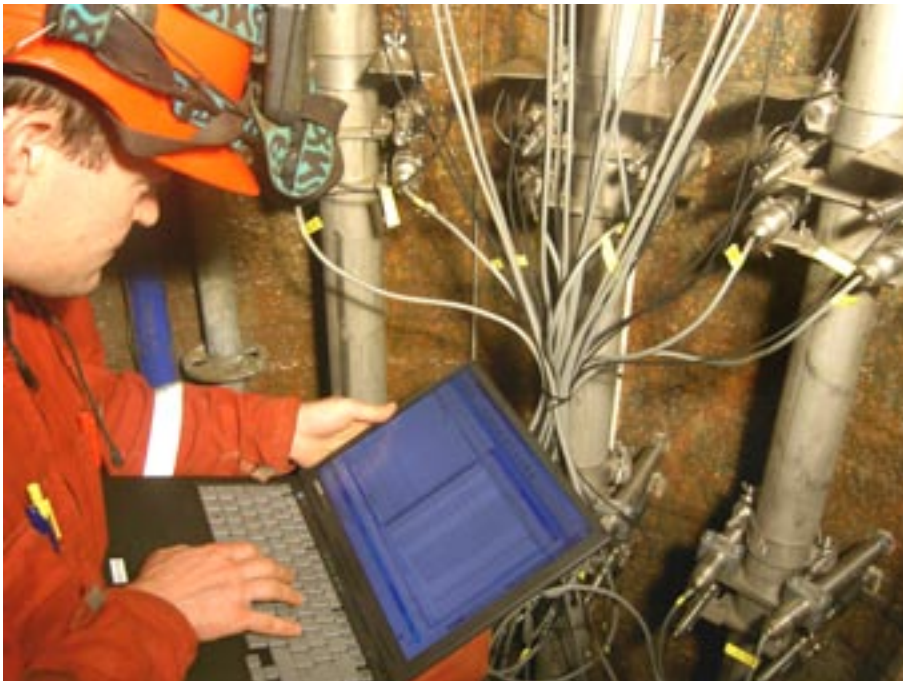
**Figure 4-4.** Function check of the radially mounted LVDTs after installation. A laptop connected to the Äspö LAN was brought down into the hole for immediate access to the LVDT response during the check.

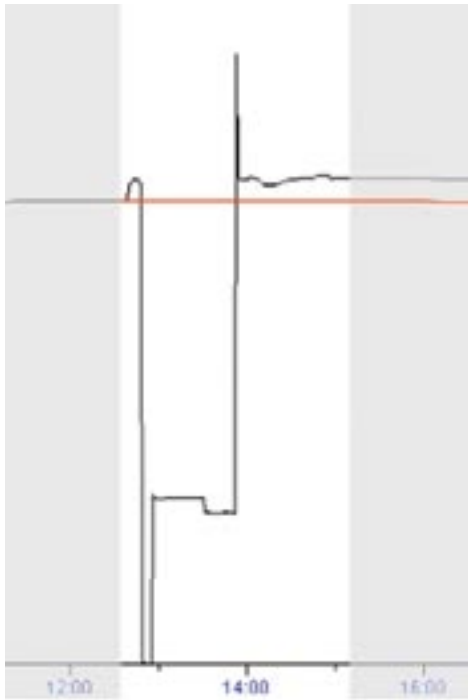
**Figure 4-7.** Example of the data filtering process. The white area is considered to be disturbed. The black line represents the measurement data from one sensor during the disturbed period. The red line represents the resulting data after filtering. As the figure shows, the filtering application removes the data from the disturbed time interval and the following data are adjusted to make a seamless continuous curve. The result is a data set that shows only the effective displacements during the experiment.

All the visits in the open hole affected the displacement monitoring. To make it easier to follow the actual displacements over time, a copy of the measured data was filtered. In this case filtering means that man-made disturbances were removed from the data set making the graphs much easier to read. For this purpose the data sampled during the disturbed periods were removed. To make the data curves readable, the data after the disturbed period were adjusted, raised or lowered, to the level prior the disturbance. An example of this is shown in Figure 4-7. This makes the data set continuous and it only shows the total displacements from the start of the experiment. It is important to note that this kind of filtering was only done at times when the log lists stated that some kind of activity had taken place in the open hole. The filtered periods are shown in Appendix 4a. The filtering process is described in greater detail in /Eng and Andersson 2004/.

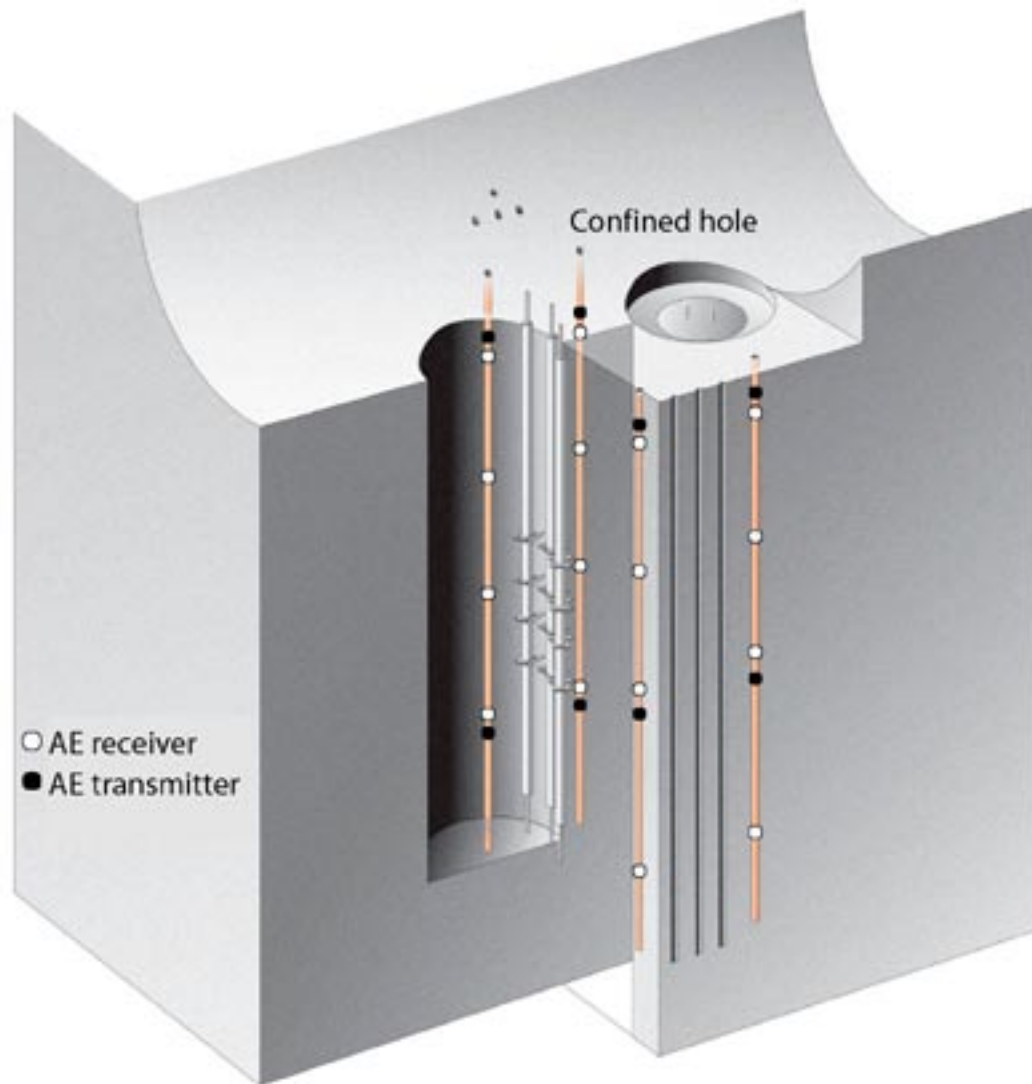
**Figure 4-8.** A schematic of the AE acquisition system and sensor configuration. There are two ultrasonic transducers and four receivers in each instrumented borehole.
