**Äspö Hard Rock Laboratory**

**Äspö Pillar Stability Experiment,  
Final report**

**Rock mass response to coupled  
mechanical thermal loading**

January 2007

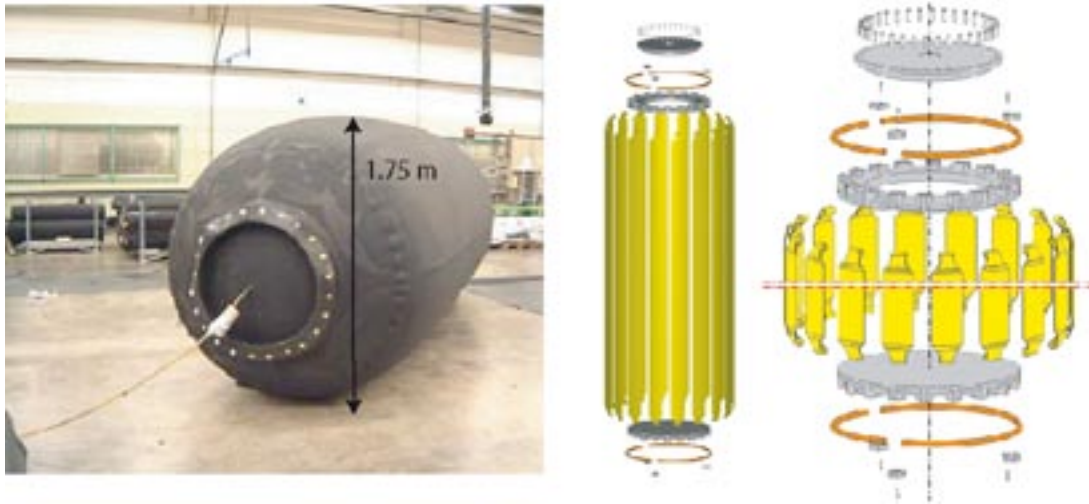
**Figure 4-9.** The specially constructed rubber bladder and the confining equipment. The vertical textile straps connected to the horizontal steel plates kept the bladder in place as it was expanded by a water pressure.

system was constructed of a rubber bladder approximately 1.75 m in diameter and 6 m long installed in a system consisting of steel plates connected by strong textile straps (Figure 4-9 and Figure 4-10). The textile straps had to fit tightly against each other to ensure that the bladder would not protrude through a small gap and burst. When the bladder was filled with water and pressurized it was self-supporting in the hole.

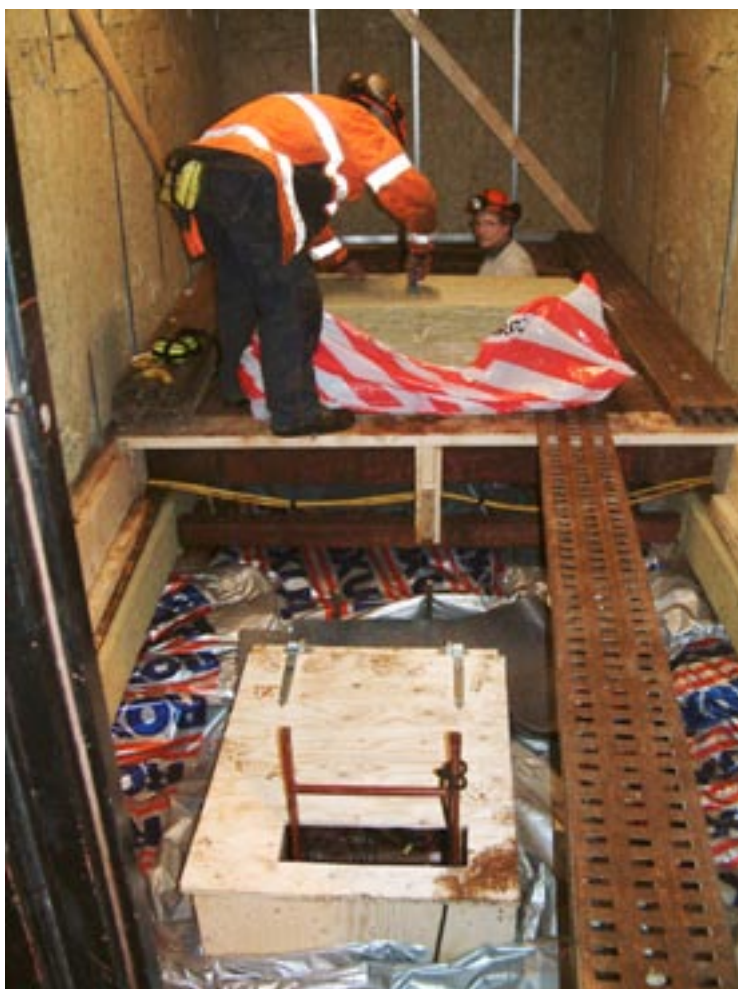
**Figure 4-12.** Photograph of rock floor insulation and the insulated plywood construction placed on top of the open hole (DQ0063G01) to prevent air convection.

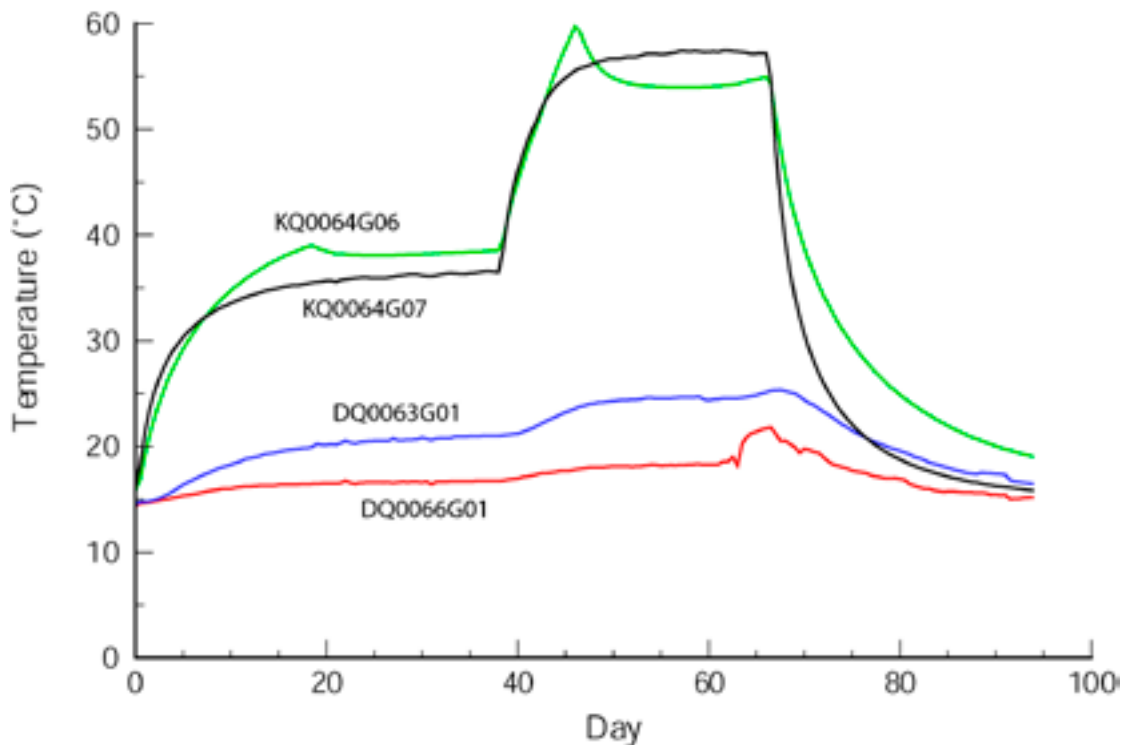
**Figure 5-1.** Temperature at a depth of 3.5 m depth below the tunnel floor on different dates. The response to the reduction of the power input to the left-side heaters is clearly evident. Hole wall temperature from large-diameter hole DQ0063G01.

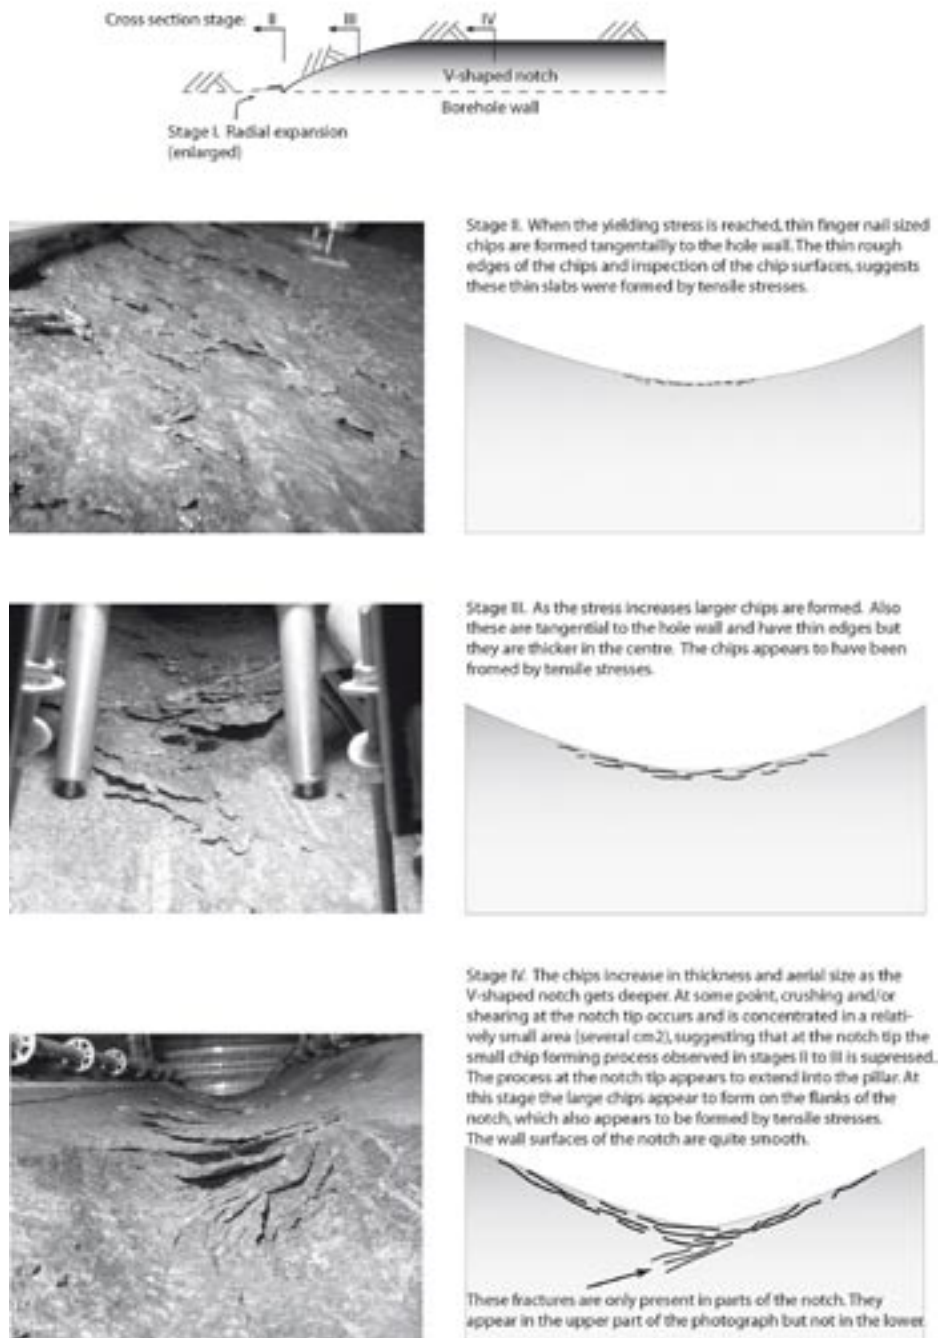
**Figure 6-14.** Illustration of the yielding process in an overstressed granitic rock.

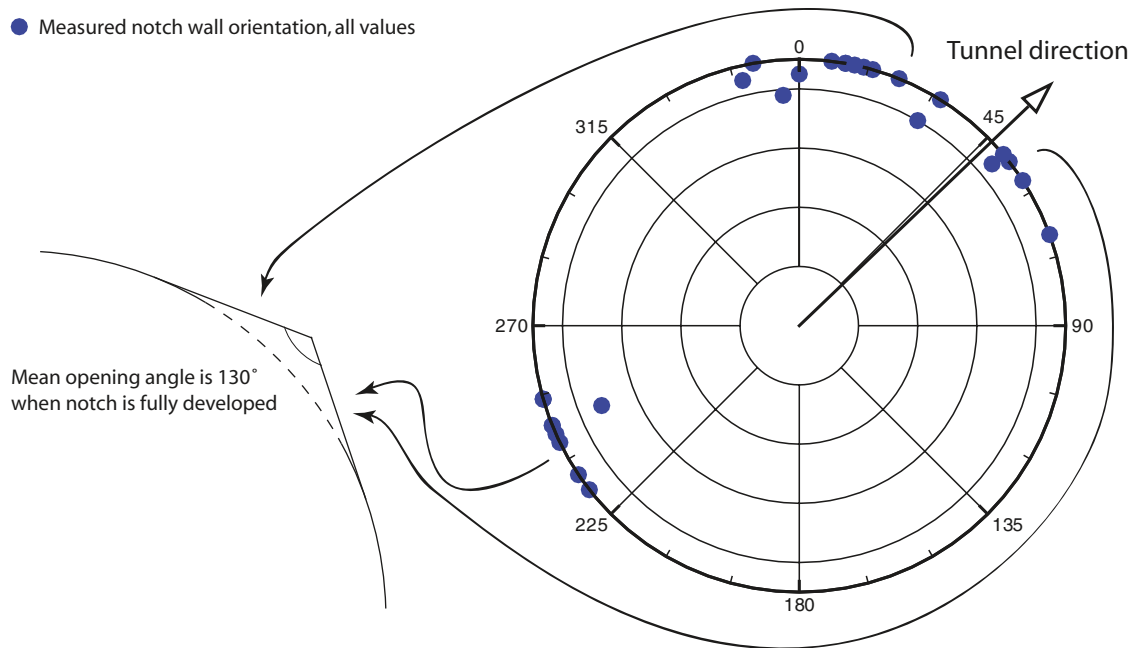
**Figure 6-15.** Lower hemisphere projection of the notch walls. The total opening angle of the notch was approximately 130 degrees.

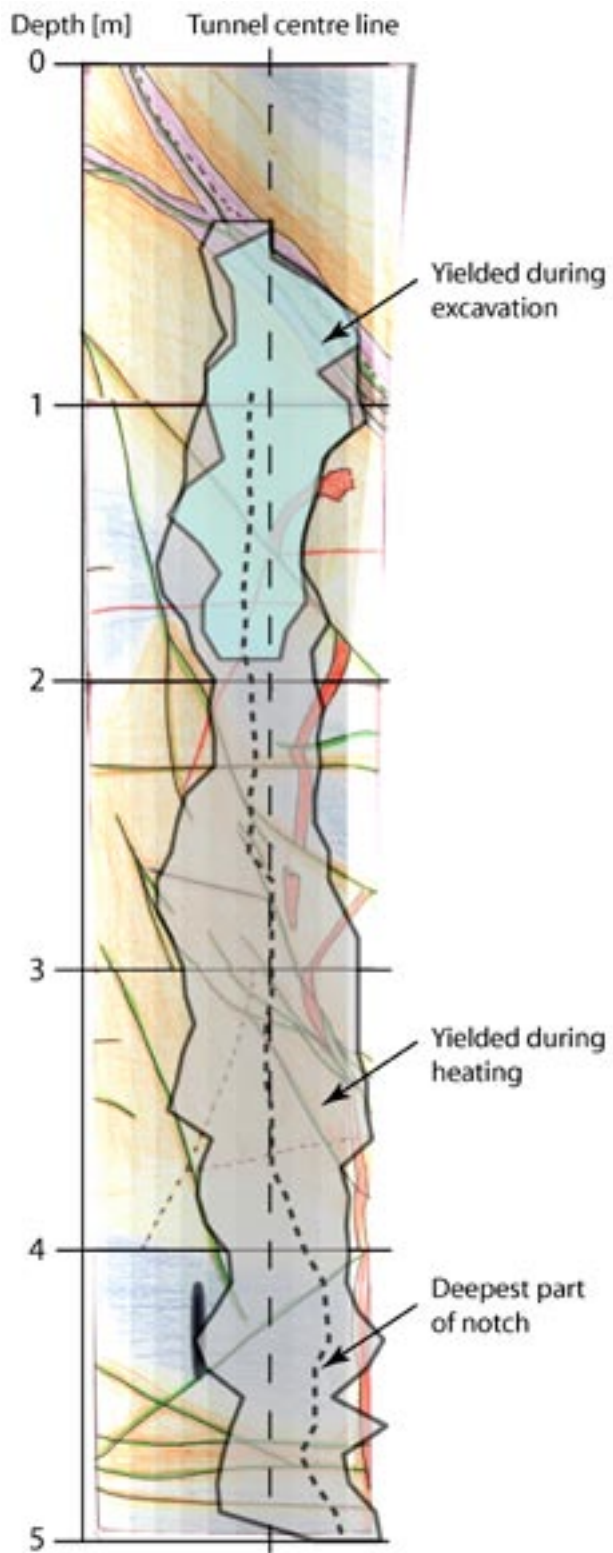
*Figure 6-16. Yielded areas before and after heating.*

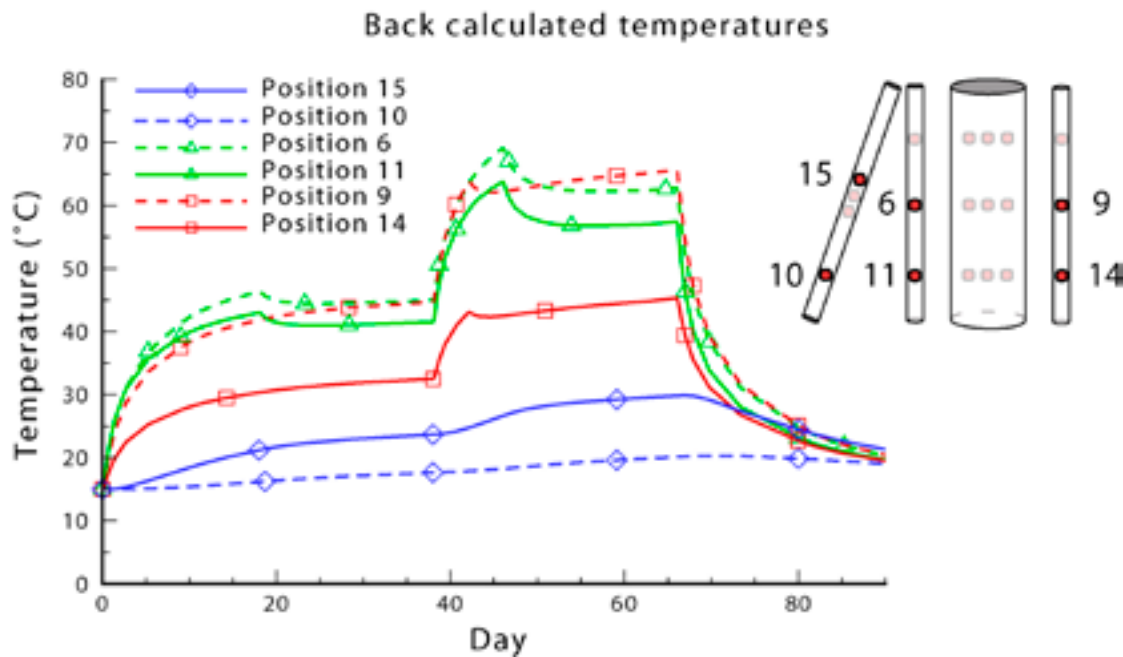
**Figure 7-2.** Graph of the results of back calculation of the temperatures. Since the temperatures in the large holes were used as boundary conditions they are not included.

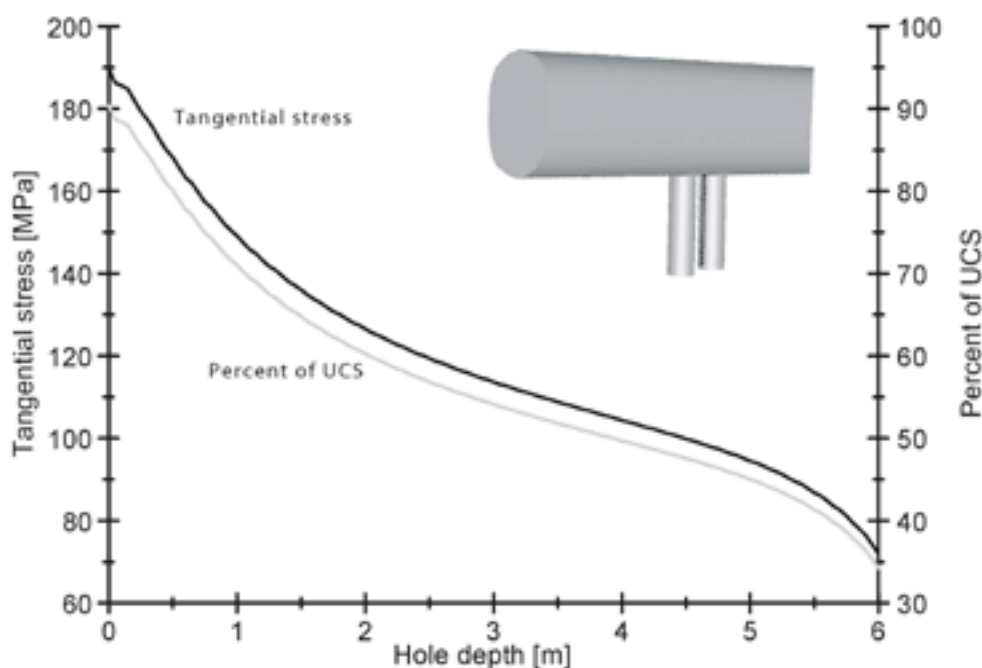
**Figure 8-2.** Excavation induced tangential stress along the most stressed part of the pillar. The dashed line indicates where the stress is modelled slightly to the left of the pillar centre in the second hole, DQ0063G01.

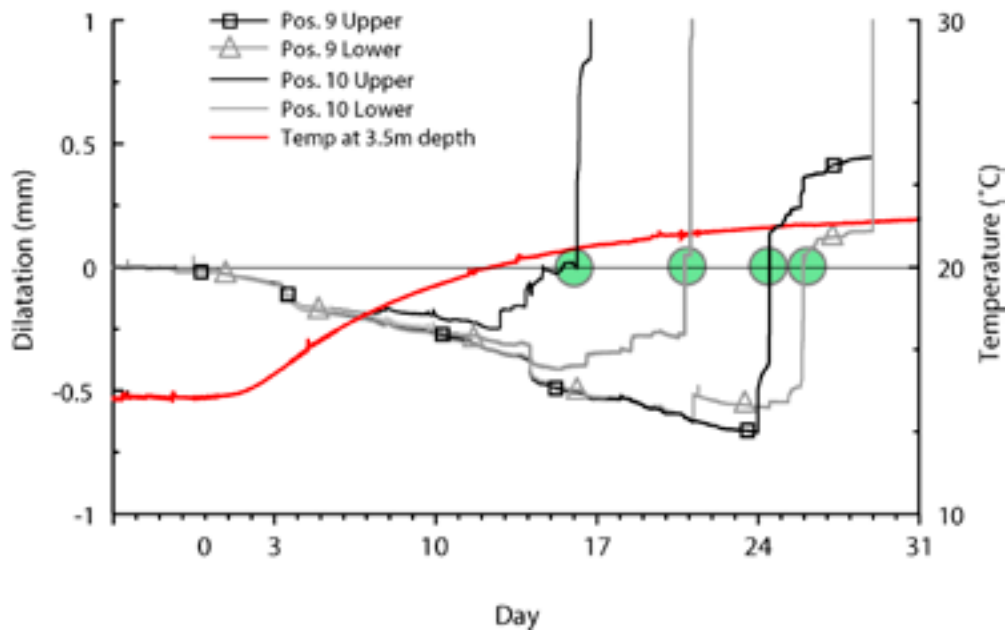
**Figure 8-6.** Displacement records at 3 m depth. Circles indicates when the transducers were compressed more than their initial setting. The negative displacements are an elastic radial expansion of the hole preceding the brittle failure. The measured temperature at the hole wall approximately 0.5 m below the LVDTs is also given.

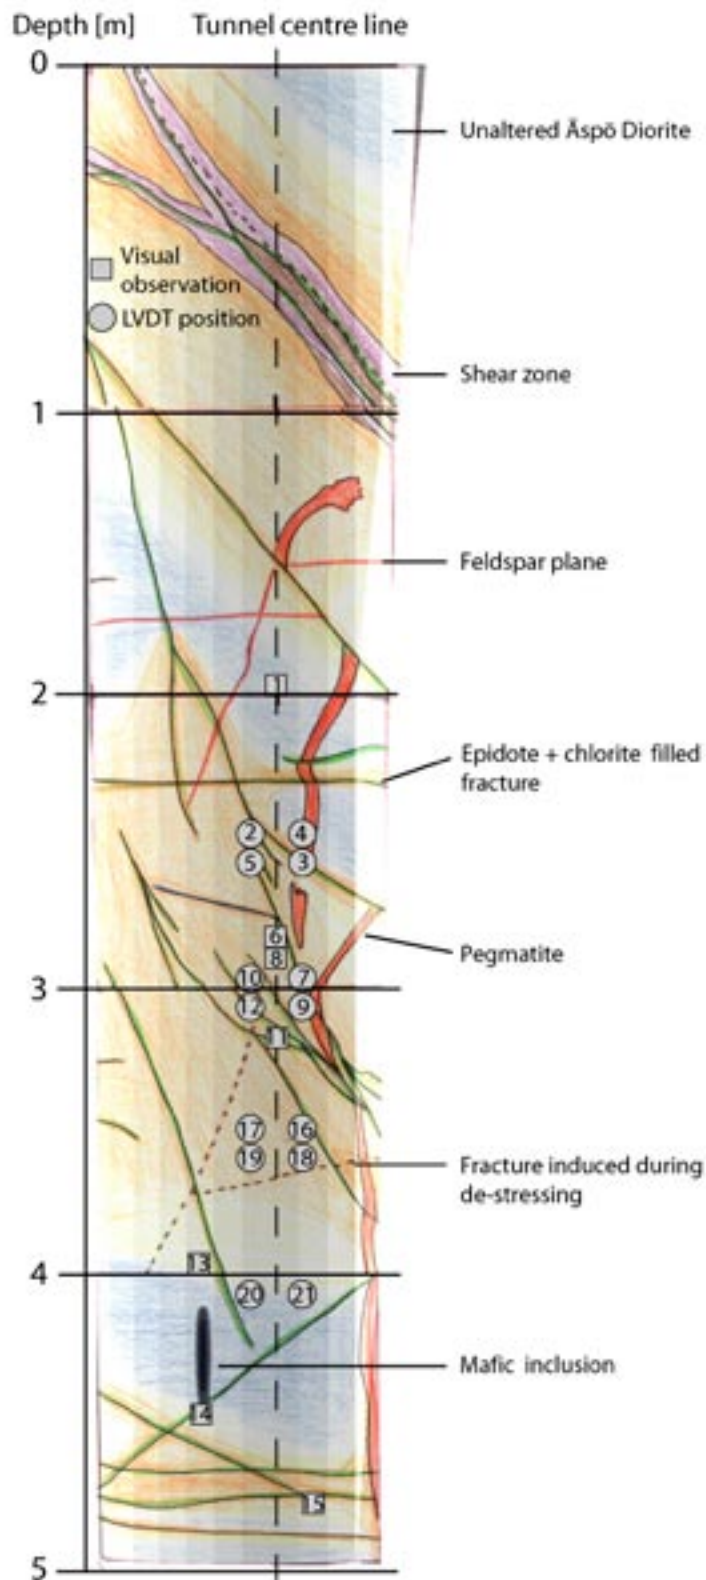
**Figure 8-7.** Illustration of the yielding locations numbered in the order they occurred placed on top of the geological mapping. Circles indicate LVDT positions and squares visual observations.

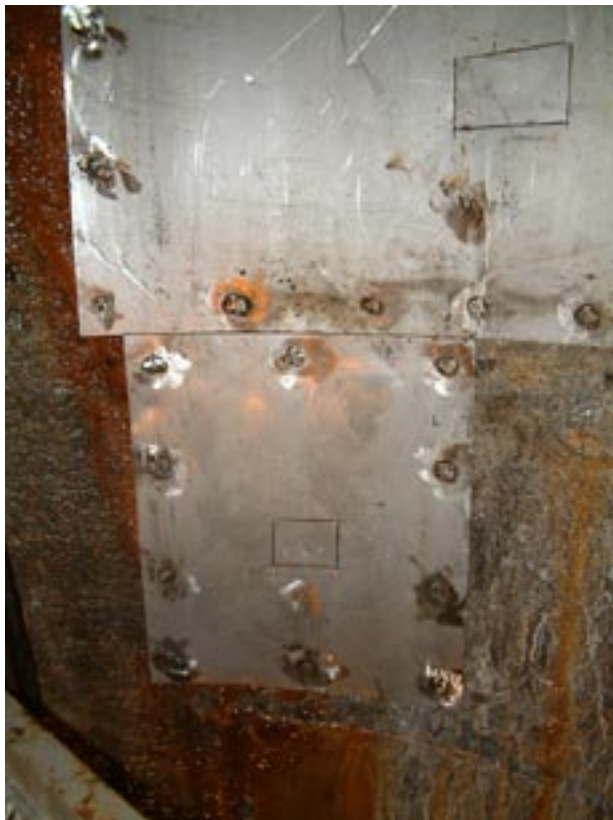
*Figure 9-1. Photograph of steel plates bolted to the hole wall.*

During the drilling of the first hole (DQ0066G01) that was later confined, yielding occurred in weak, altered, parts of the hole wall located relatively close to the most stressed zone of the hole. The confinement equipment required a smooth hole wall to work against. Cavities in the hole wall would cause the rubber bladder to deform and be punctured. To avoid this, the cavities caused by yielding were filled. In the upper part of the pillar where water leakage was low, a cement mixture was used. A thin steel mesh had to be put up in those cavities as reinforcement to hold the cement during curing. The mesh was fastened with short bolts drilled a few centimetres into the rock wall. In the lower part of the hole, where the water inflow was more intense, another technique was used. Steel plates, Figure 9-1, were bolted against the rock wall with approximately 5 cm long bolts drilled into the rock wall. The volume behind the plates was filled with sand.

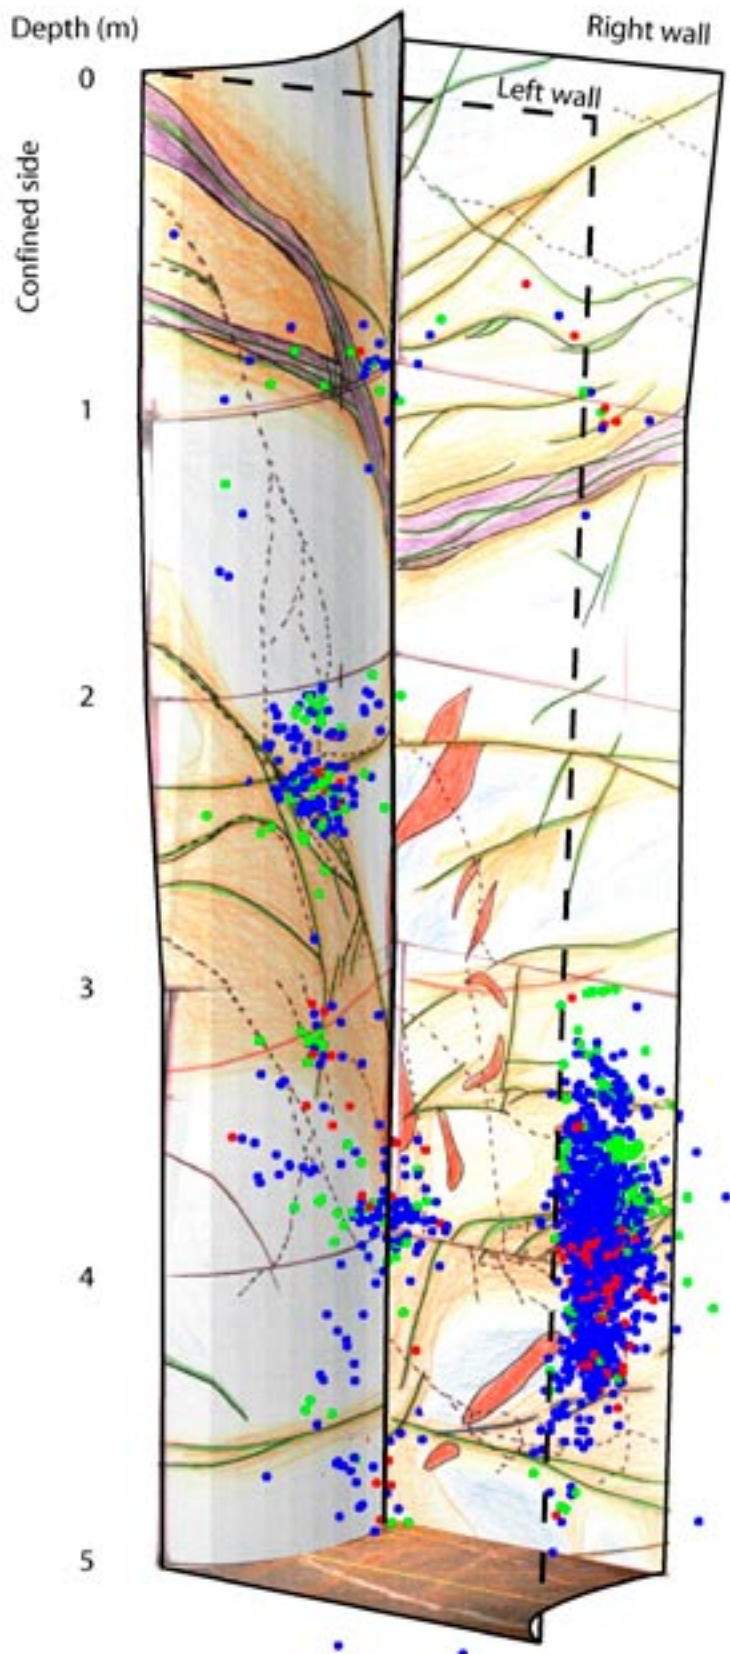
**Figure 9-8.** Location of AEs at the confined side viewed from the open side. The figure contains all data from day 61 to day 63.

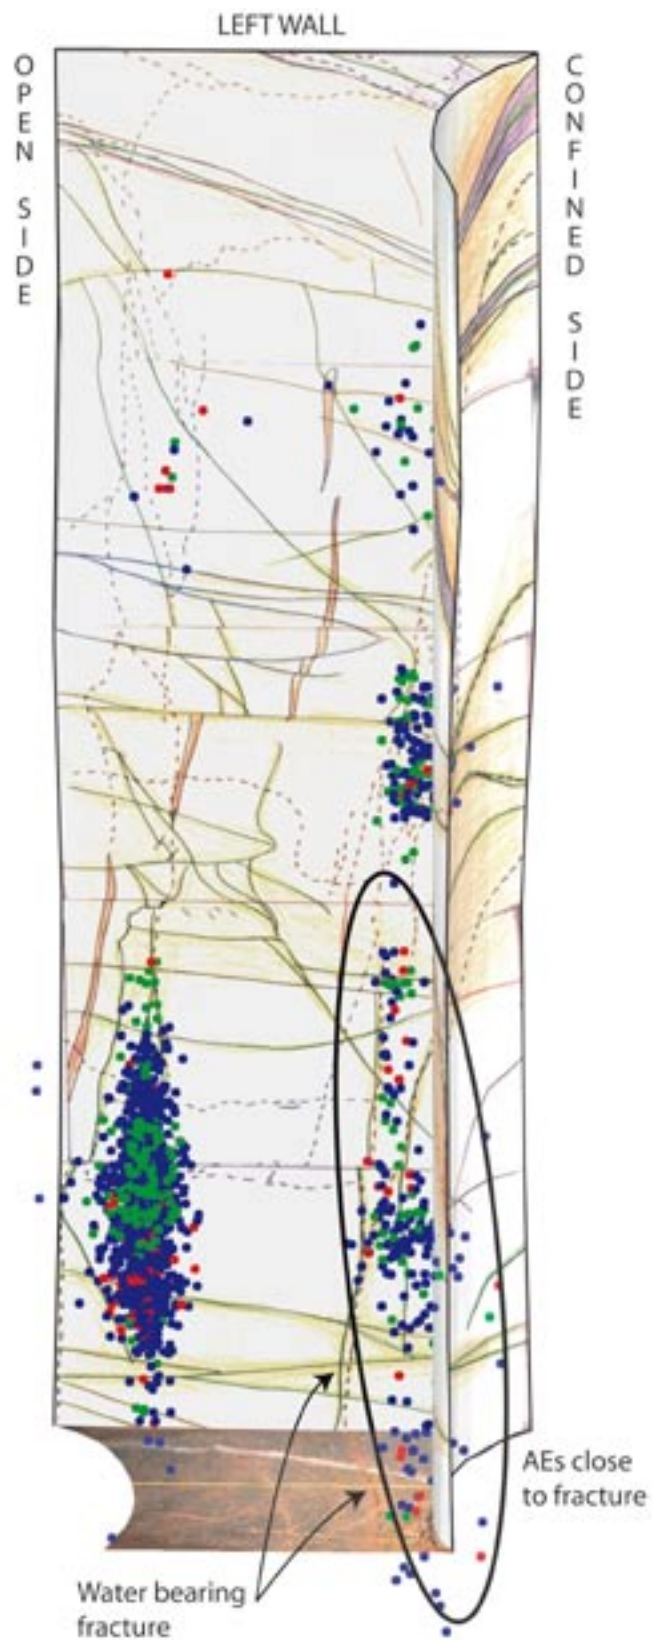
**Figure 9-9.** Location of the AEs in relation to the water-bearing fracture. The figure contains all data from day 61 to day 63.

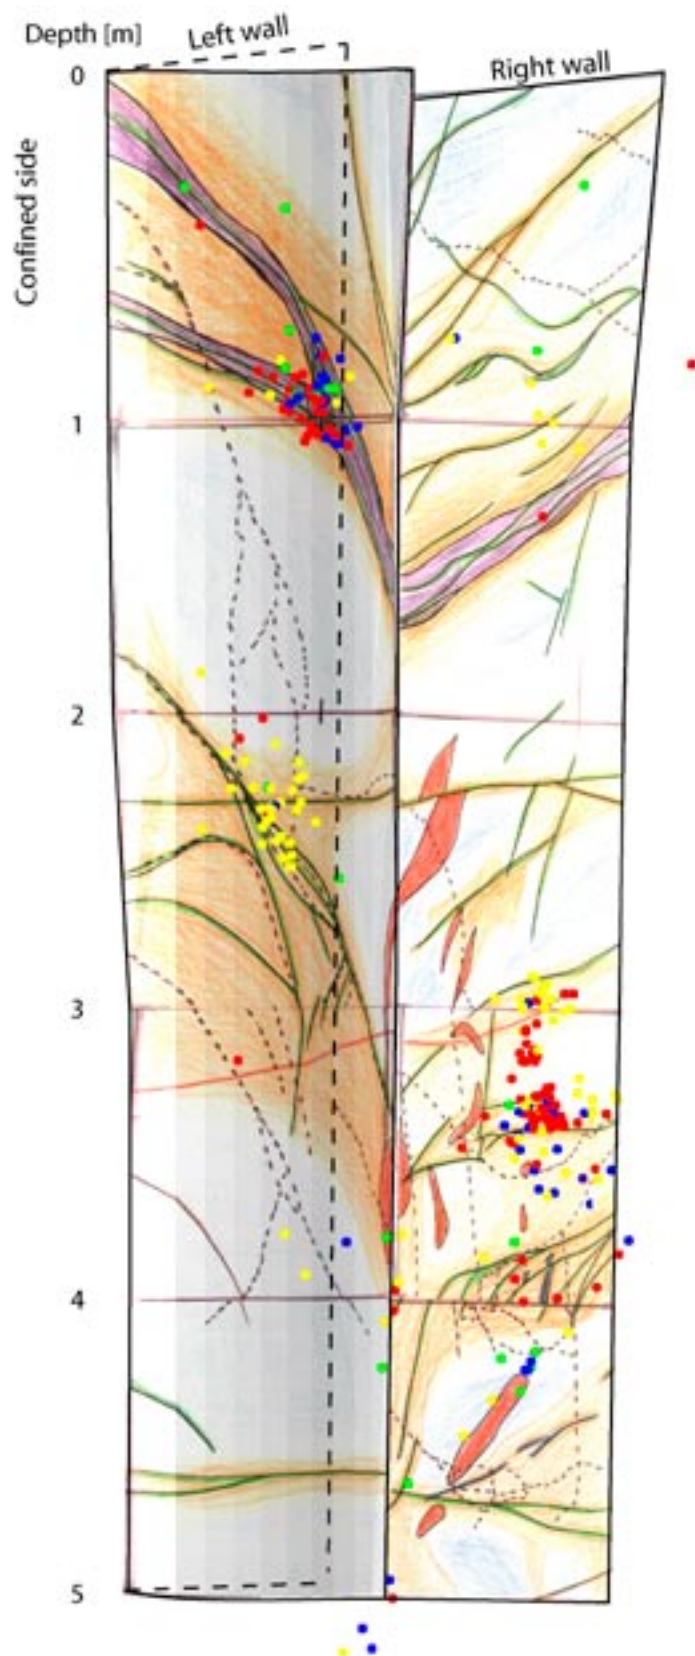
*Figure 9-10. Location of AEs from day 64 to day 66.*

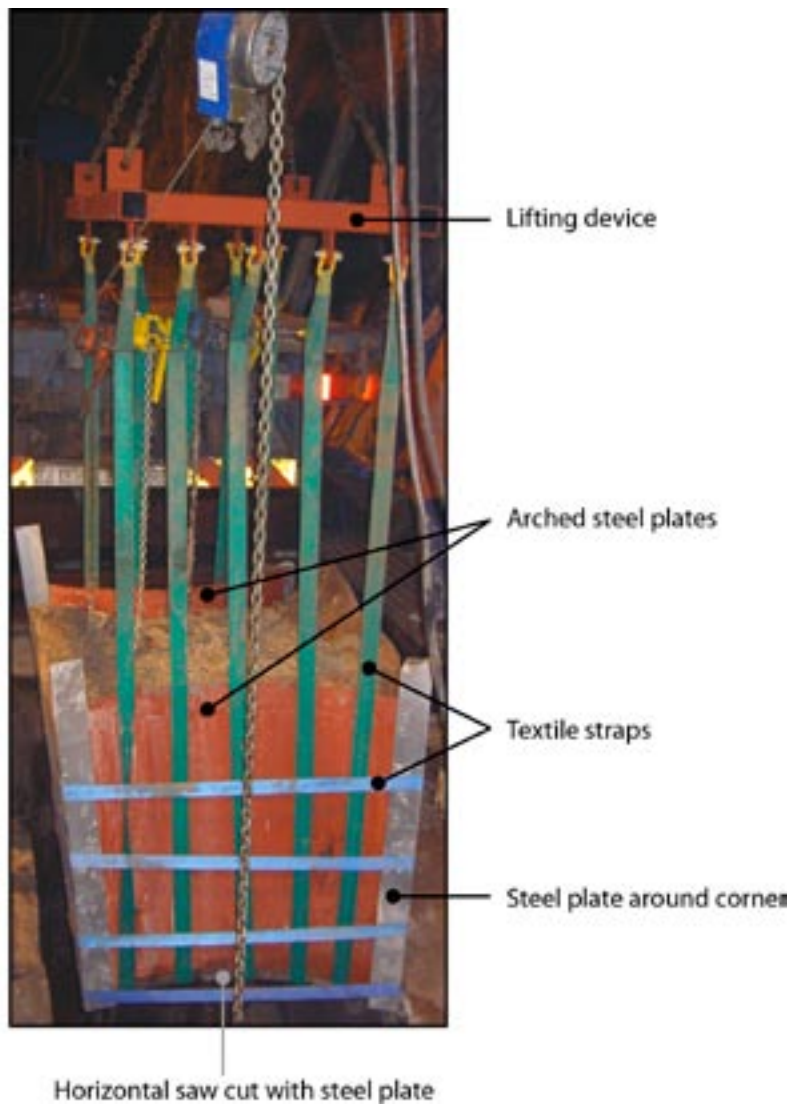
**Figure 10-2.** *Lifting of block number 1 (the top block). Some of the work steps described in the numbered list above are indicated in the figure.*

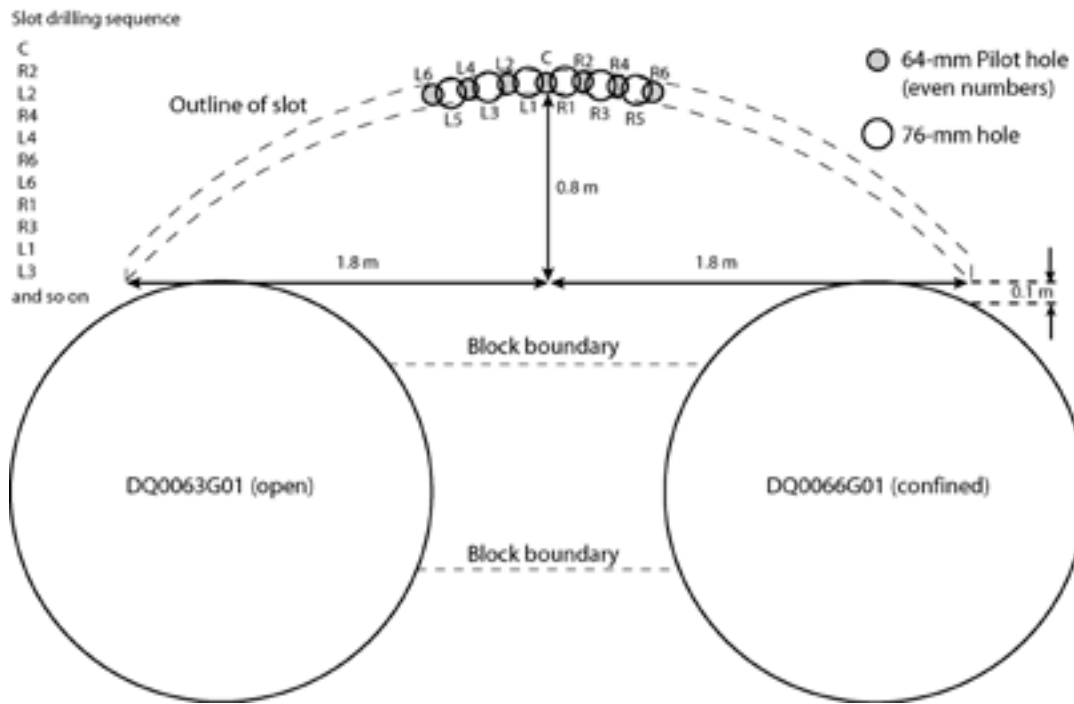
**Figure 10-3.** Illustration of the Swedish slot drilling technique and the geometry of the APSE de-stressing slot.

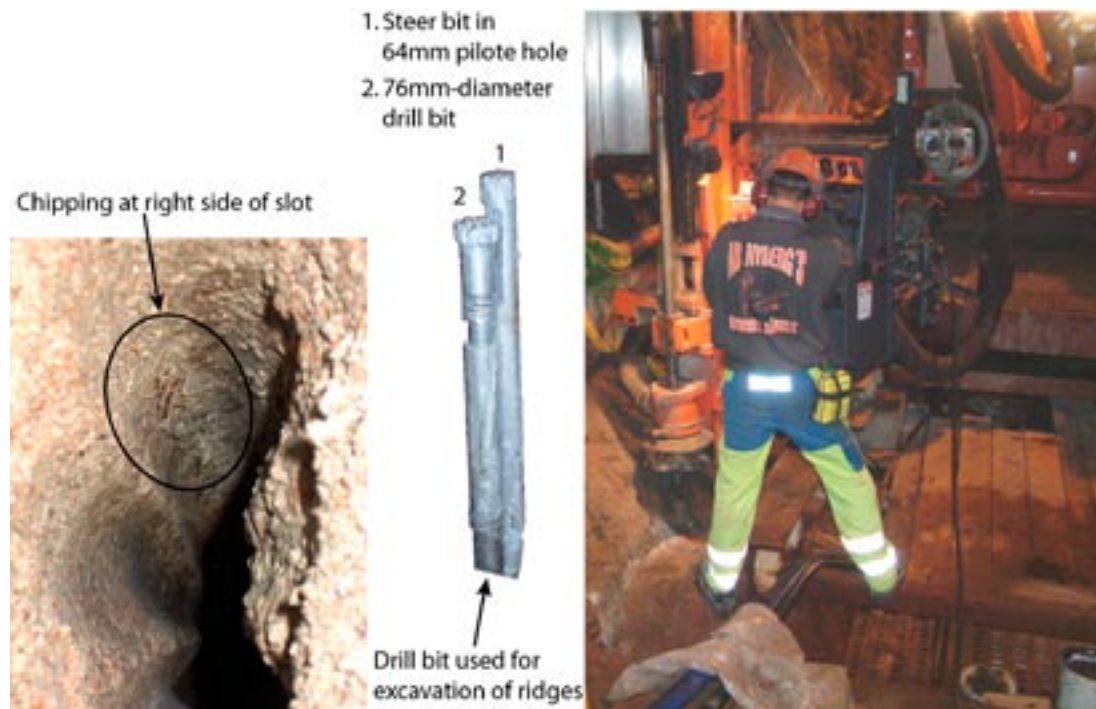
**Figure 10-4.** Left: chipping initiated from the top of the right part of the notch. Right: photograph of the drilling of the slot.

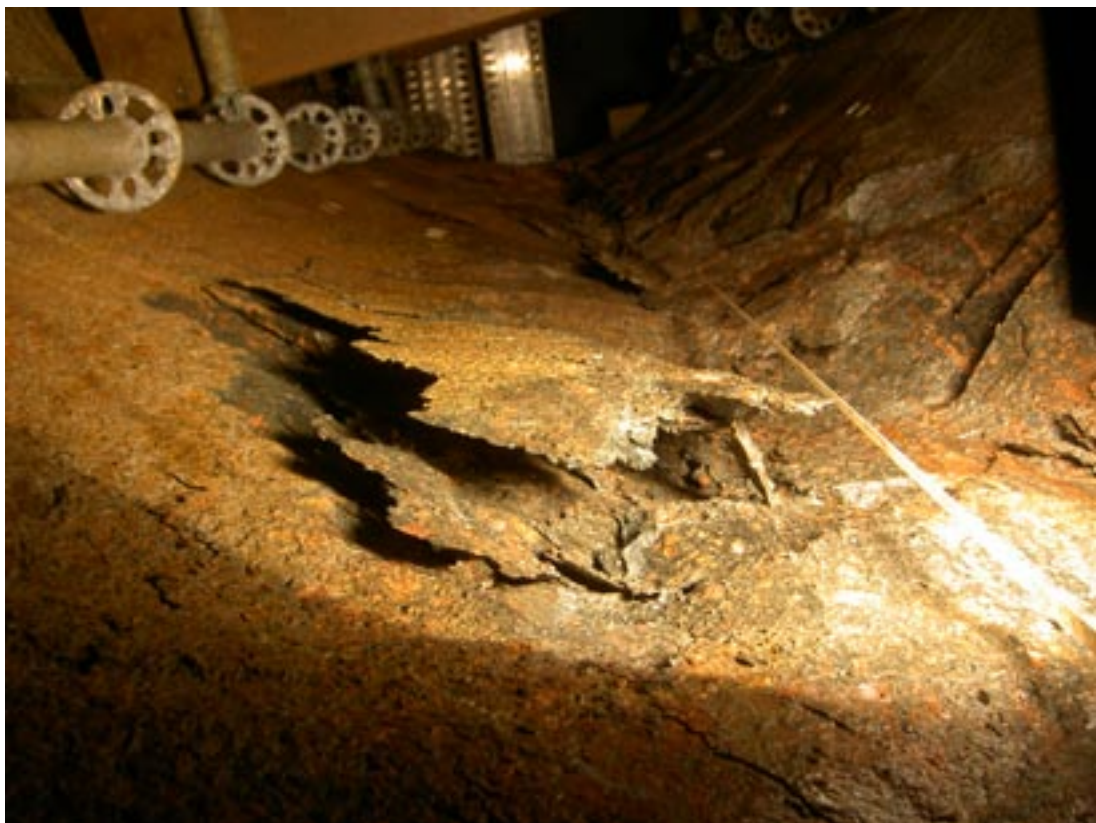
**Figure 10-5.** Photograph of the extensive yielding that took place as the slot was drilled.

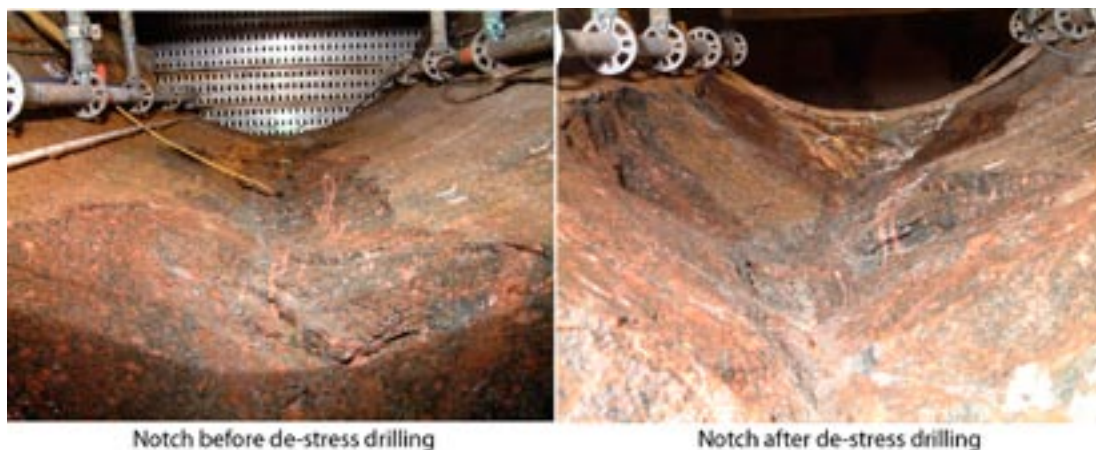
**Figure 10-6.** Photograph of the pillar taken in DQ0063G01 from a depth of approximately 3 m and up. The photograph on the left was taken before de-stressing began and the one on the right after removal of the slabs created during de-stressing.

Yielding of the rock was more extensive on the left side of the pillar. The blocks were therefore not cut symmetrically around the centre line of the tunnel but optimized so that the entire yielded part of the pillar was retrieved with the blocks (Figure 10-6). The size of the blocks differed somewhat since they were made conical to reduce the risk of jamming as they were lifted.

All slot boreholes were percussion-drilled with a Tamrock Dino 560 machine, Figure 10-4. When approximately 0.2 m had been drilled on each side of the centre, it was noticed that chipping occurred on both sides of the slot. On the left side the chipping began at a depth of  $\sim 0.4$  m and on the right side right at the surface, Figure 10-4. The chipping stopped when the drilling had reached a horizontal distance of  $\sim 0.8$  m on either side of the centre of the slot. Initial inspection of hole DQ0063G01 was undertaken when the chipping had just stopped. Extensive yielding had taken place as is indicated in Figure 10-5. Before de-stress drilling was initiated, the notch wall was smooth and no slabs were loose, Figure 10-6. In Figure 10-6 there is also photograph of the hole wall after the slabs formed during de-stressing had been removed. As can be seen, there is quite a big difference between the two photos.

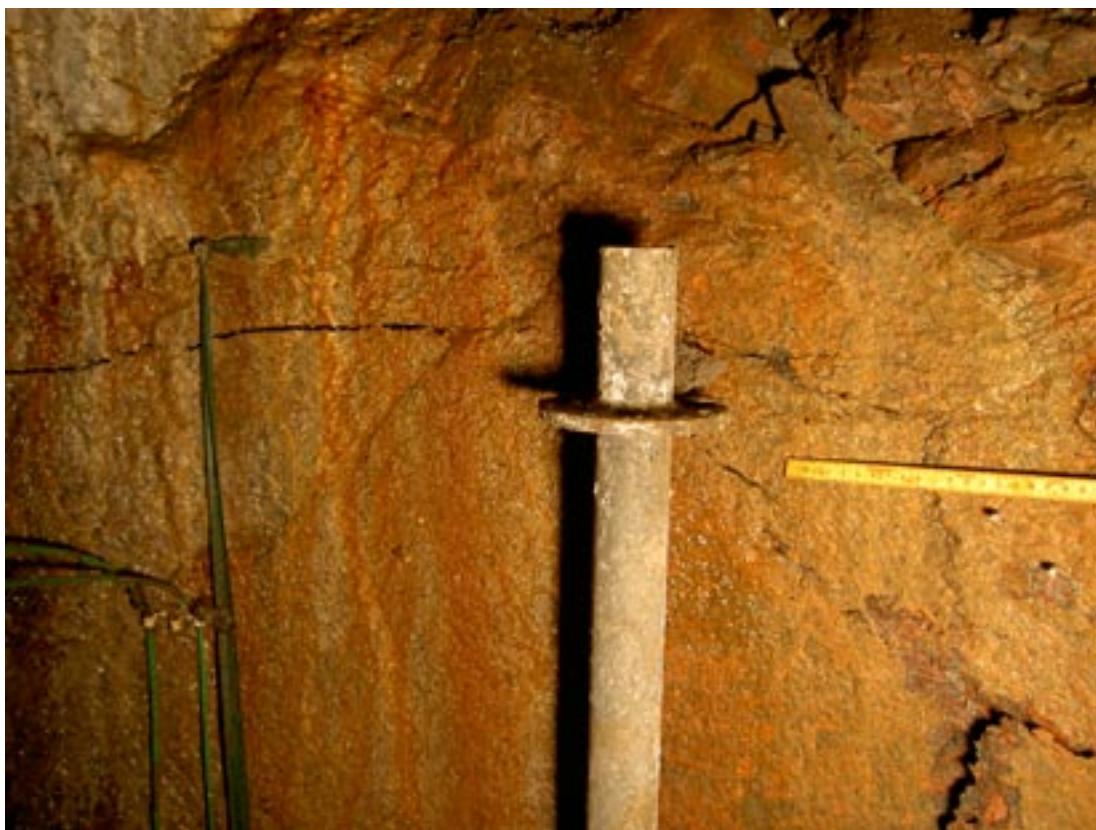
**Figure 10-7.** Photograph of the horizontal fracture that dilated during de-stress drilling. Note how it ends/begins close to the shear zone.

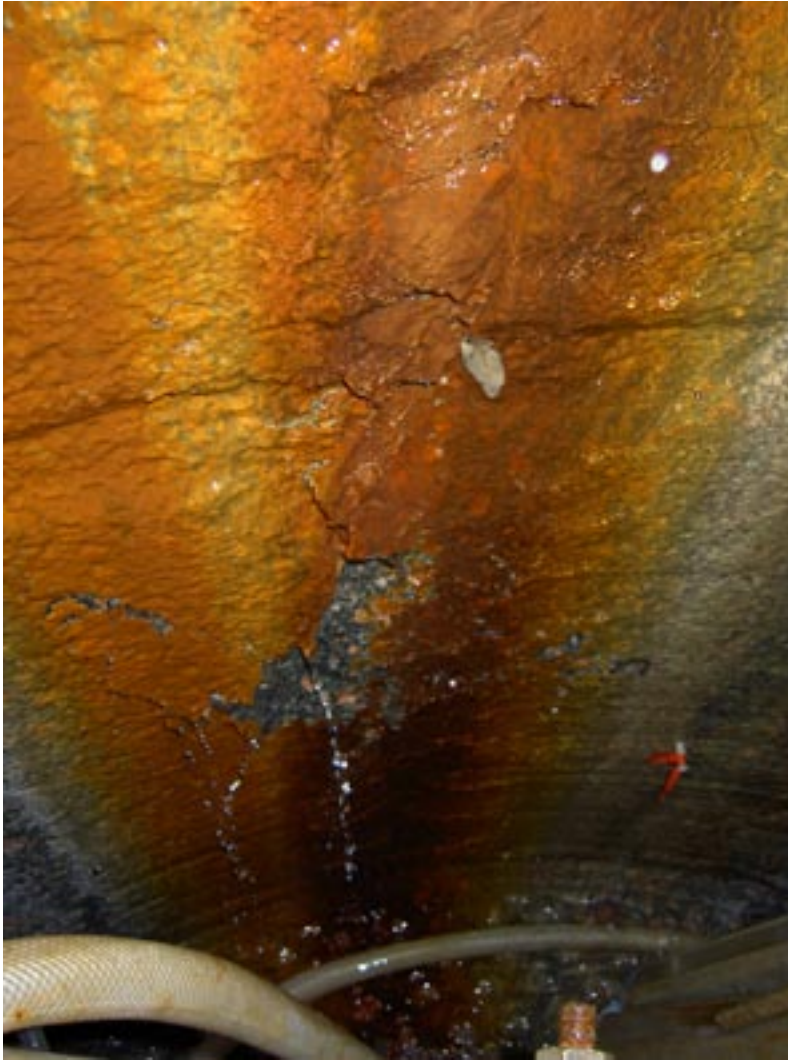
**Figure 10-8.** Yielding at the back side of DQ0063G01. Dilation of rock slabs and the previous location of the ejected rock piece are visible.

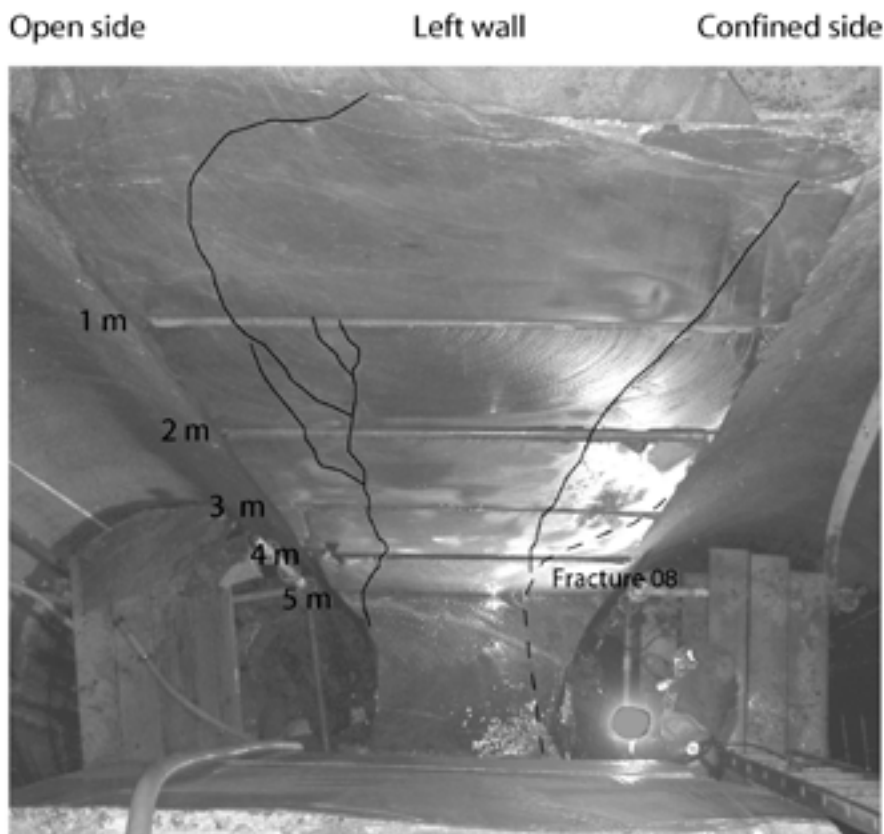
**Figure 10-9.** Photograph down the left wall of the host rock after removal of the pillar blocks. The failed zones and fracture 08 (dashed line) are indicated.

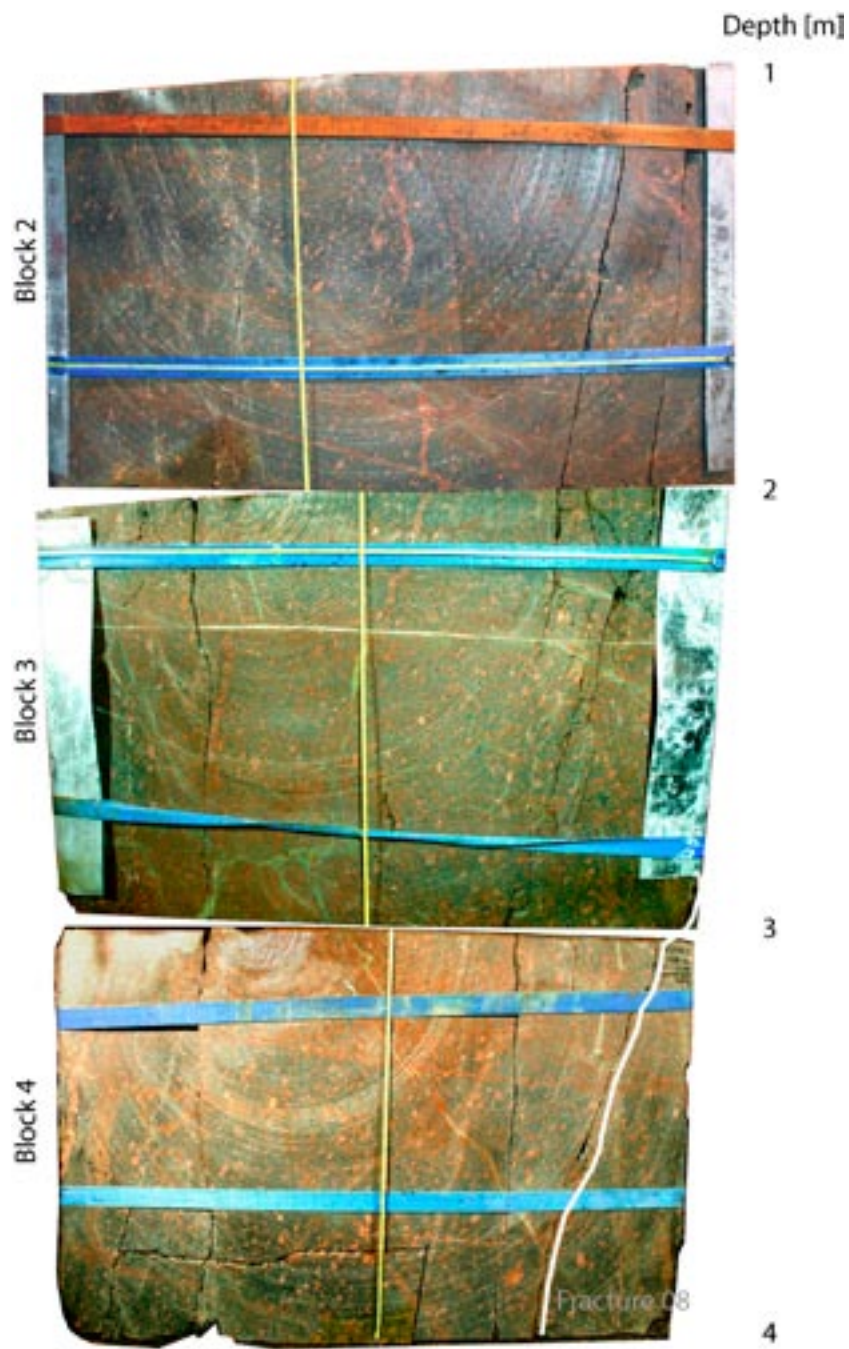
**Figure 10-10.** Assembly of photographs of the left side of blocks 2, 3 and 4. The photographs have been mirrored to permit direct comparison with the photograph of the remaining wall.

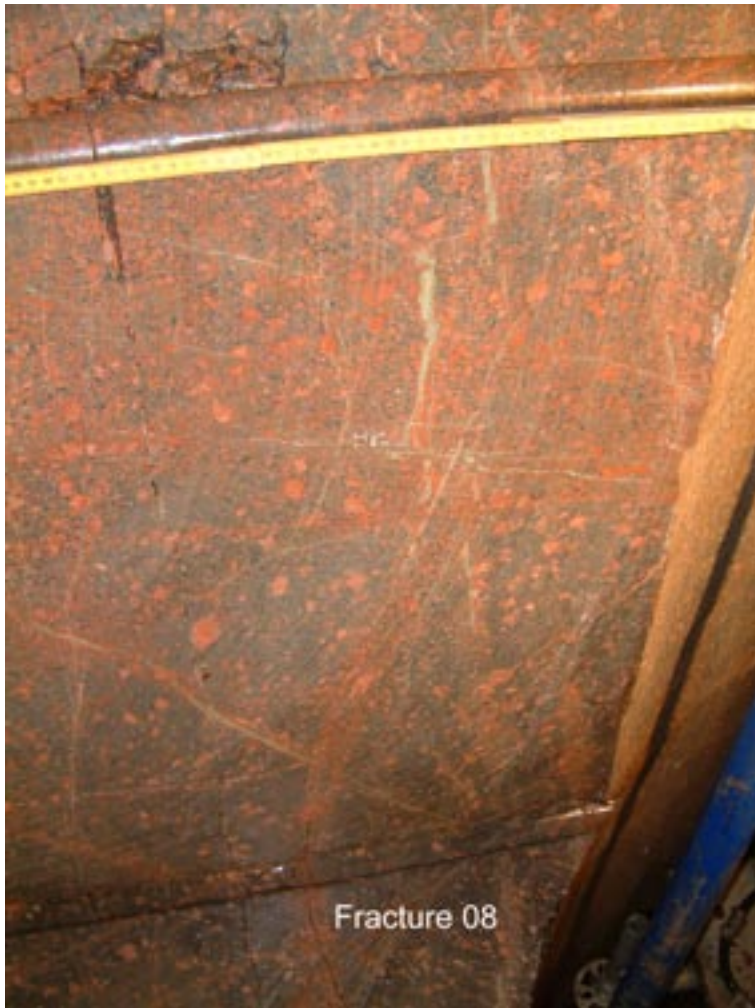
**Figure 10-11.** Photograph taken of fracture 08 in the remaining left wall. The drill pipe is at a depth of 4 m. The intersection between the failed zone and the pre-existing fracture indicated by the oxidized band is clearly visible.
