**Äspö Hard Rock Laboratory**

**Äspö Pillar Stability Experiment,  
Final report**

**Rock mass response to coupled  
mechanical thermal loading**

January 2007

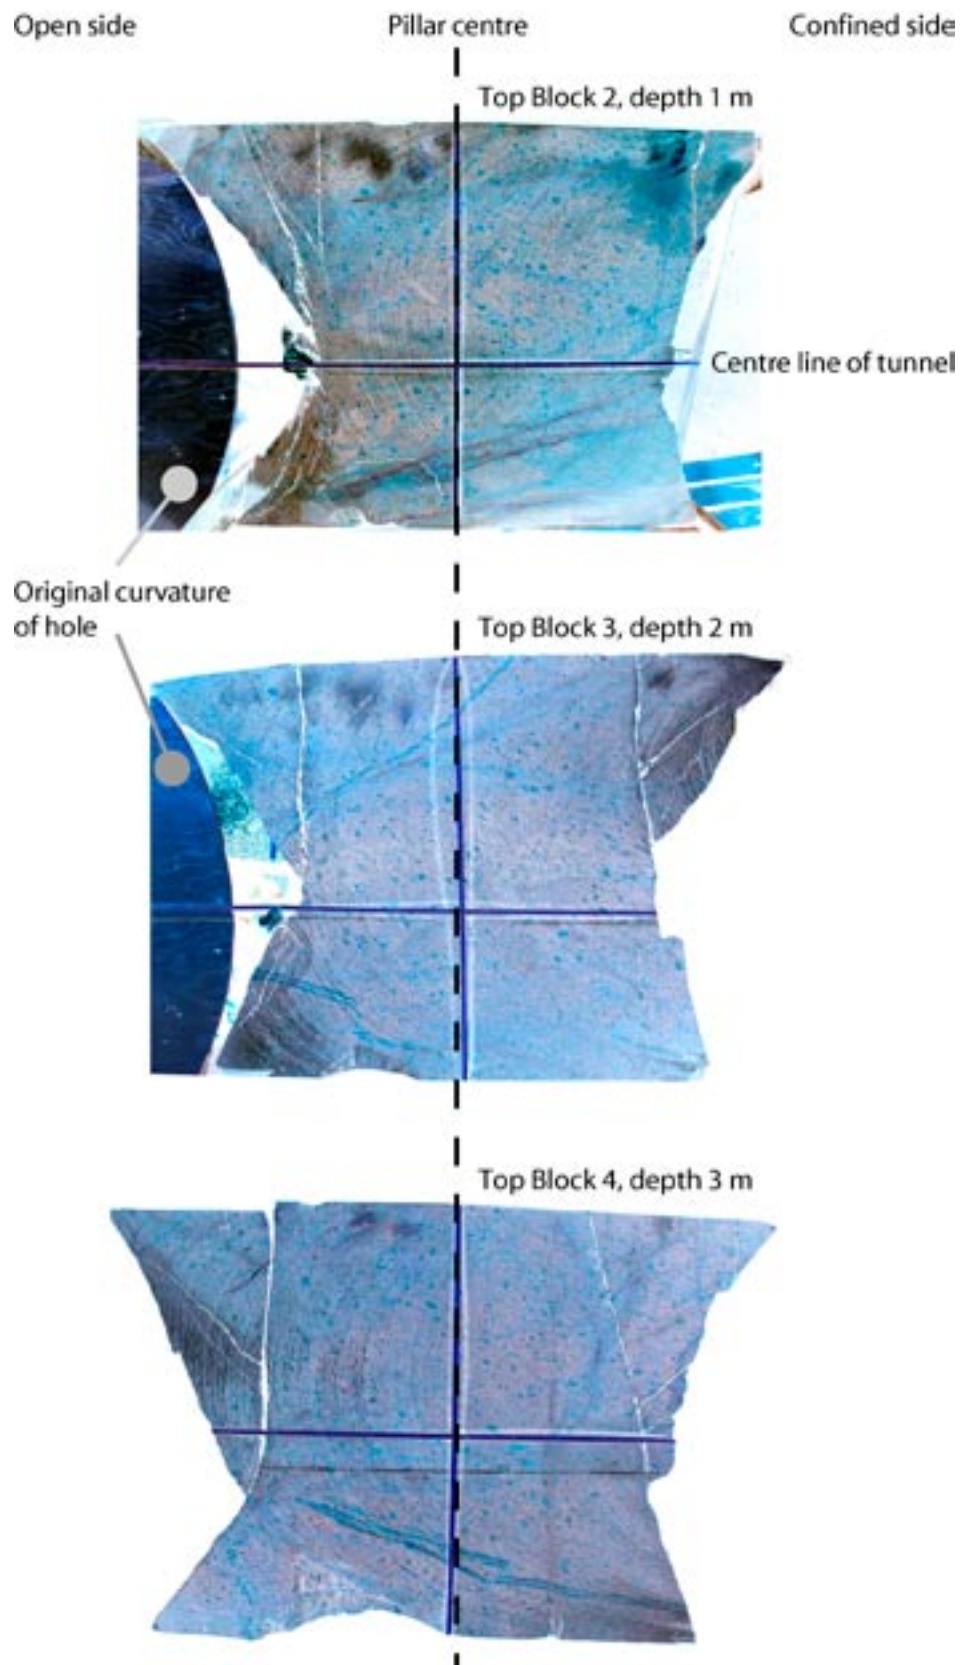
**Figure 10-12.** Photographs of the tops of block 2, 3 and 4 with the general fracture pattern. The colours have been inverted to better illustrate the fracturing. The white traces of the failed zones are clearly visible above the centre line of the tunnel.

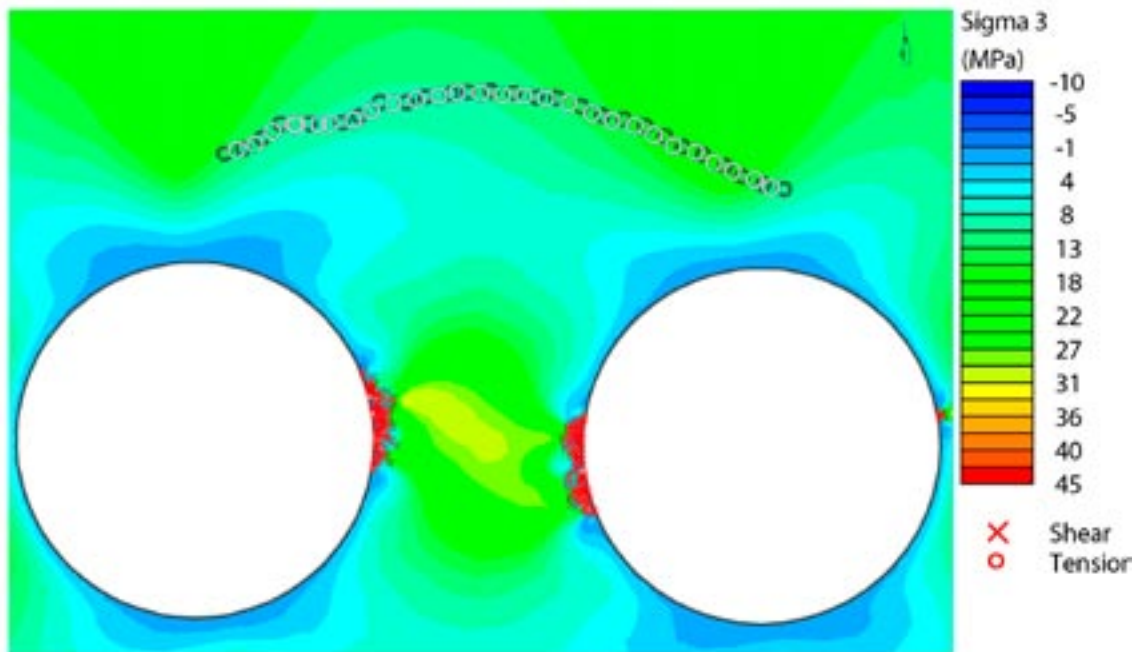
**Figure 10-16.** Yielded elements and minor principal stress at modelling stage 6.

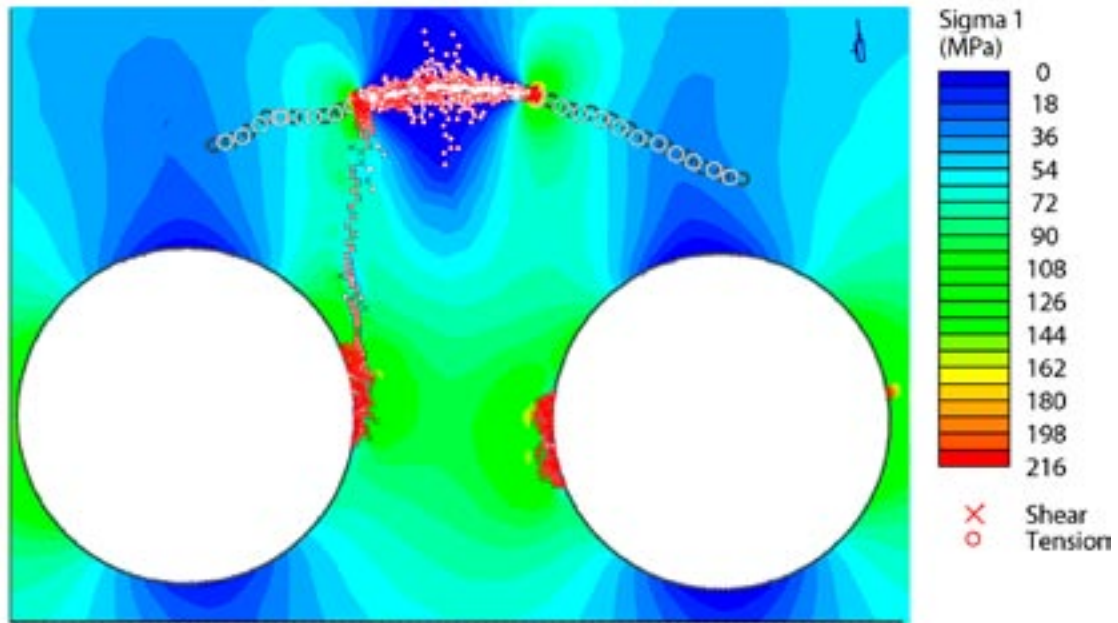
**Figure 10-17.** Yielded elements and major principal stress at modelling stage 14. The extent of the notch is indicated. A failed zone has formed between the slot and DQ0063G01.

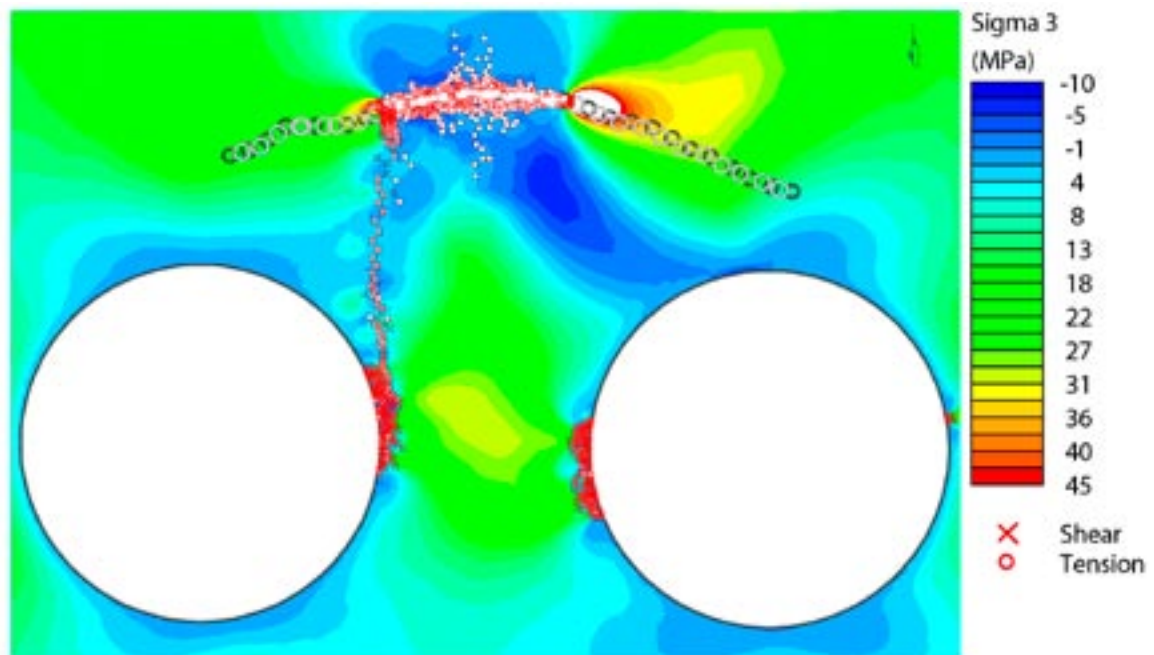
**Figure 10-18.** Yielded elements and minor principal stress at modelling stage 14. The confinement is around zero along the failed zone and a band with tensile stresses has formed between the slot and DQ0066G01.

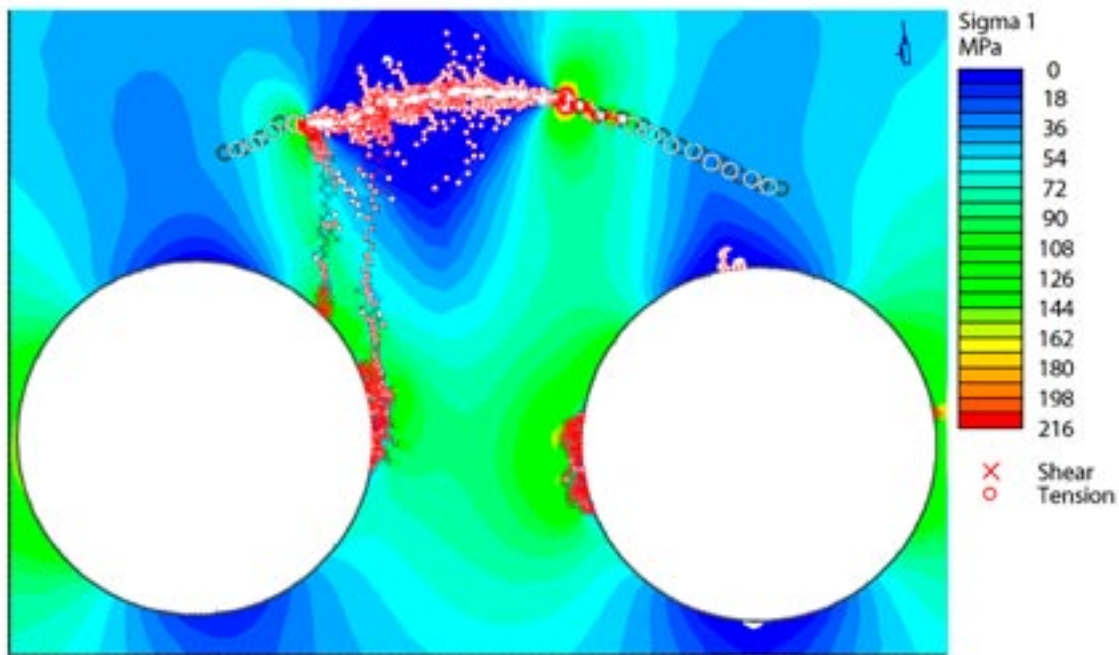
**Figure 10-19.** Yielded elements and major principal stress at modelling stage 18. Another failed zone has formed.

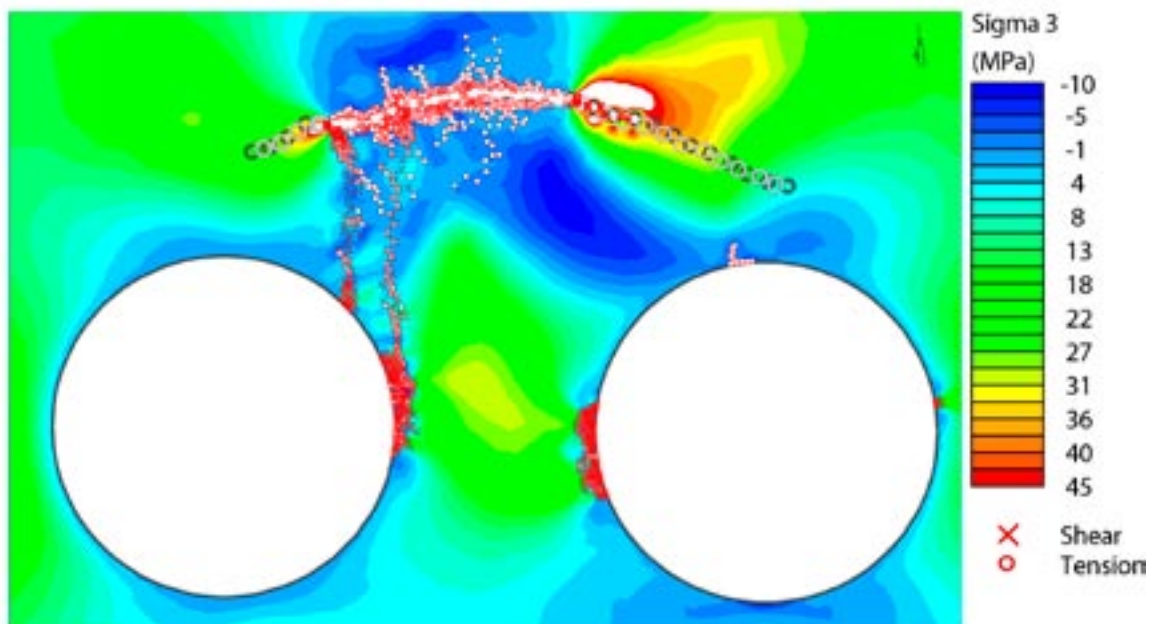
**Figure 10-20.** Yielded elements and minor principal stress at modelling stage 18. The magnitude of the tensile stresses between DQ0066G01 and the slot has increased.

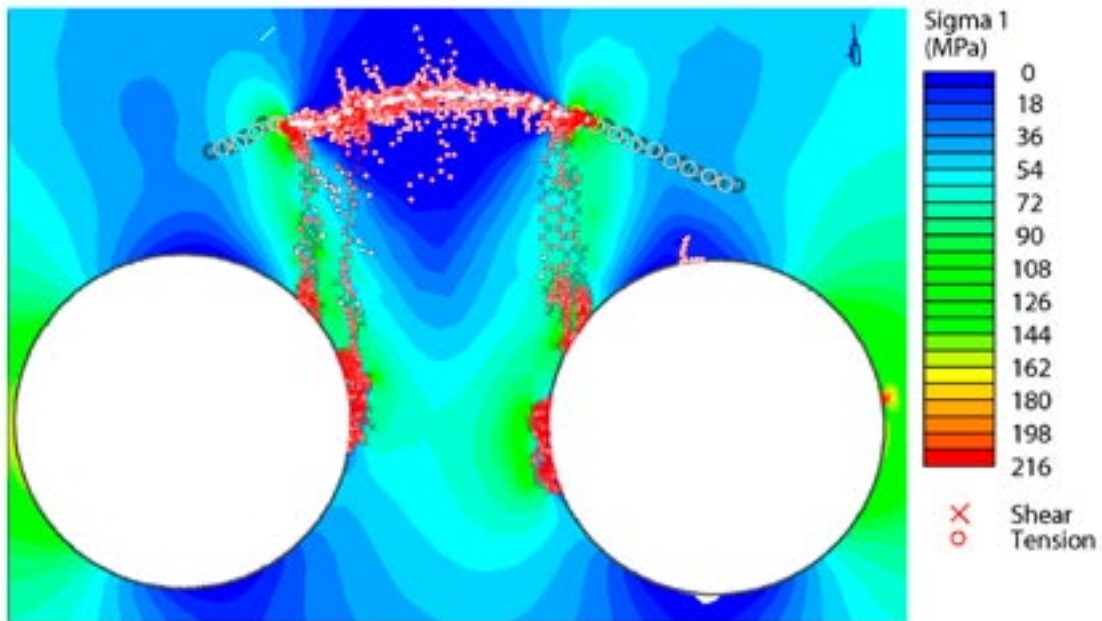
**Figure 10-21.** Yielded elements and major principal stress at modelling stage 20. A failed zone has formed between the slot and DQ0066G01.

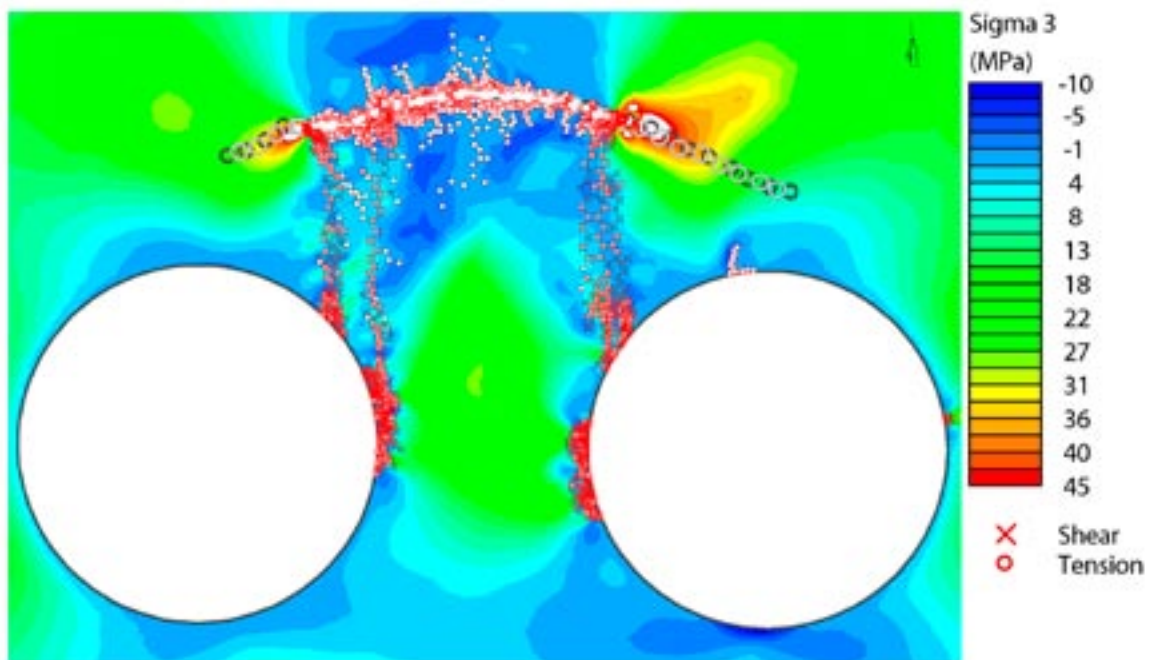
**Figure 10-22.** Yielded elements and minor principal stress at modelling stage 20. The forming of the new shear band has reduced the tensile stresses and the confinement along the failed zones is around zero.

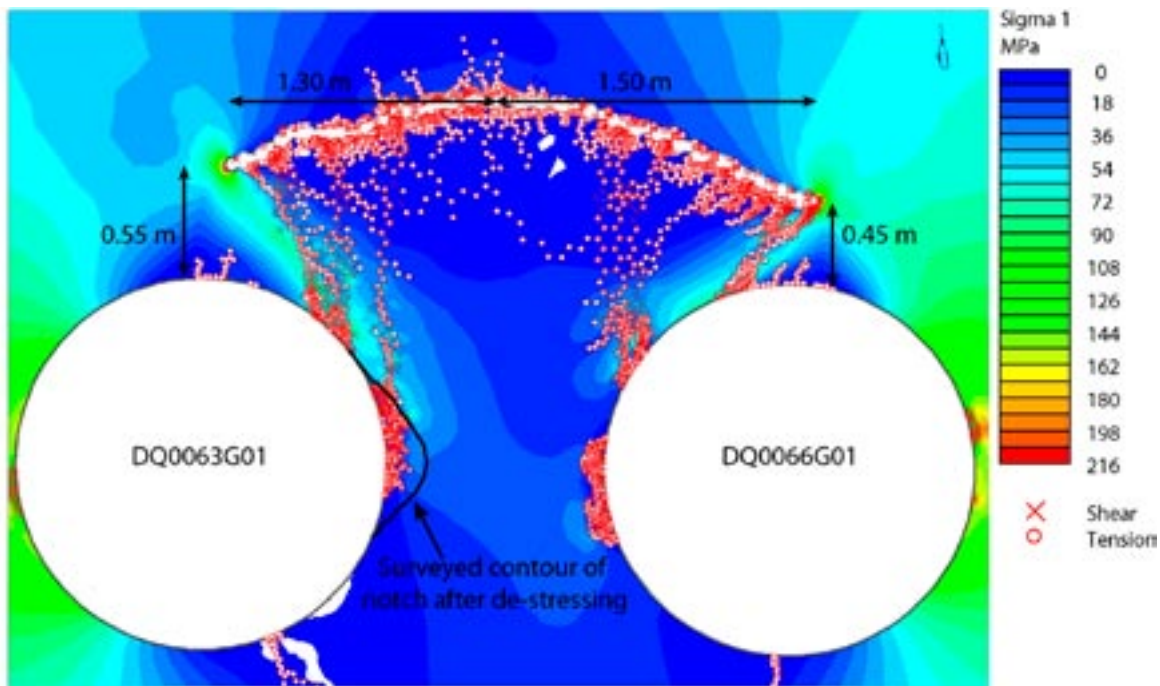
**Figure 10-23.** Yielded elements and major principal stress The final geometry of the notch is indicated. The general yielding pattern is the same but expanded. A failed zone between the end of the slot and DQ0066G01 is indicated. The failed zone was not observed in field.

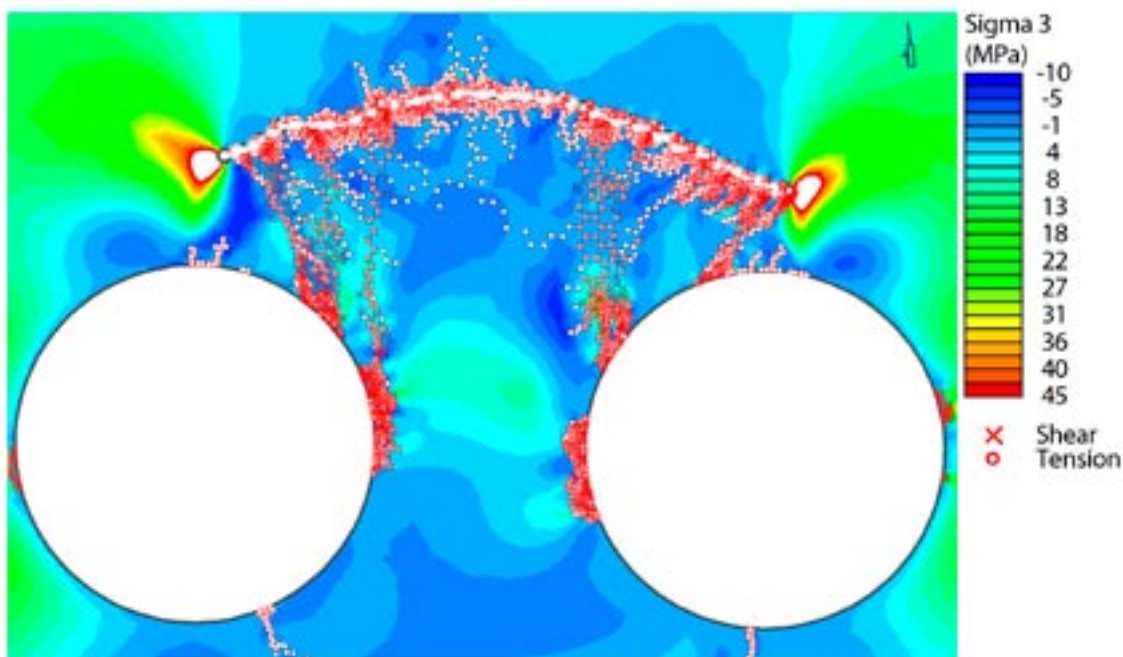
**Figure 10-24.** Yielded elements and minor principal stress at modelling stage 36, the final stage. Large areas of small tensile stresses have formed. Only the centre part of the pillar is confined.

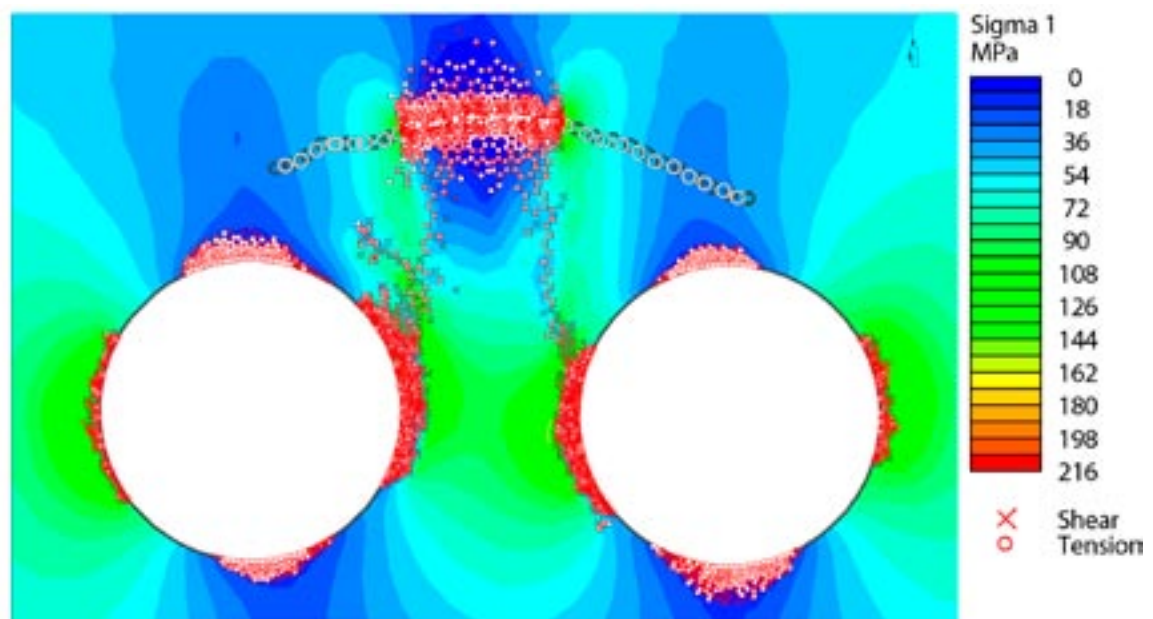
**Figure 10-26.** Results from the Hoek – Brown model at stage 14. The yielding is much more extensive compared with the Mohr – Coulomb model. Field observations do not support the Hoek – Brown modelling results.

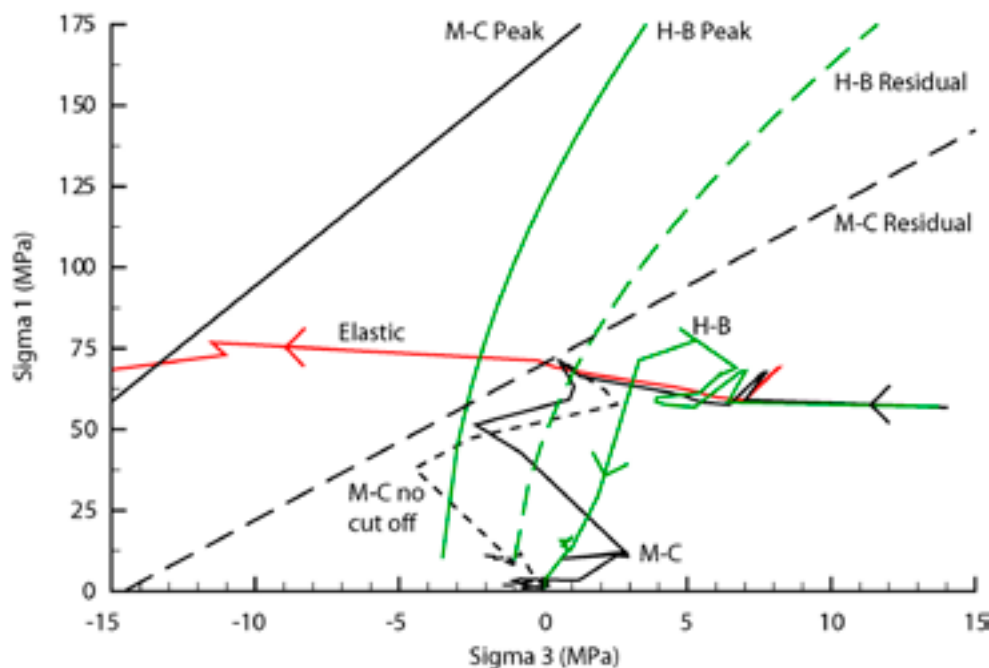
**Figure 10-29.** Stress path for point L1.

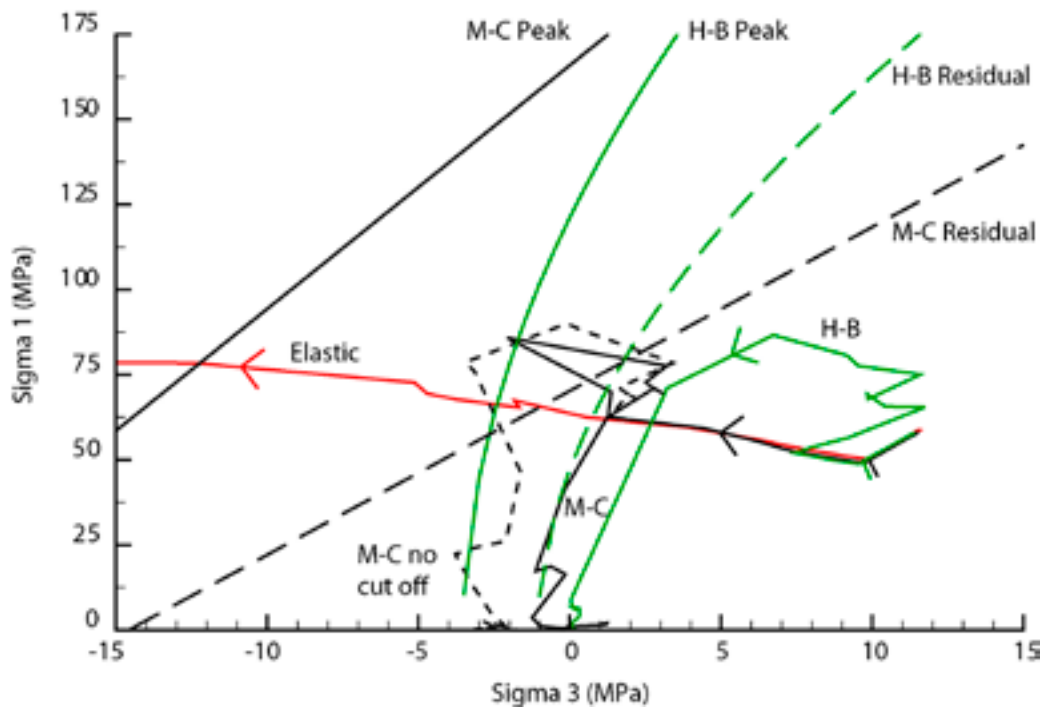
Figure 10-30. Stress path for point R1.

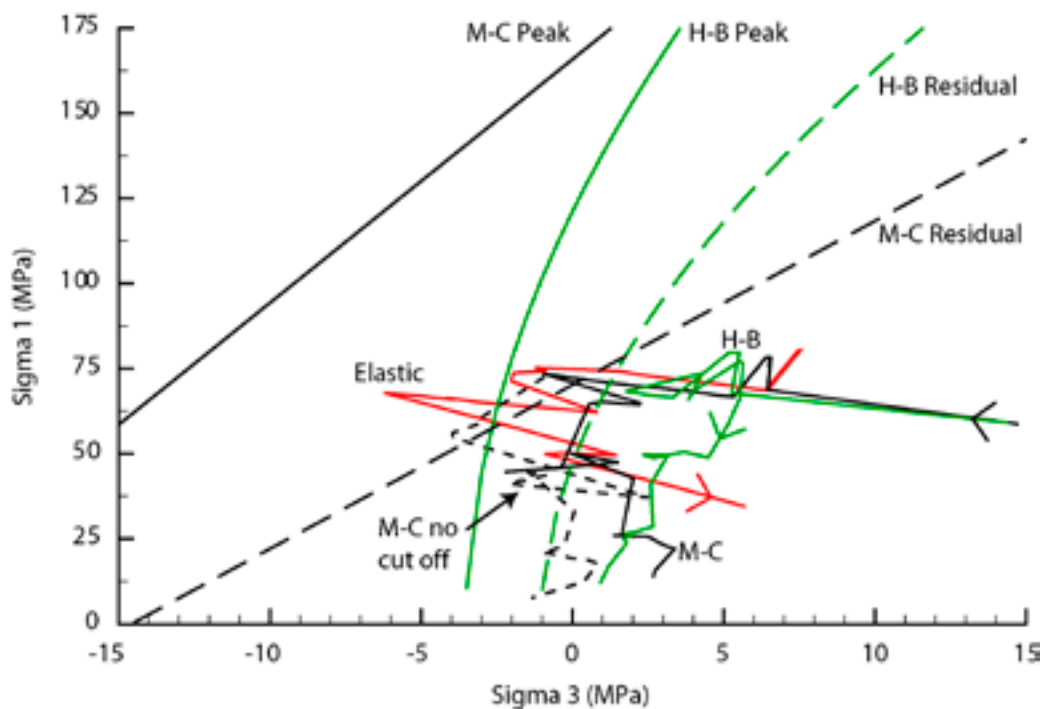
Figure 10-31. Stress path for point L2.

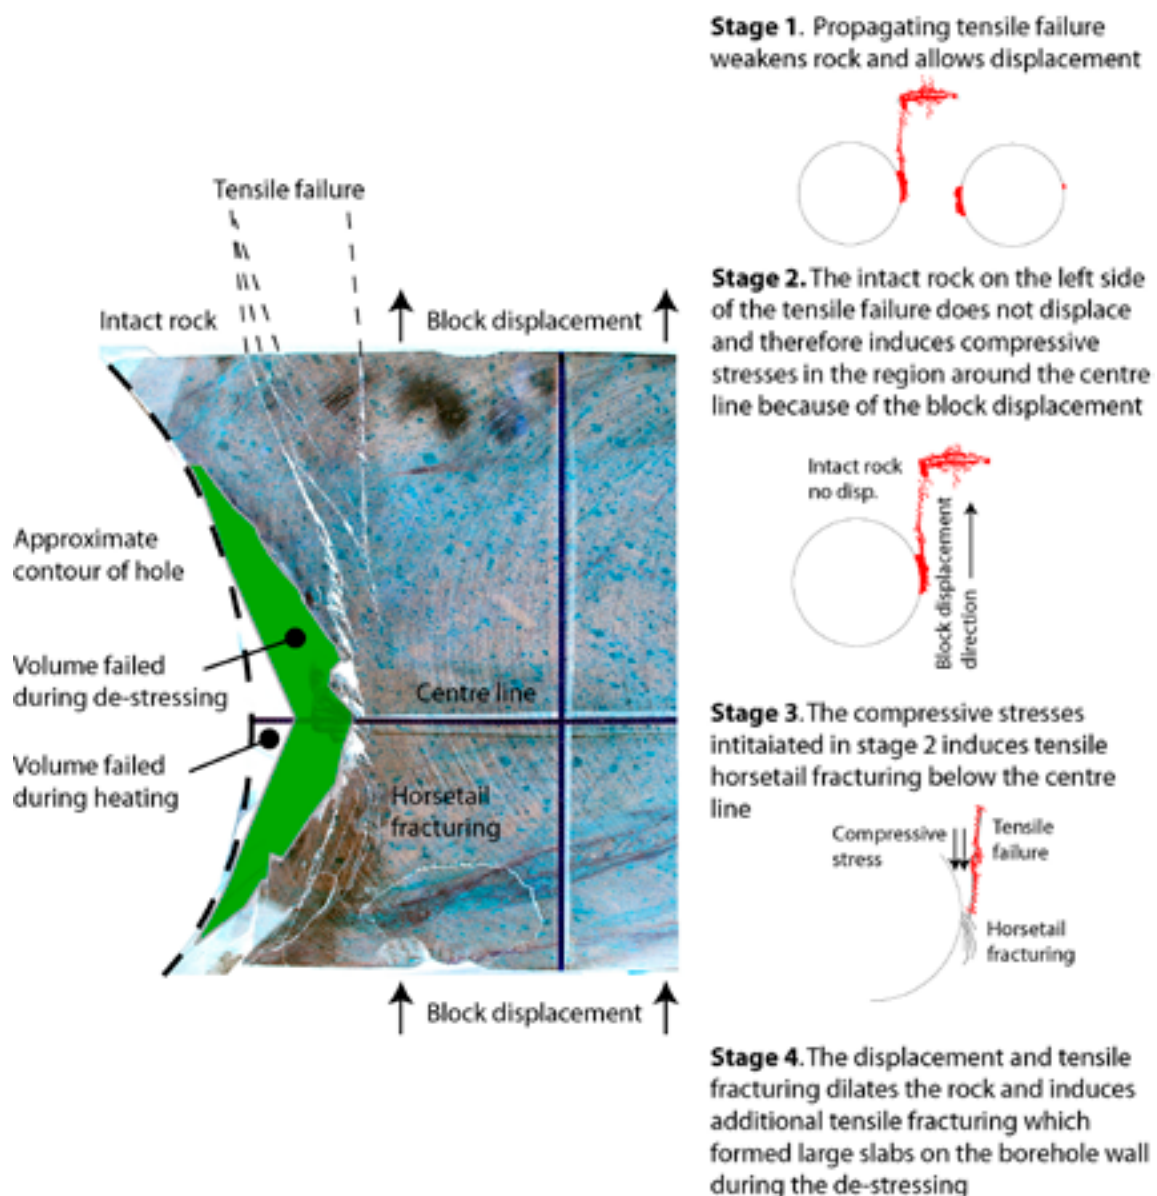
**Figure 10-33.** Illustration of how the tensile failures induced the horsetail fractures and the additional yielding or the pillar wall during the de-stress drilling.

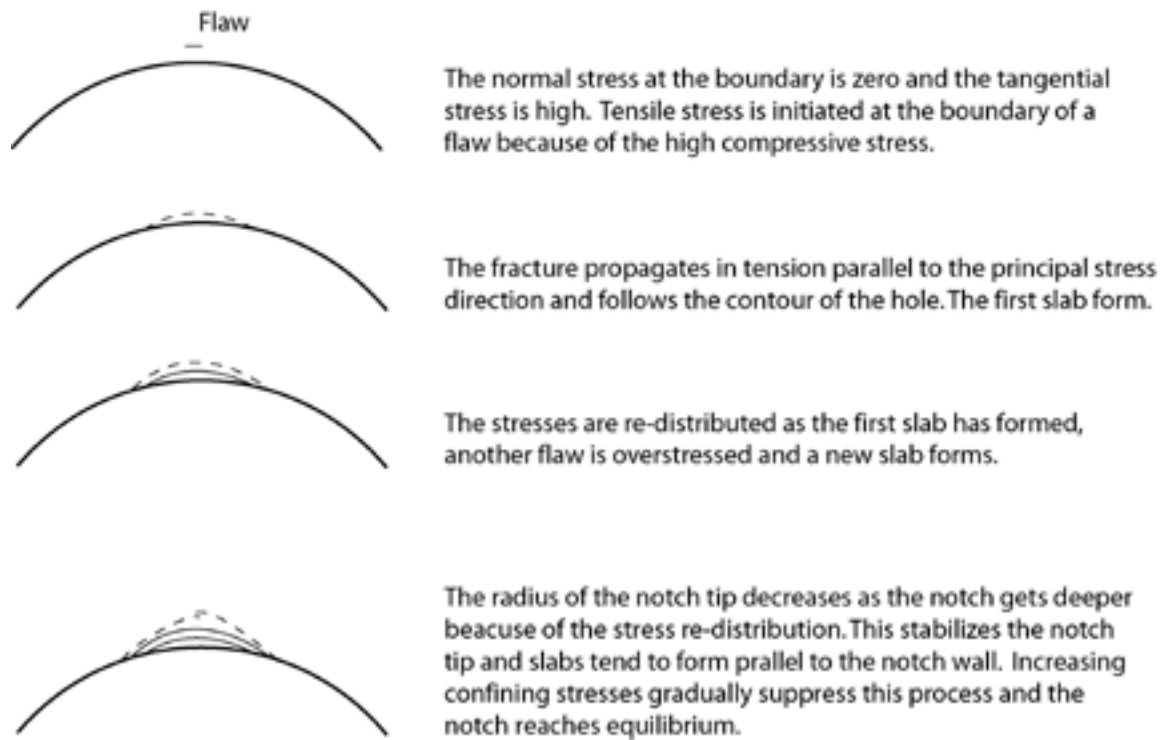
**Figure 11-1.** Illustration of the fracturing process in the Pillar Stability Experiment.

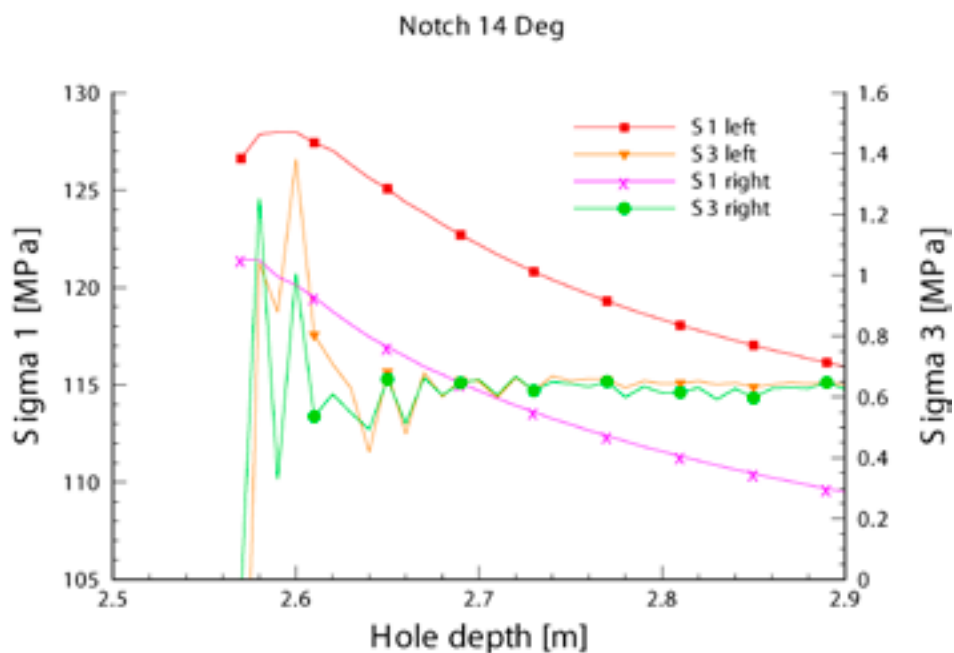
**Figure A2d-12.** Notch angle 14 degrees. Major and minor principal stresses five degrees left and right of the pillar centre.

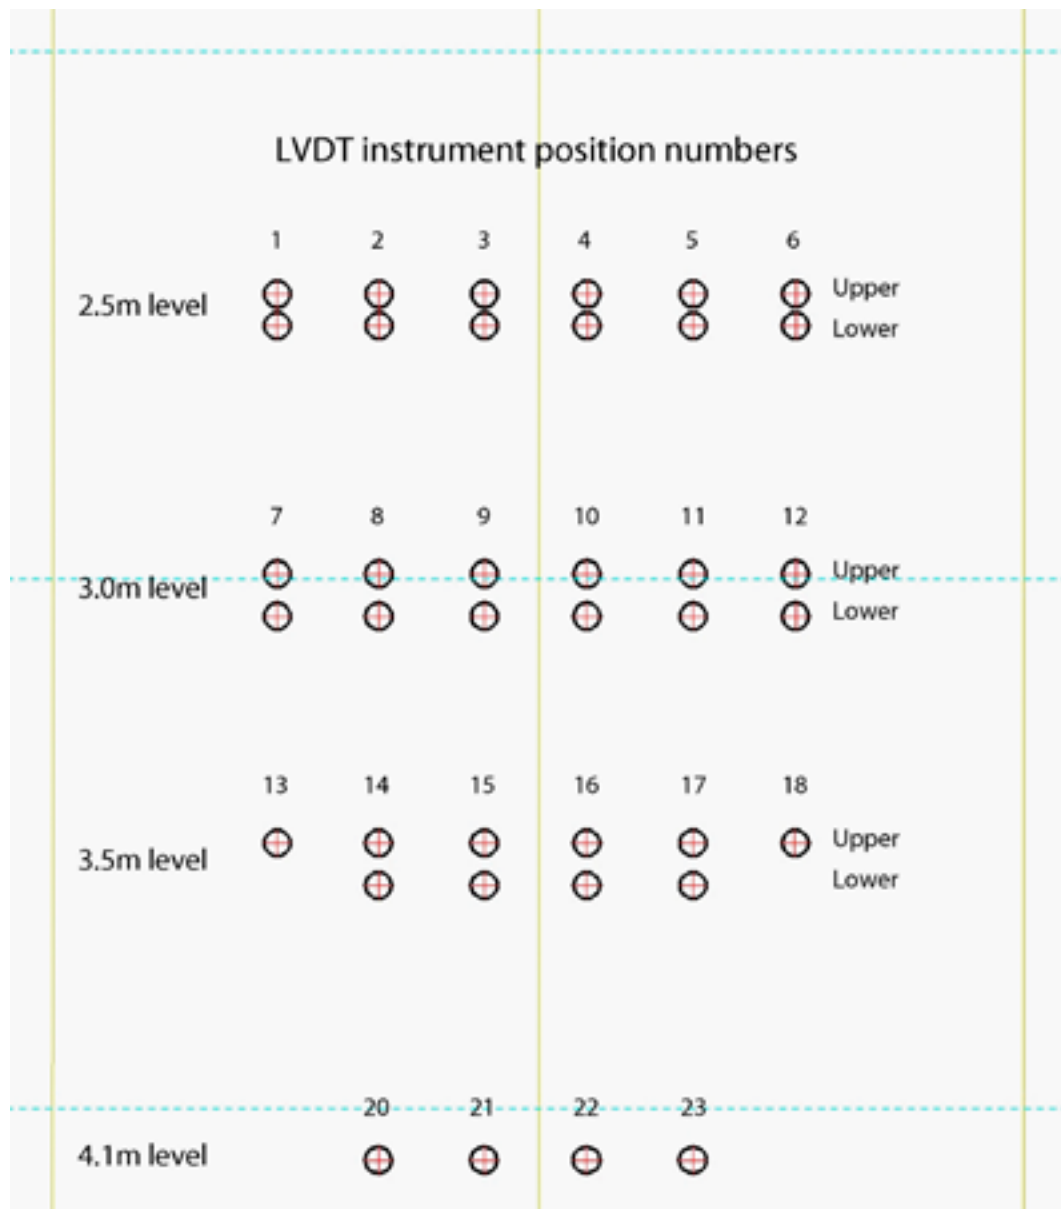
**Figure A2e-1.** Template used for the spalling including the sensor positions. Grid spacing is 1 m.

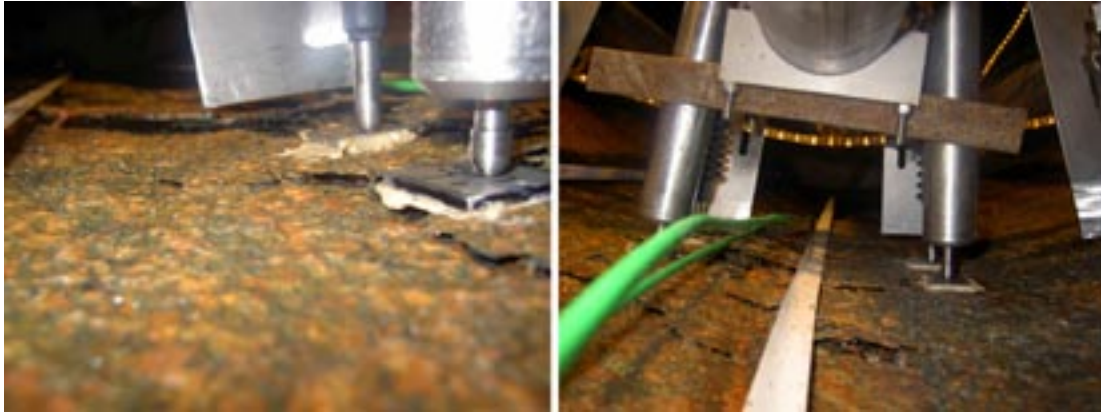
**Figure A2e-4.** May 18. Photographs of the pillar wall. Left: close-up of position 3 (2.5 m level); the short-range LVDT is the lower one. Right: photograph from below along the centre of the pillar (pos. 3 to the left and pos. 4 right of the pipe).

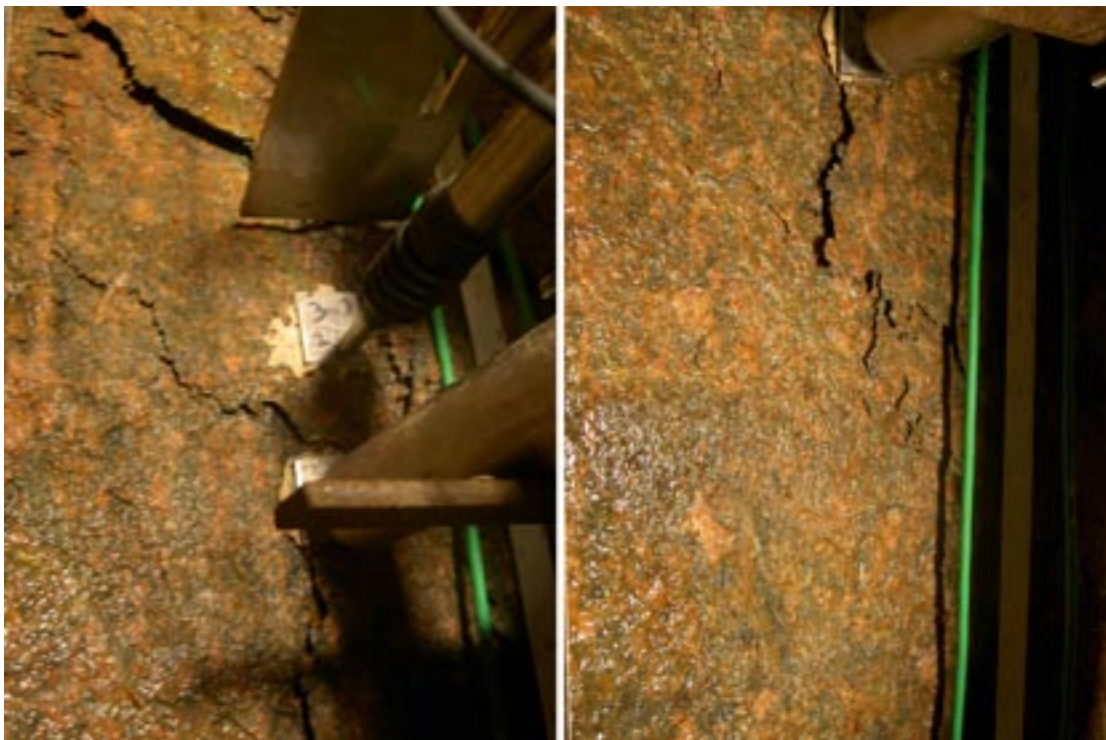
**Figure A2e-8.** May 27. Photograph of position 3, left both sensors and right below the short range sensor.

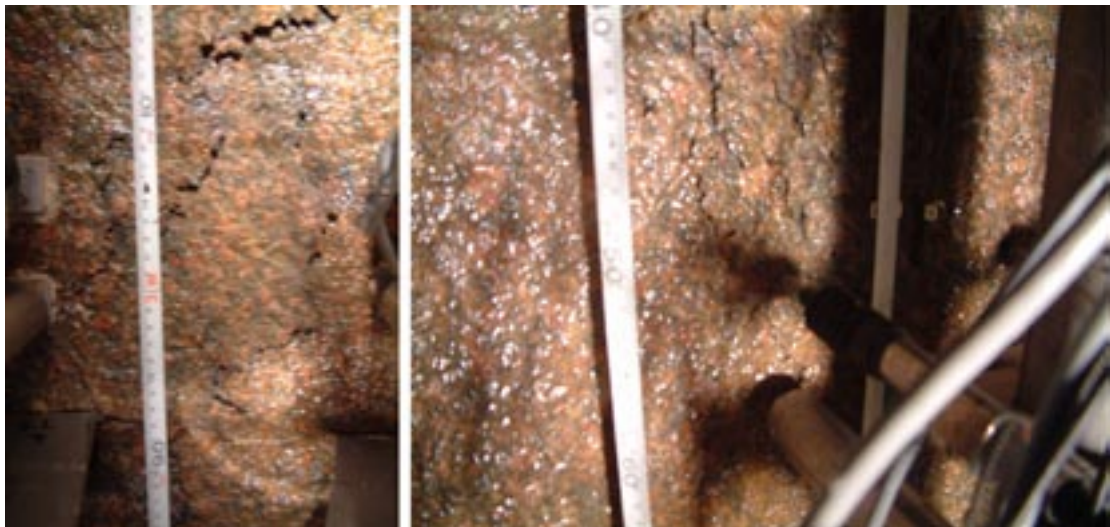
*Figure A2e-10. June 2. Photograph of spalling/fracturing at positions 3 (left) and 10 (right).*

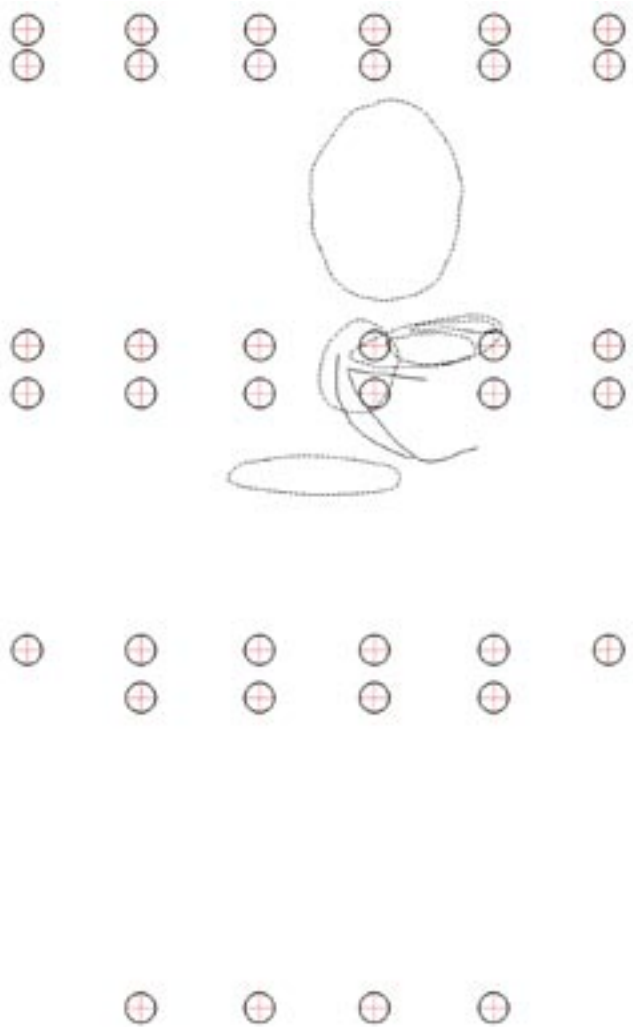
**Figure A2e-11.** Spalling observations on June 8.

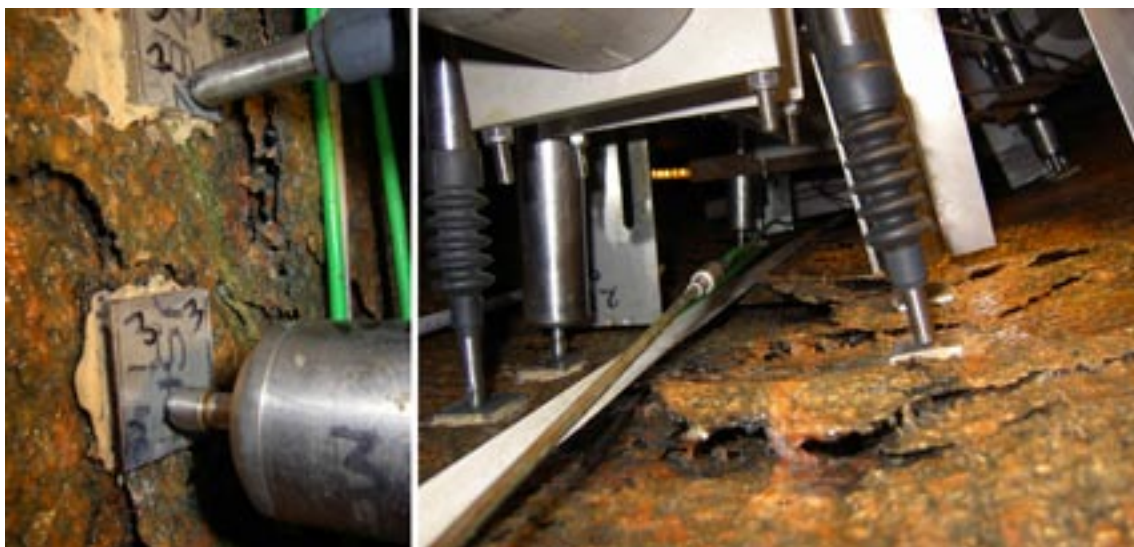
**Figure A2e-12.** June 8. Photographs of spalling/fracturing at position 3 (2.5 m level) and between positions 9 and 10 at the 3 m level. In the right photograph position 9 is to the left.

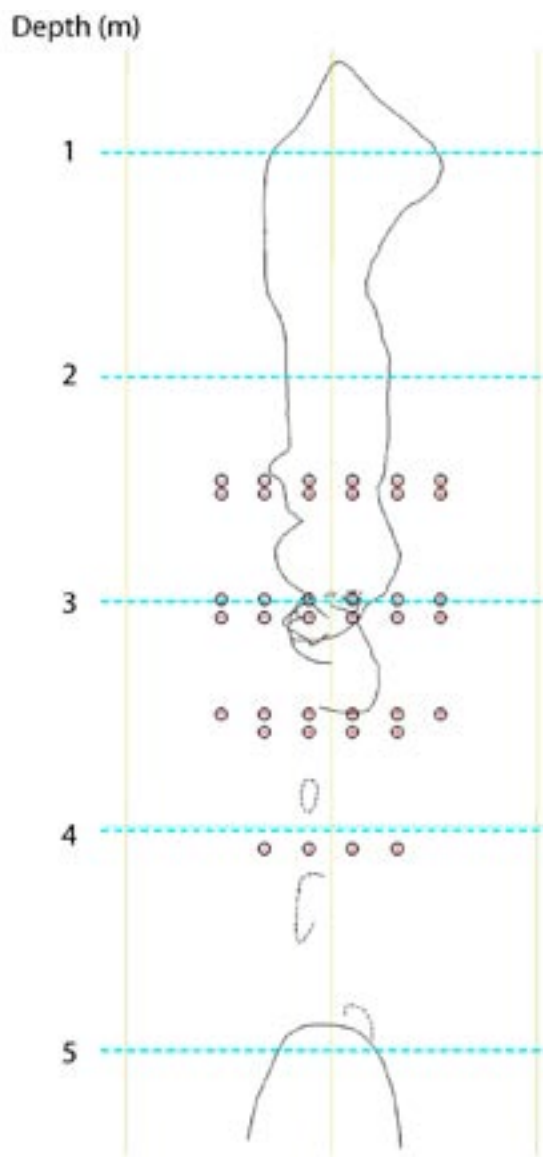
*Figure A2e-13. General extent of spalling on June 16.*

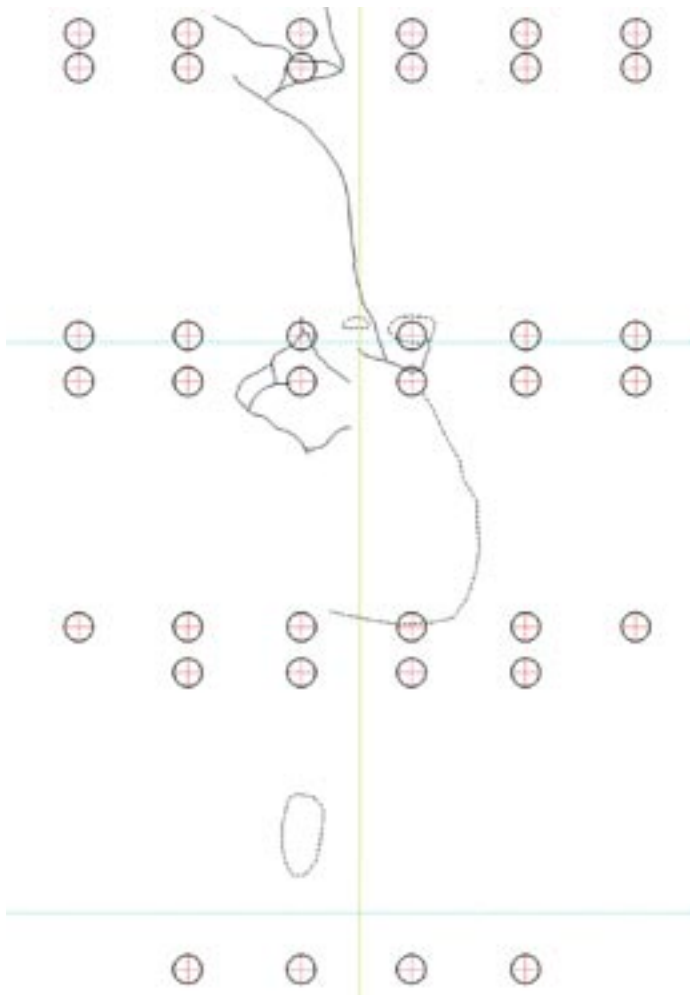
**Figure A2e-14.** Detailed spalling observations on June 16. At 3 m depth a small rock fragment had fallen of at the very pillar centre (dashed oval).

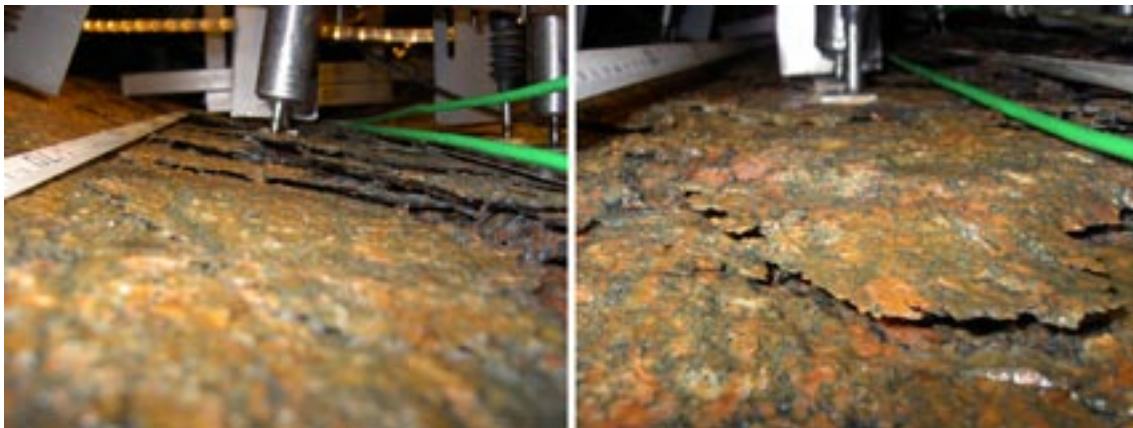
**Figure A2e-15.** June 16. Photographs of spalling/fracturing at position 3 on the 2.5 m level (left) and at position 9 on the 3 m level (right).

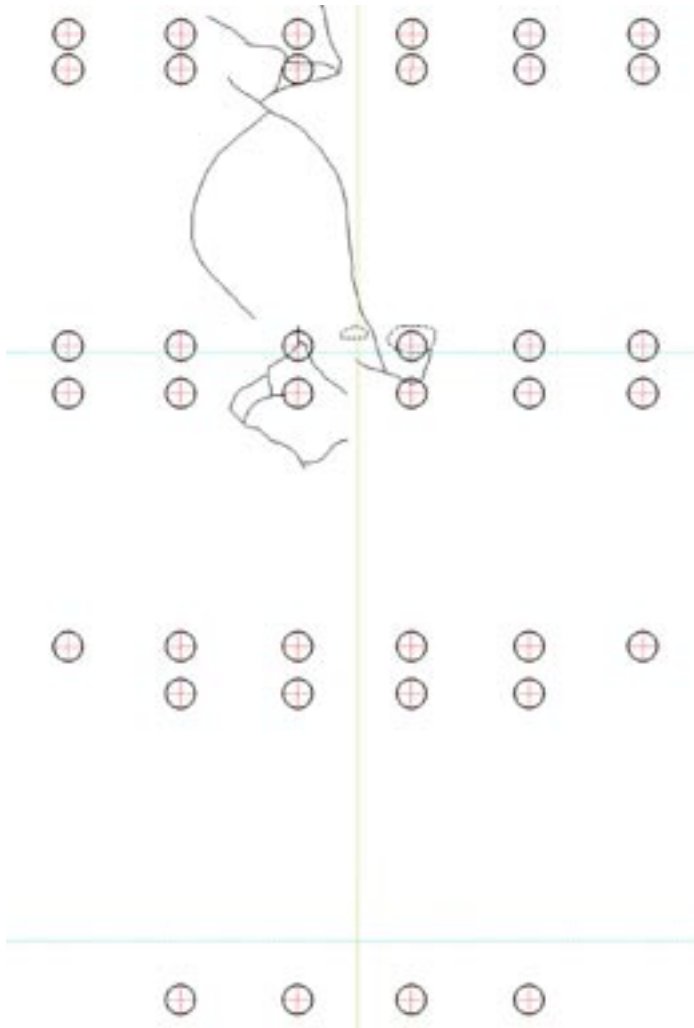
**Figure A2e-16.** General extent of spalling on June 23.

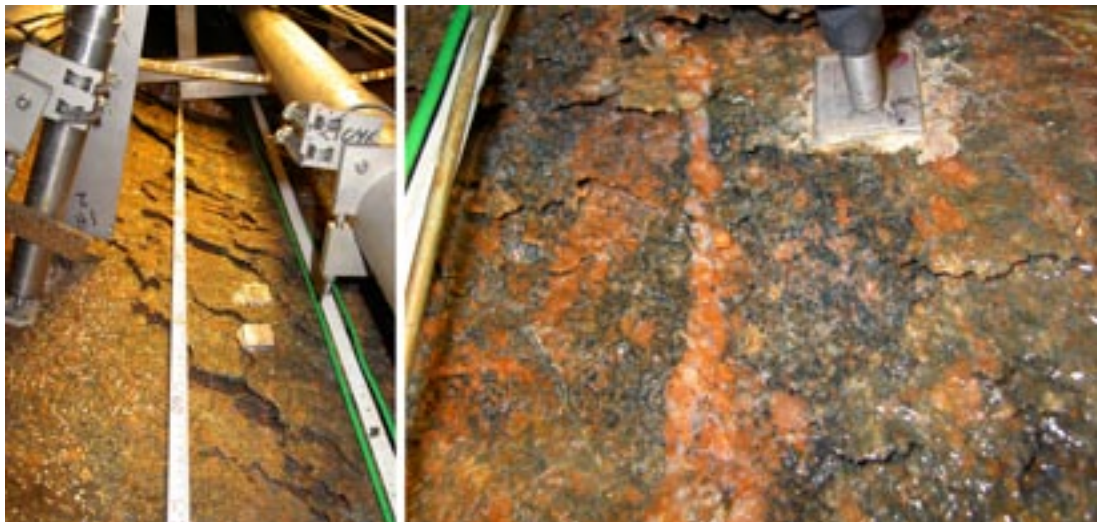
**Figure A2e-17.** June 23. Photographs of spalling/fracturing at position 3 on the 2.5 m level (left) and at position 10 on the 3 m level (right).
