**Äspö Hard Rock Laboratory**

**Äspö Pillar Stability Experiment,  
Final report**

**Rock mass response to coupled  
mechanical thermal loading**

January 2007

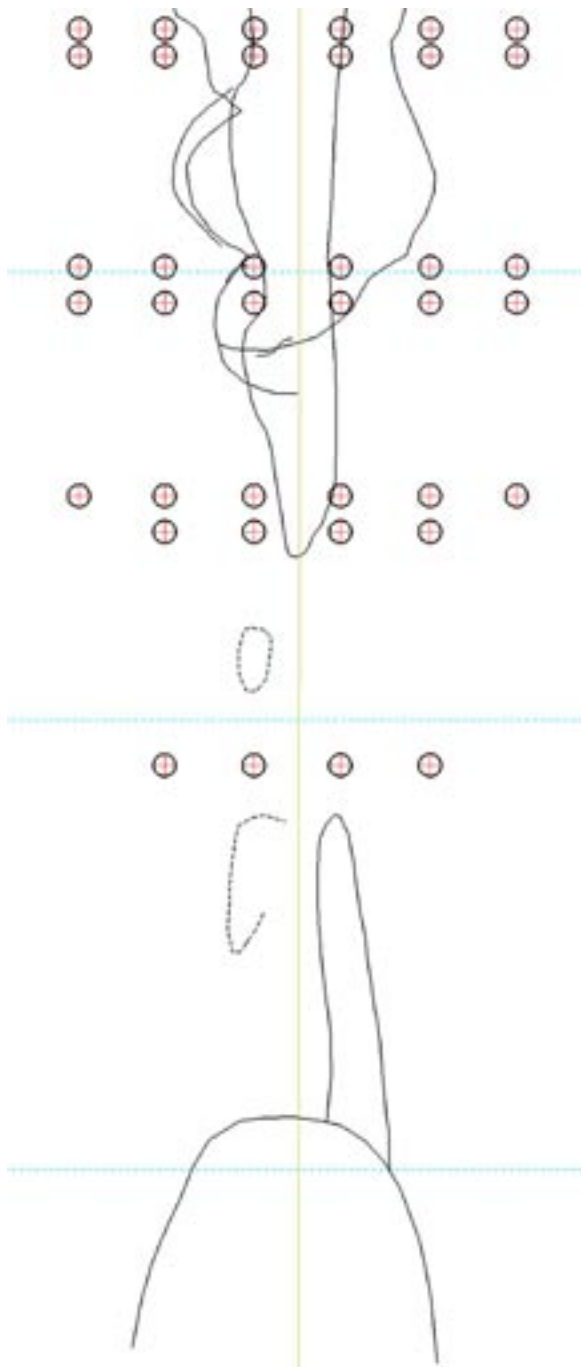
**Figure A2e-18.** General extent of spalling on June 29.

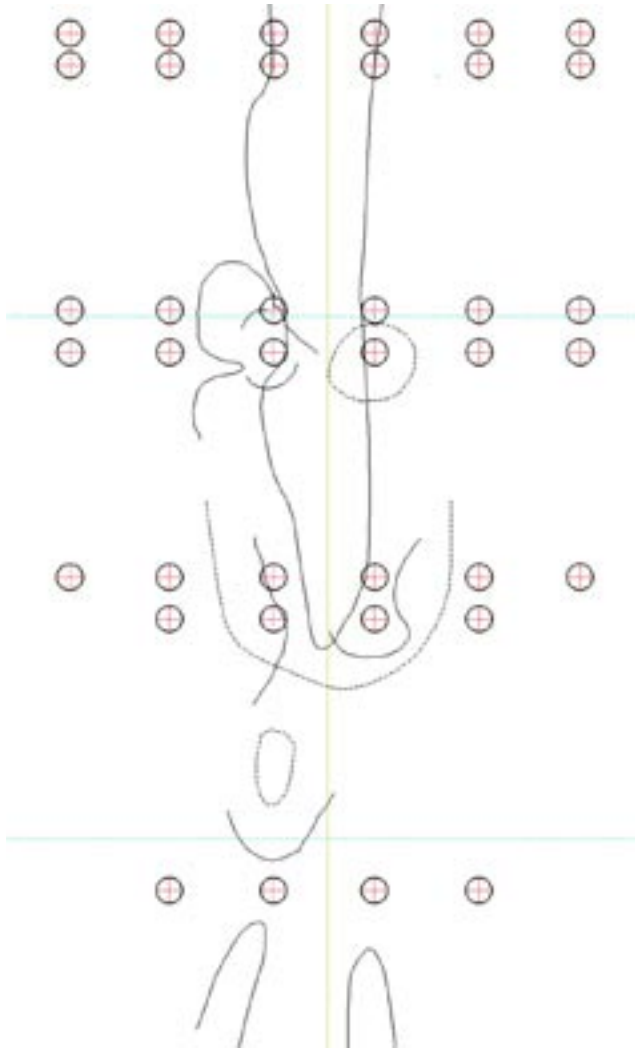
**Figure A2e-19.** Detailed spalling observations on June 29.

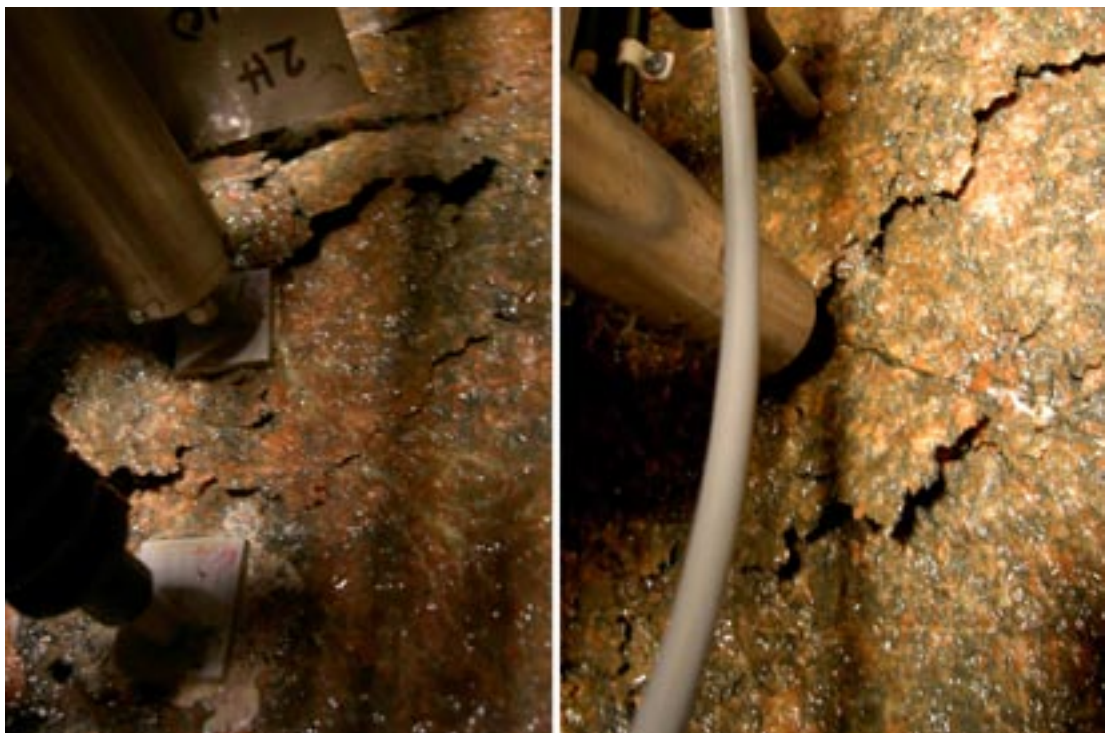
*Figure A2e-23. July 6. Photographs of position 10 (left) and position 16 (right).*

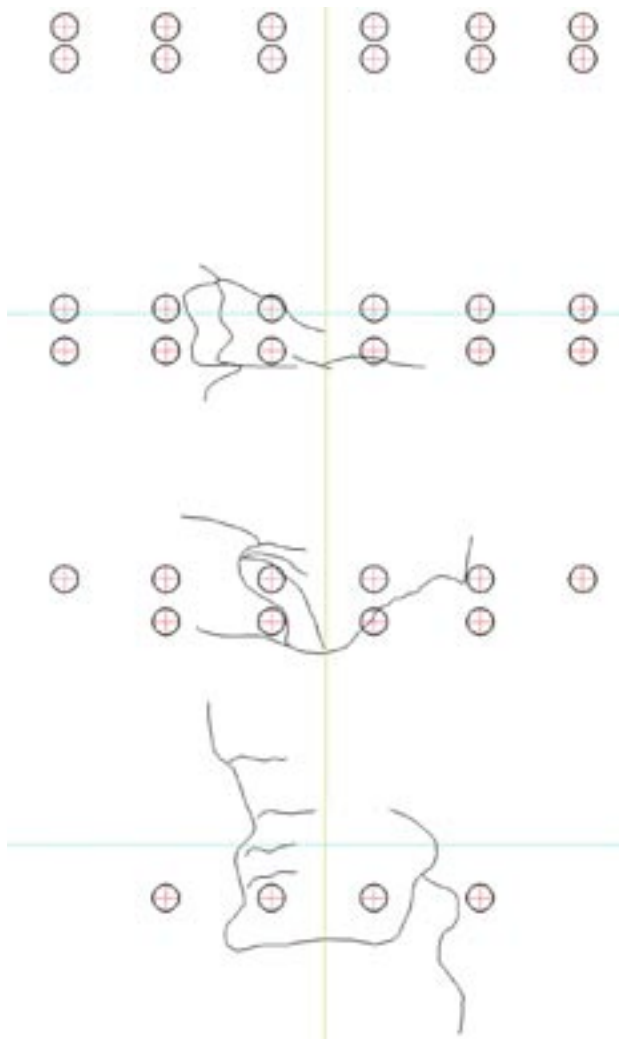
**Figure A2e-24.** Spalling observations July 12.

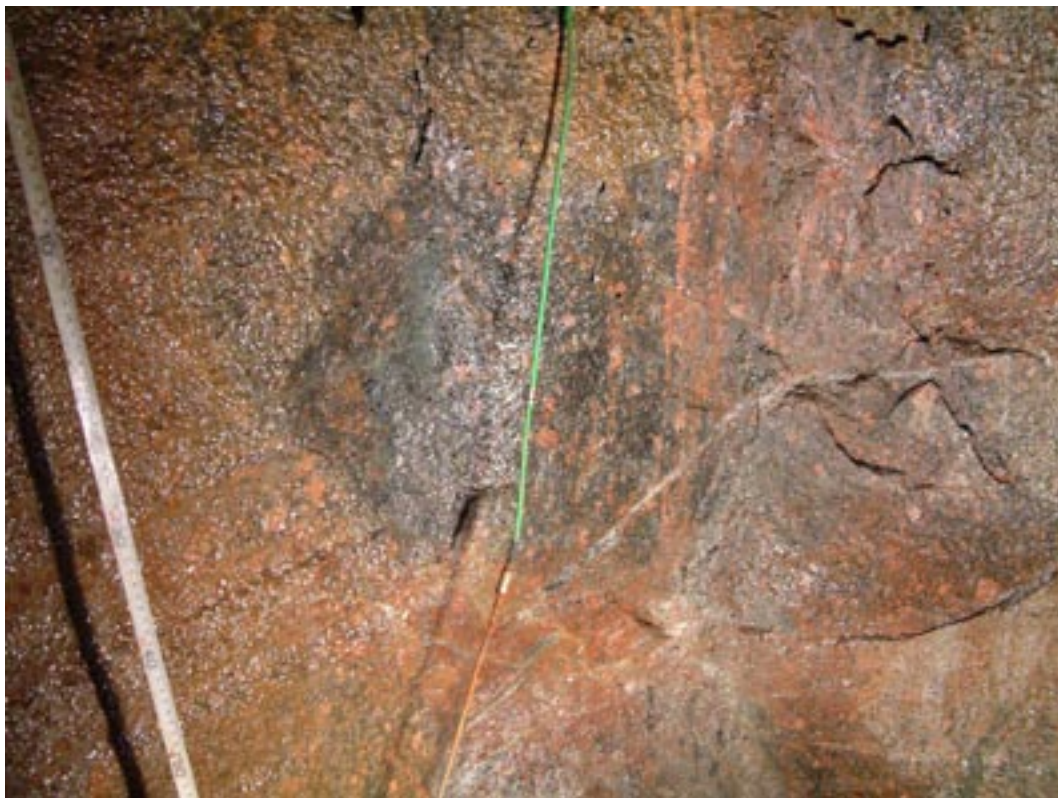
*Figure A2e-25. The greenstone body that created a small pit in the rock wall.*

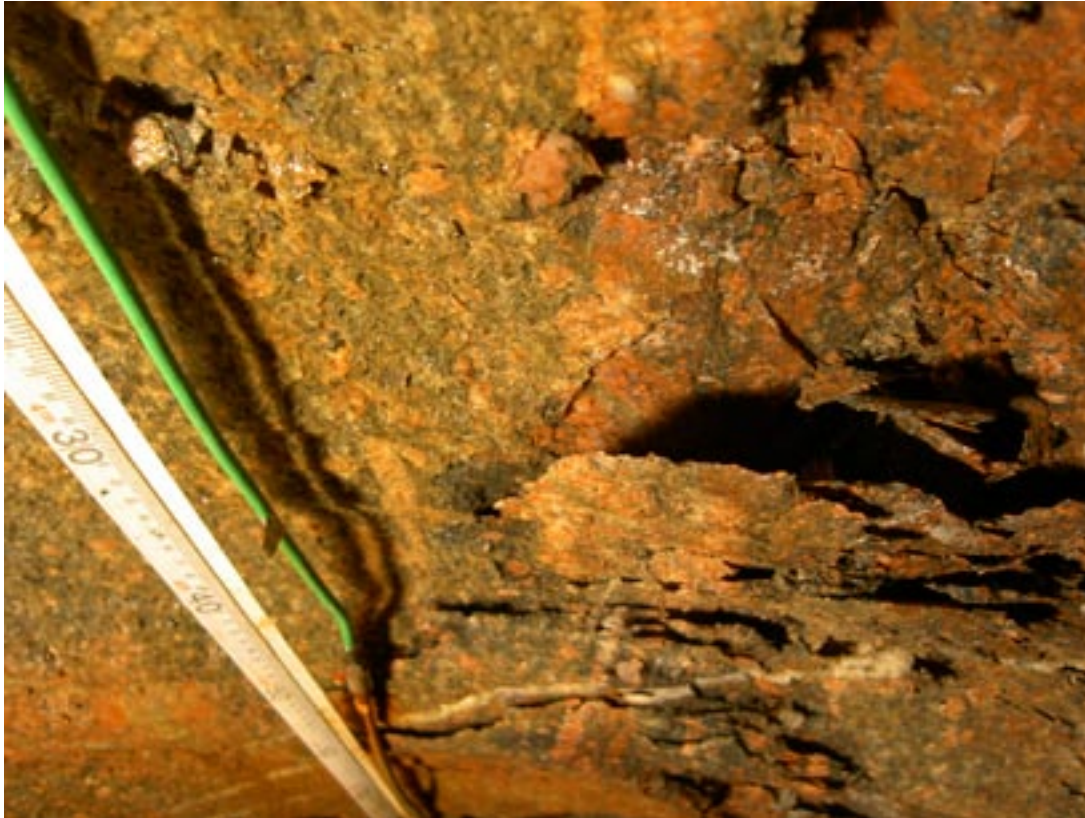
*Figure A2e-26. Photograph of the upward-pointing chips.*

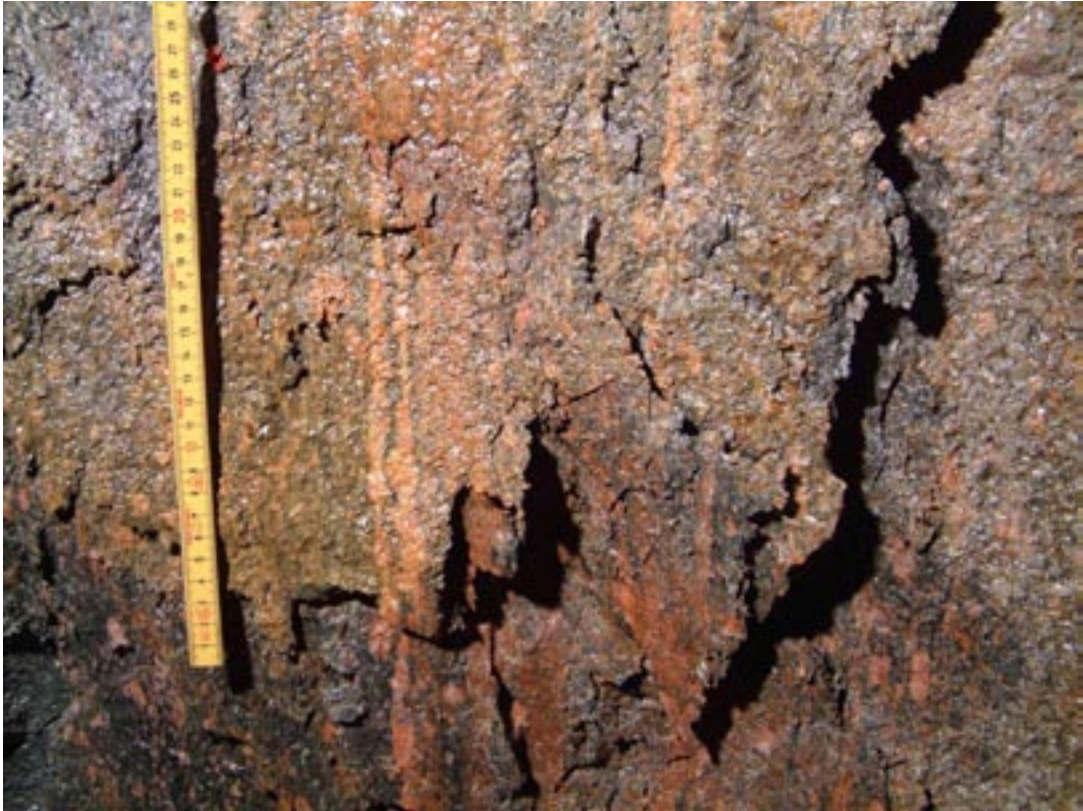
**Figure A2e-27.** Photograph of rock wall at depth of approximately 4 m. The small cm-scale chips on top of the larger chips are clearly visible.

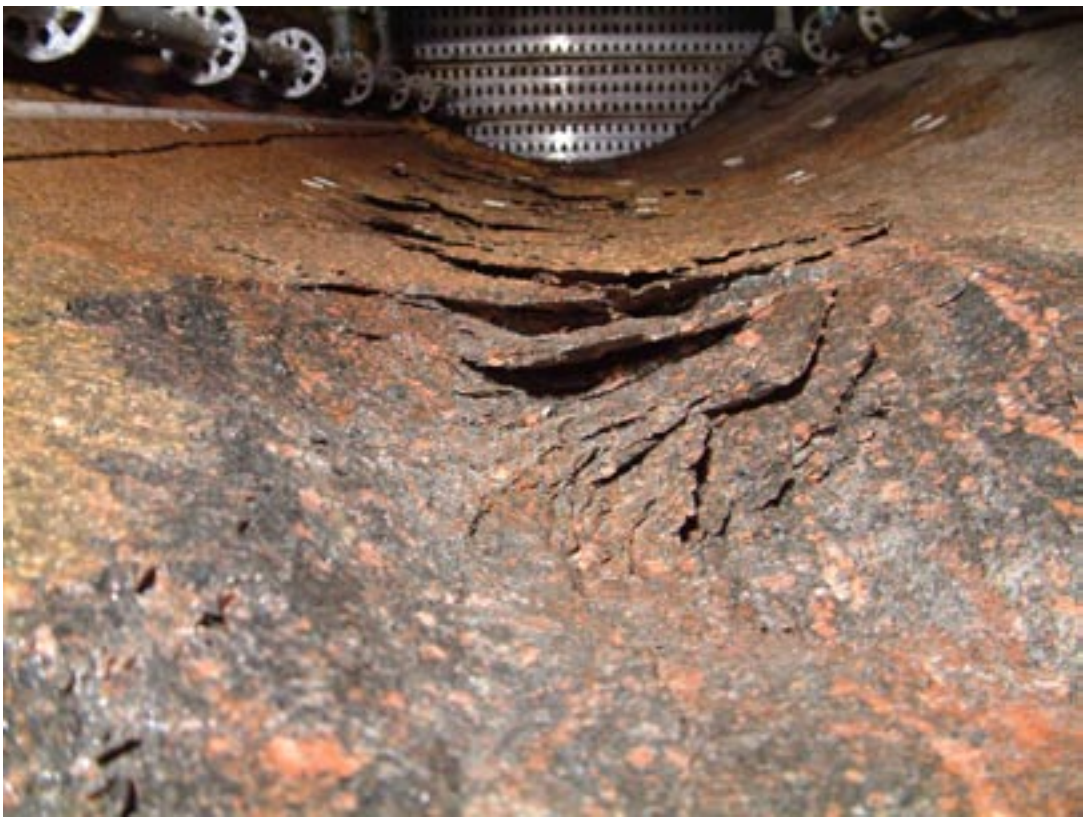
**Figure A2e-28.** Photograph taken from below of chips at 3.7 m and up. The dilatation and curvature of the slabs can be seen.

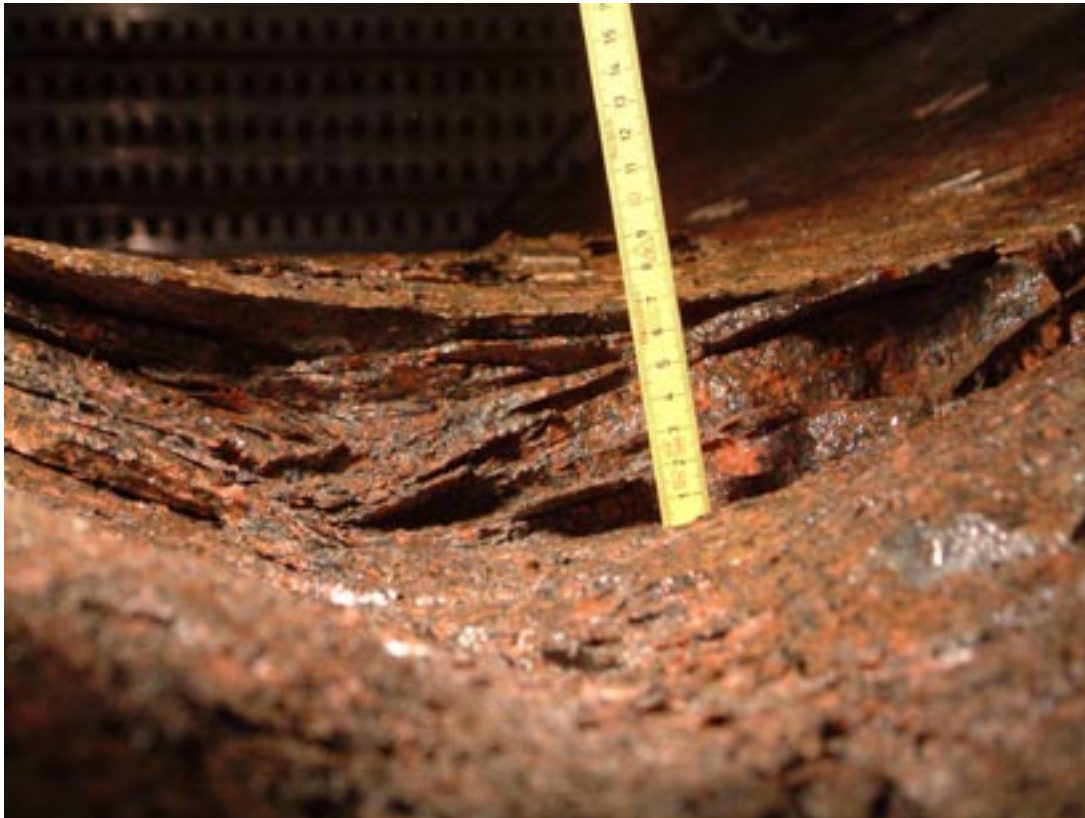
*Figure A2e-29. Photograph of the smooth arched notch at a depth of 3.7 m.*

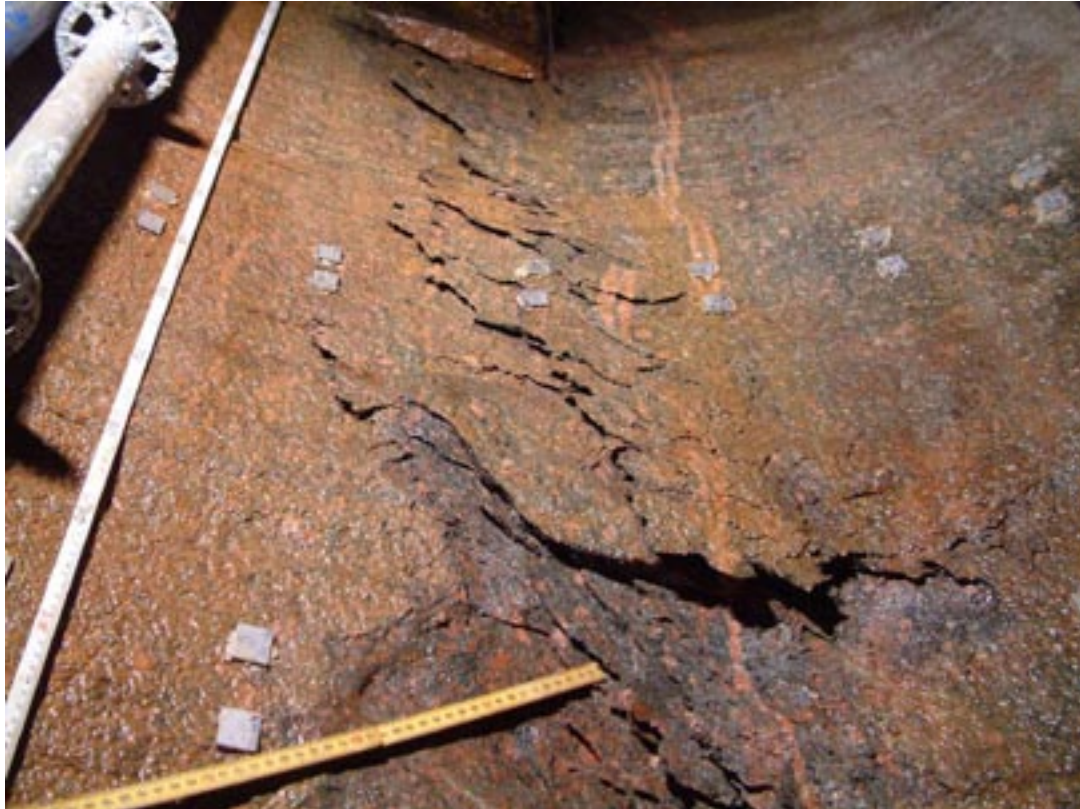
**Figure A2e-30.** Photograph of the slabs with a free left surface and the right side attached to the rock wall. The depth at the bottom of the photograph is 3 m.

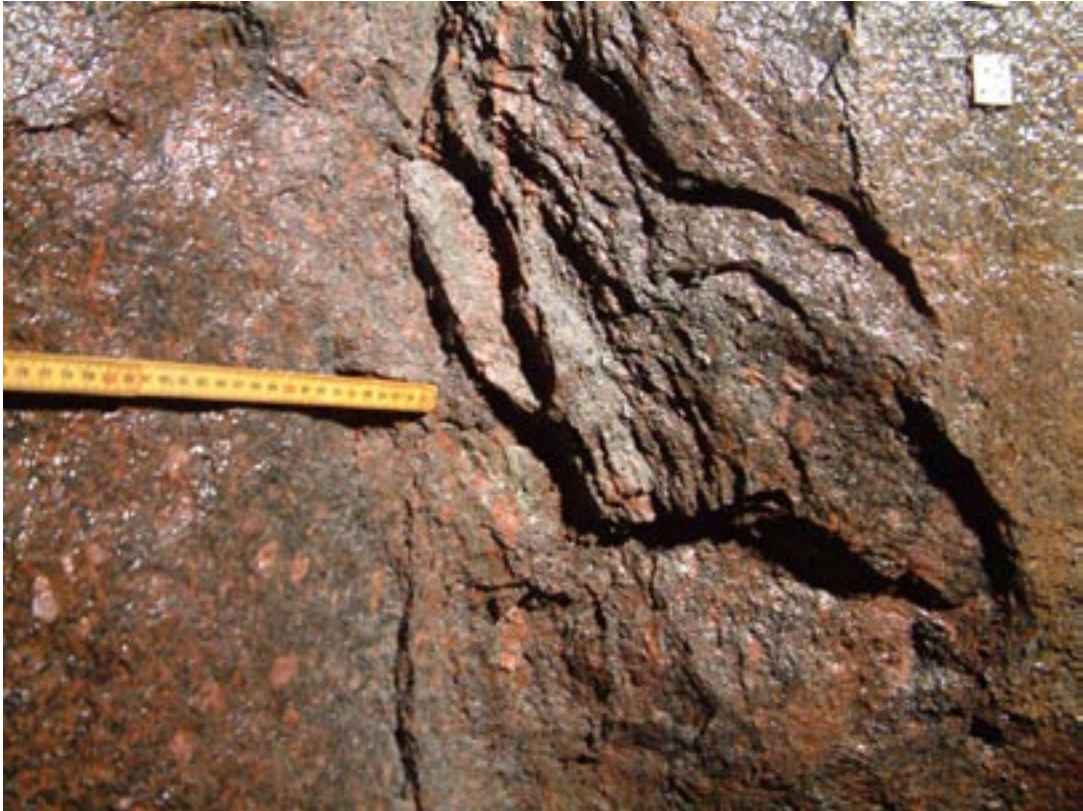
**Figure A2e-33.** Photograph at depth of approximately 2.5 m showing the right side of the pillar, where almost no slabs could be removed.

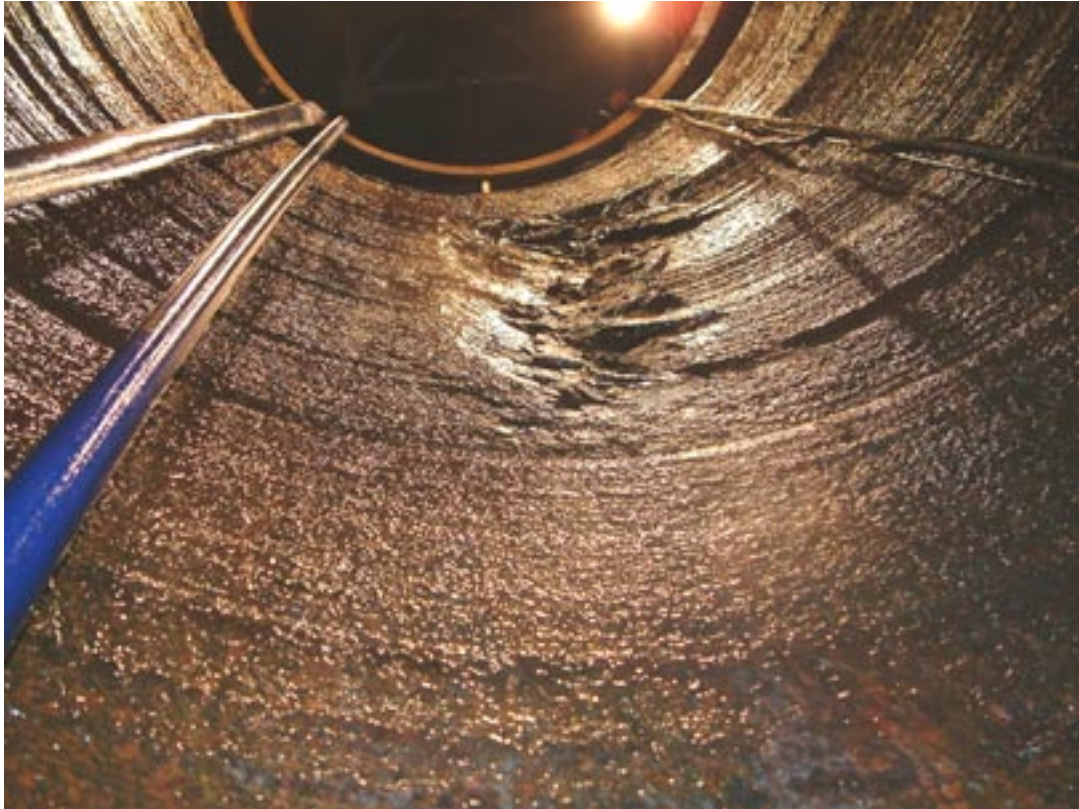
*Figure A2e-34. Photograph of the initial spalling in DQ0063G01 that occurred during the drilling.*

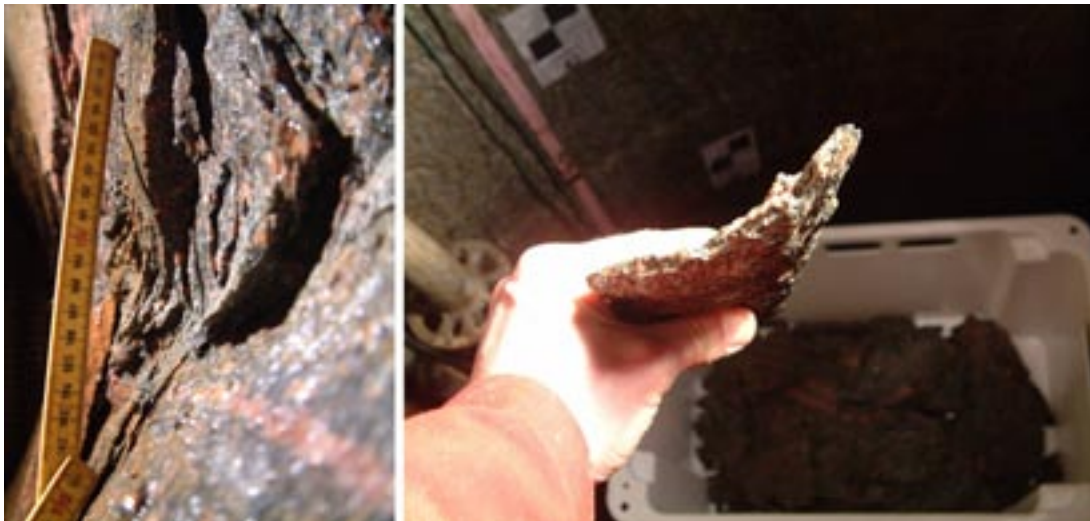
*Figure A2e-35. Photograph of the location of the arched chip and the chip itself.*

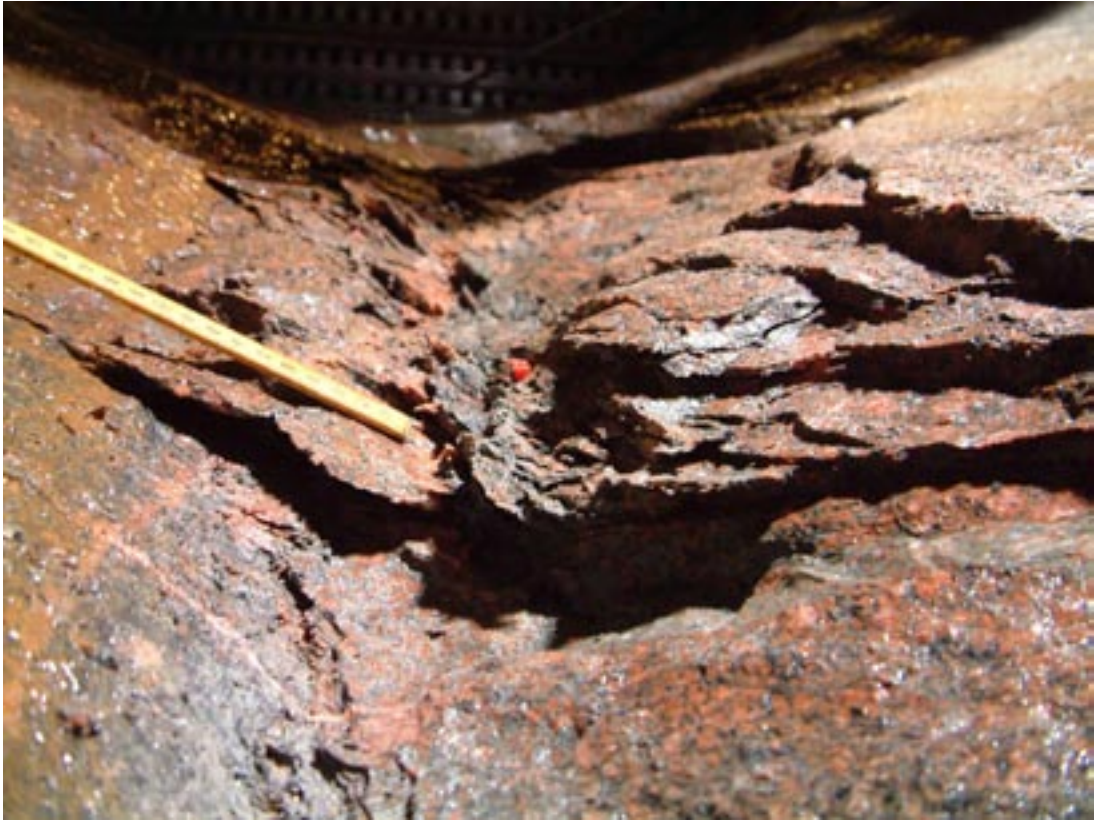
**Figure A2e-36.** *Photograph of the fractures and slabs between 1.6 and 1.1 m.*

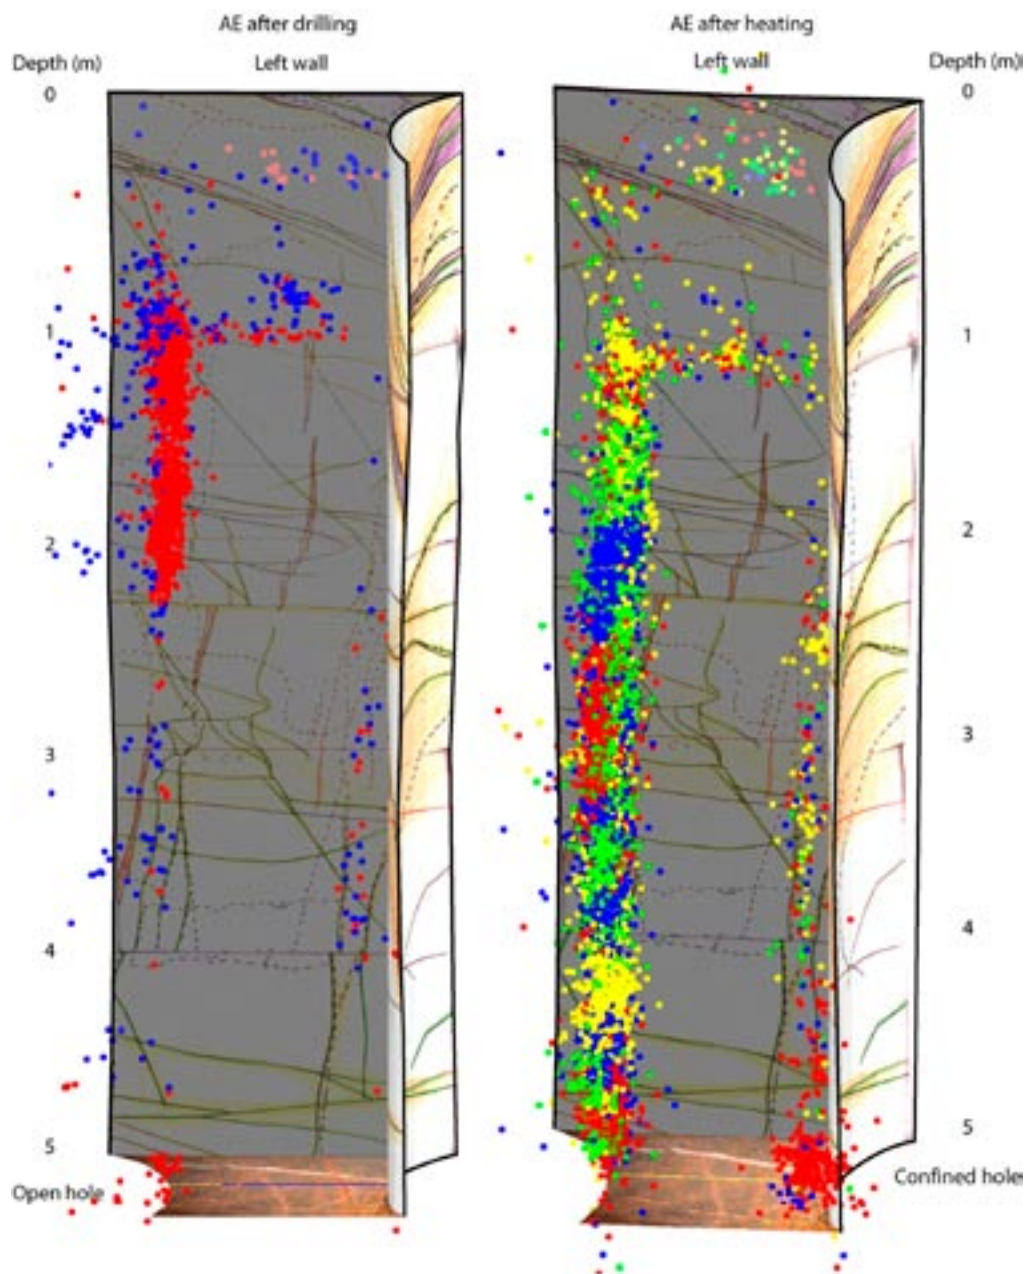
**Figure A2f-3.** Accumulated source located AE events during the drilling of the second large borehole DQ0063G01 (left) and during the heating (right).
