**TECHNICAL
REPORT**

90-04

**Examination of the surface deposit
on an irradiated PWR fuel specimen
subjected to corrosion in deionized
water**

R. S. Forsyth, U-B. Eklund, O. Mattsson, D. Schrire
Studsvik Nuclear

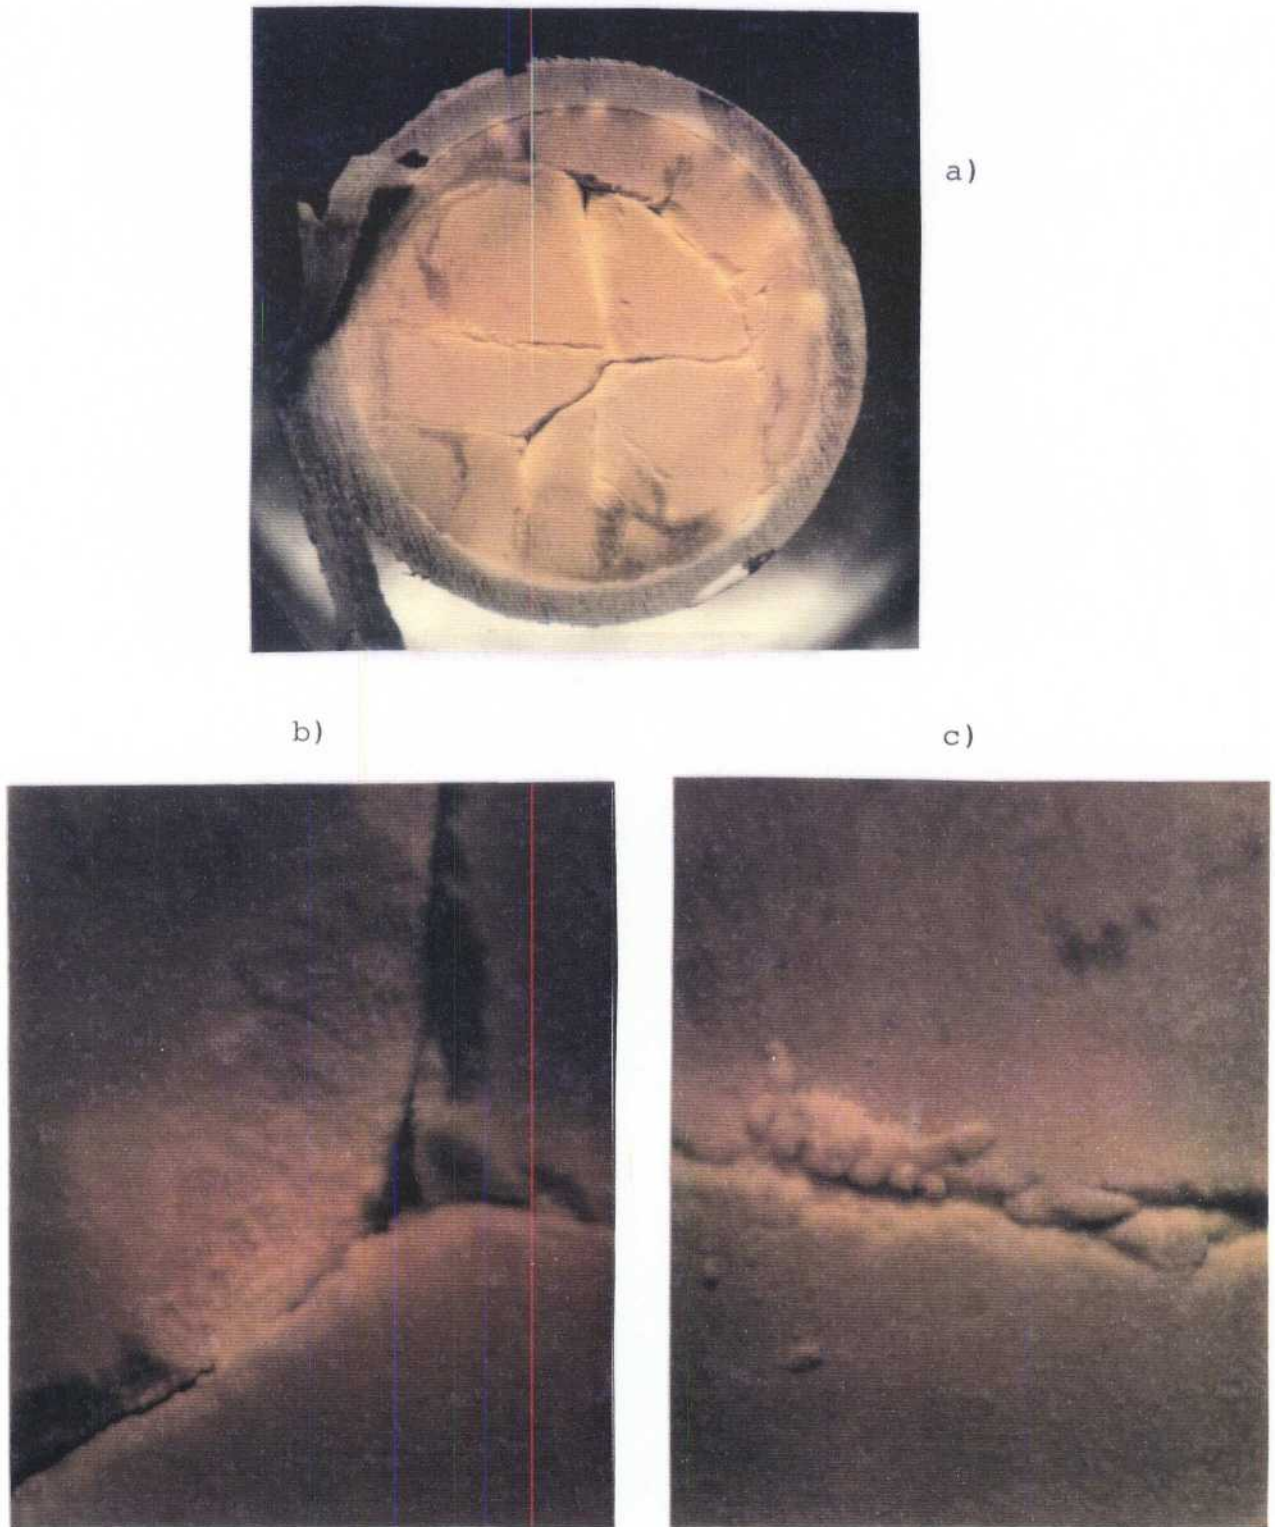
Fig 1. Fuel/clad segment 7.1 after 436 days in deionized water under oxidizing conditions and 5 months of air storage.

a) upper surface (x7) b) and c) details of surface deposit (x50)

A hot-cell periscope photograph of one of the open (cut) ends of fuel/clad segment 7.1 is presented in Fig. 1a, which shows that the yellow deposit completely covers the surface. Details of the surface, including some deposit nodules near a radial crack, are given in Figs. 1b and 1c.

Two small samples of the deposit were removed from the open-end surface shown in Fig. 1, mounted on tape and subjected to XRD analysis in a Guinier-Hägg focussing camera.

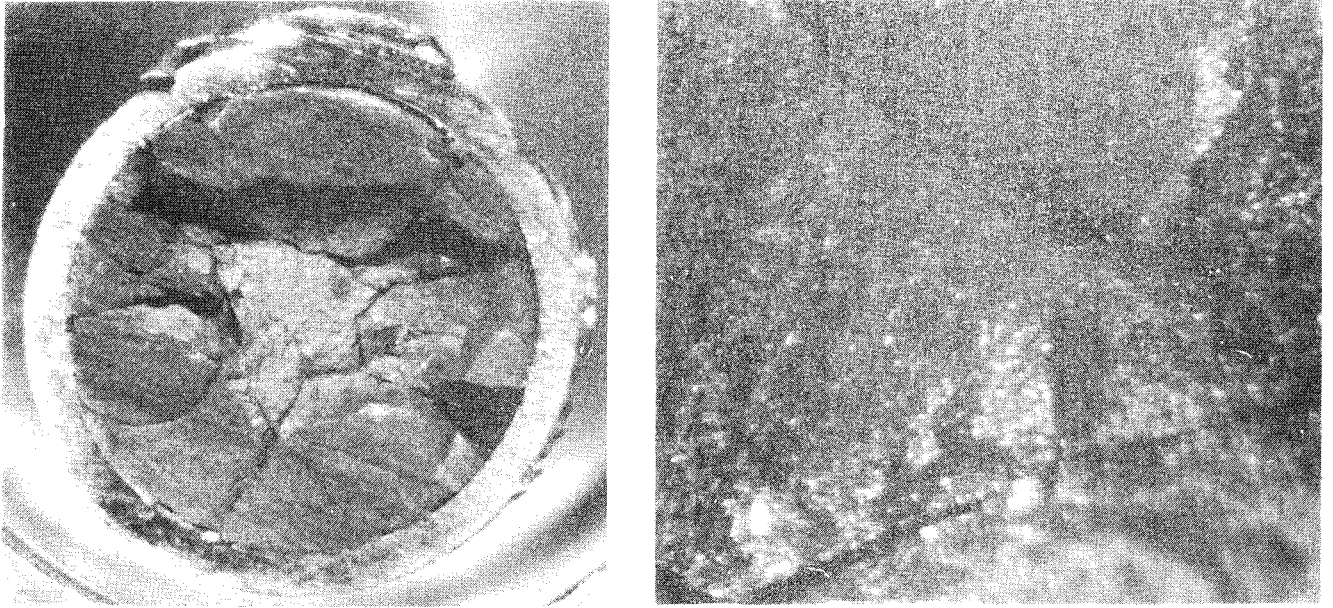
Fig 2. Fuel/clad segment 7.3 after a cumulative contact with Allard GW under oxidizing conditions of 688 days. 5 months of air storage. Upper surface (x7) and detail of fuel surface (x50).

Corresponding photographs of the other two specimens, 7.3 and 7.7, which had been contacted with Allard groundwater (123 ppm bicarbonate) under oxidizing and mildly reducing conditions respectively, are presented in Figs. 2 and 3. No yellow surface deposit could be distinguished on these specimens by periscopic examination.

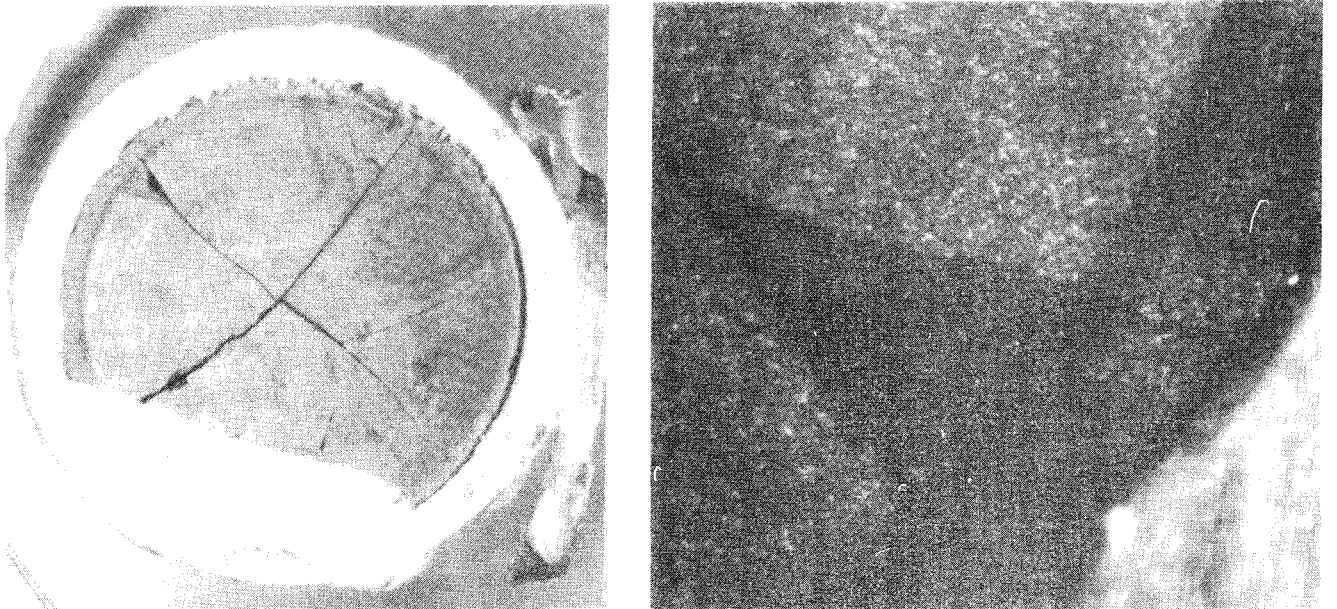
Fig 3. Fuel/clad segment 7.7 after a cumulative contact with Allard GW under slightly reducing conditions of 688 days. 5 months of air storage. Upper surface (x7) and detail of fuel surface (x50). (The white material is silicone grease from the leaching vessel.)

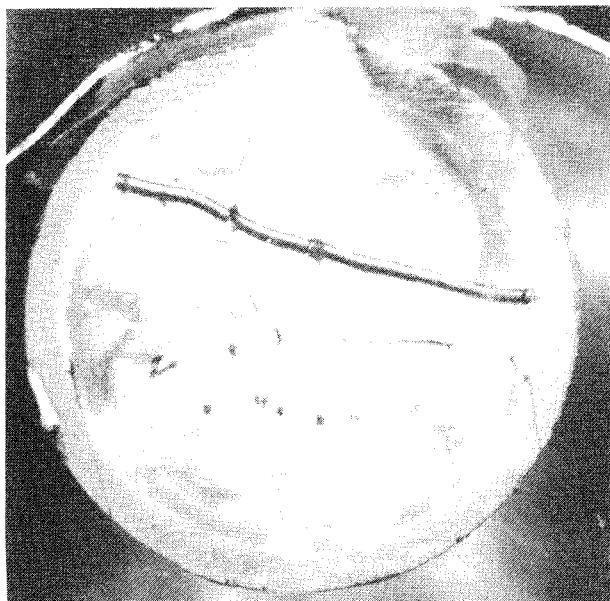
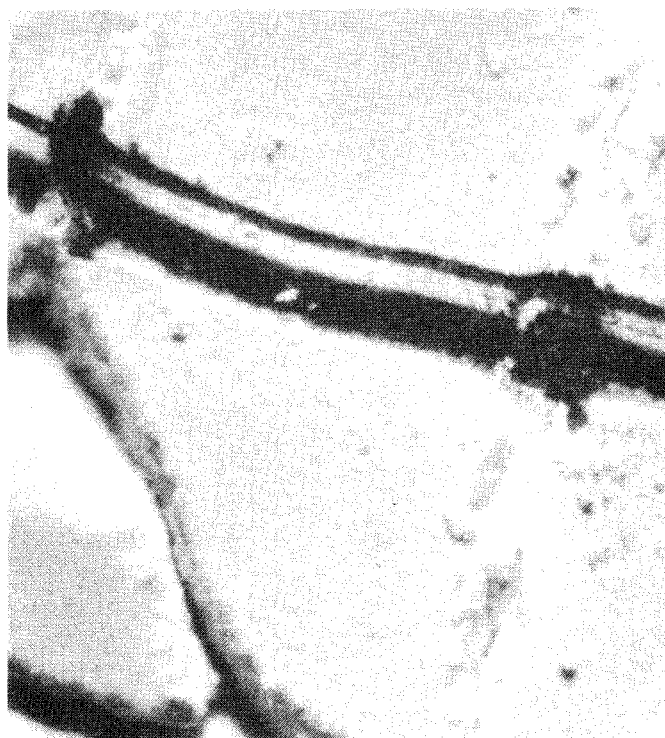
Fig 4. Fuel/clad segment 7.1 after scraping showing position (x7) and detail (x40) of scrape mark.

This was effected by first scraping the deposit with a scalpel point in an attempt to estimate the thickness of the deposit (Fig. 4) and then by pressing a pre-warmed (about 100^o) plastic tape against the deposit surface, thereby transferring an "image" of the deposit including material from the scrape mark, fuel cracks and general surface (Fig. 5).

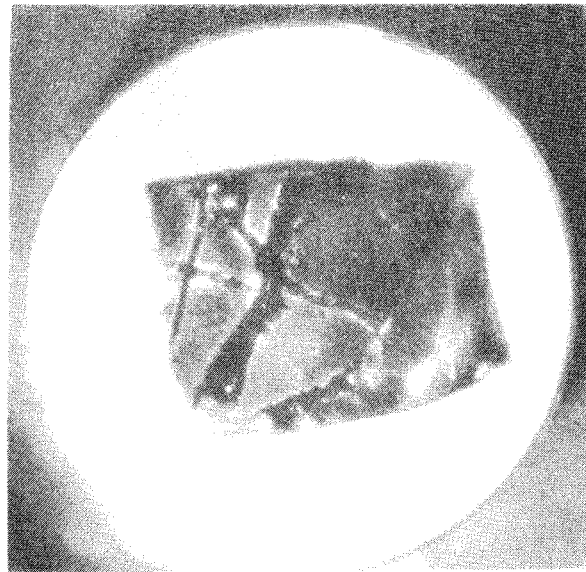
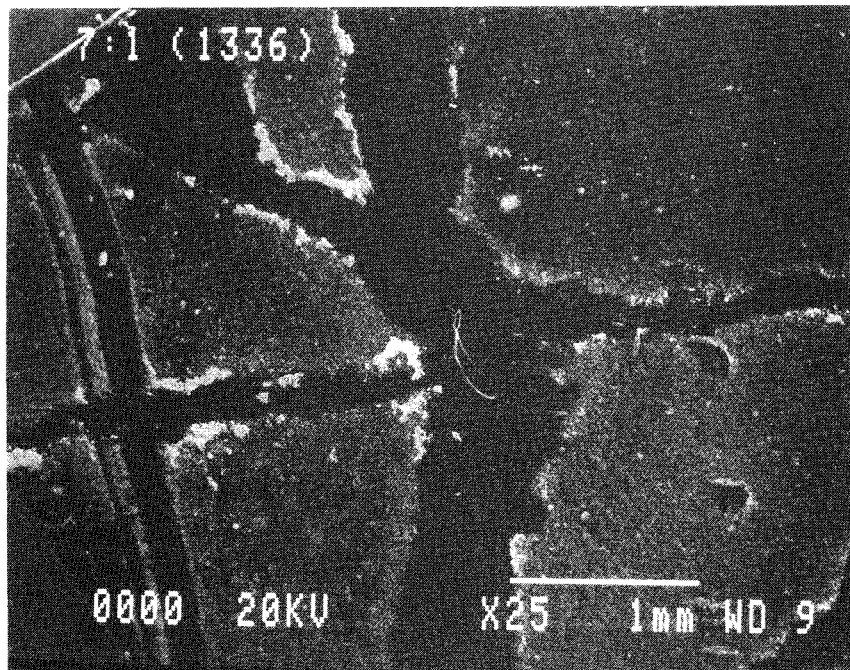
Fig 5. Overview (x6) and detail (x40) of the material transferred to the plastic tape.

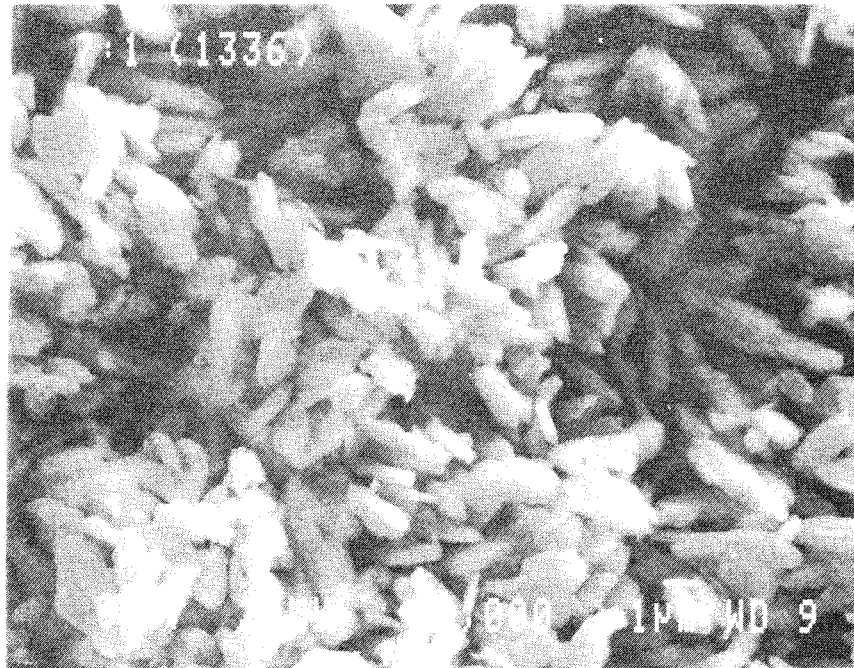
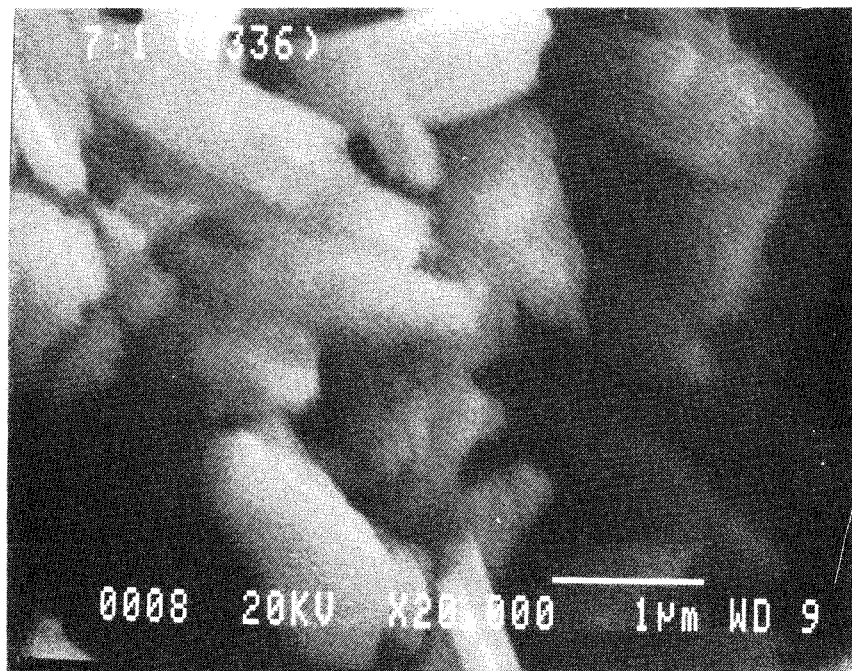
Fig 6. SEM photographs of the surface deposit.

The tape and deposit sample was mounted on a brass specimen holder, introduced into the SEM, and photographs of the deposit were taken at 15 locations. Photographs from three of these locations, which are representative of all locations, are presented in Figs. 6-8.

The surface deposit was seen to consist of roughly orthorhombic crystals about 2 microns in length. Although slight differences in appearance were noted, as exemplified in the figures, no correlation between appearance and location could be made. For comparison purposes, the material is also shown at lower magnification (x1000) in the optical microscope (Fig. 9).

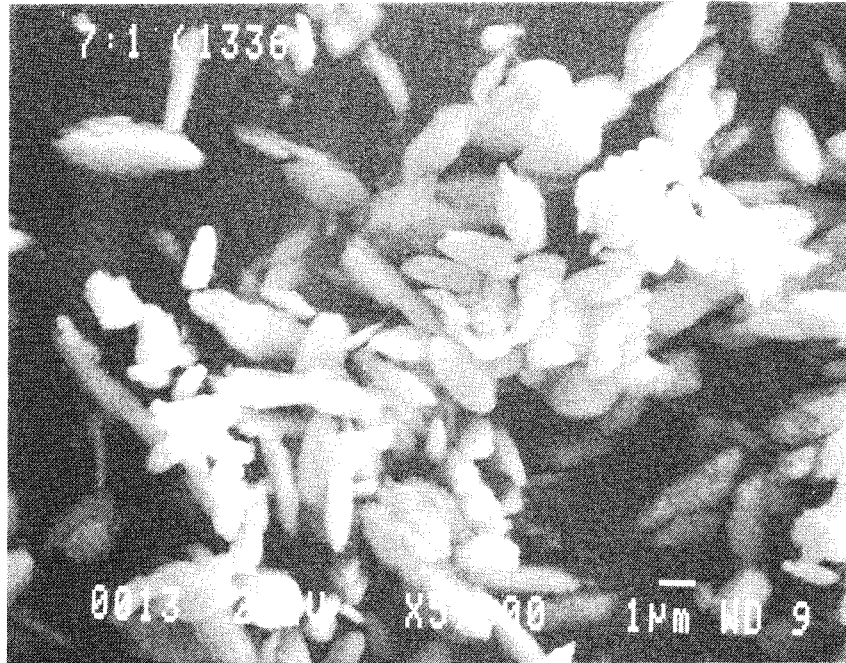
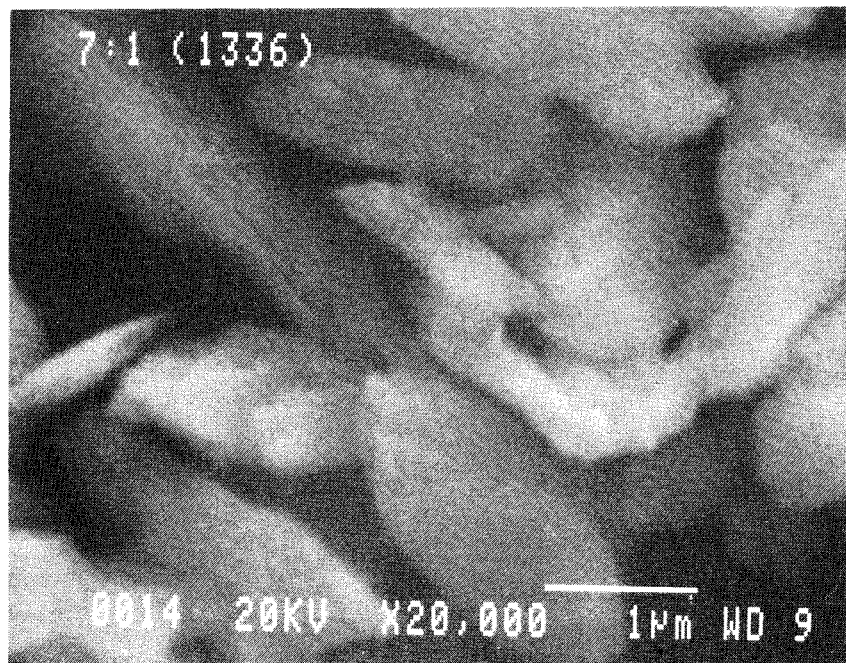
Fig 7. SEM photographs of the surface deposit.

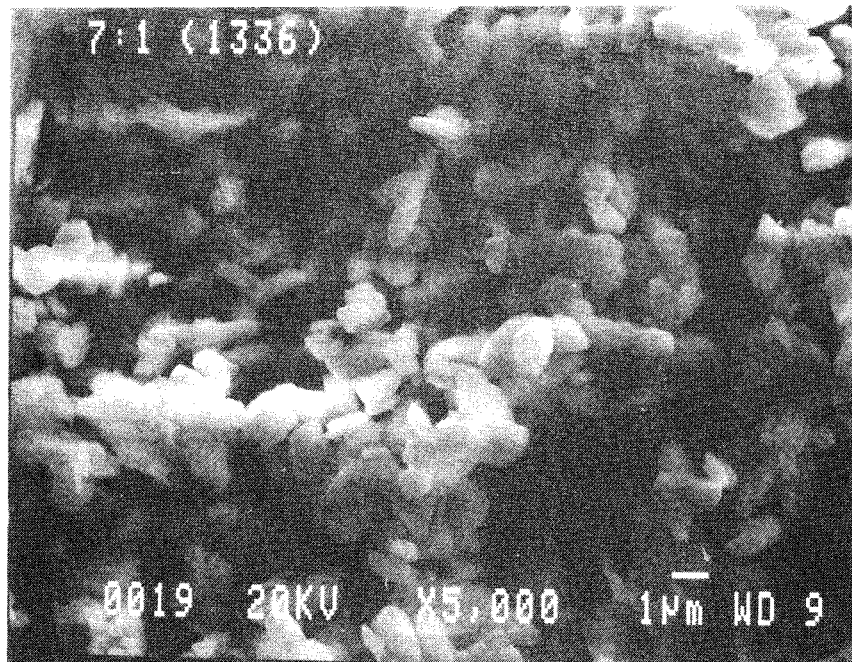
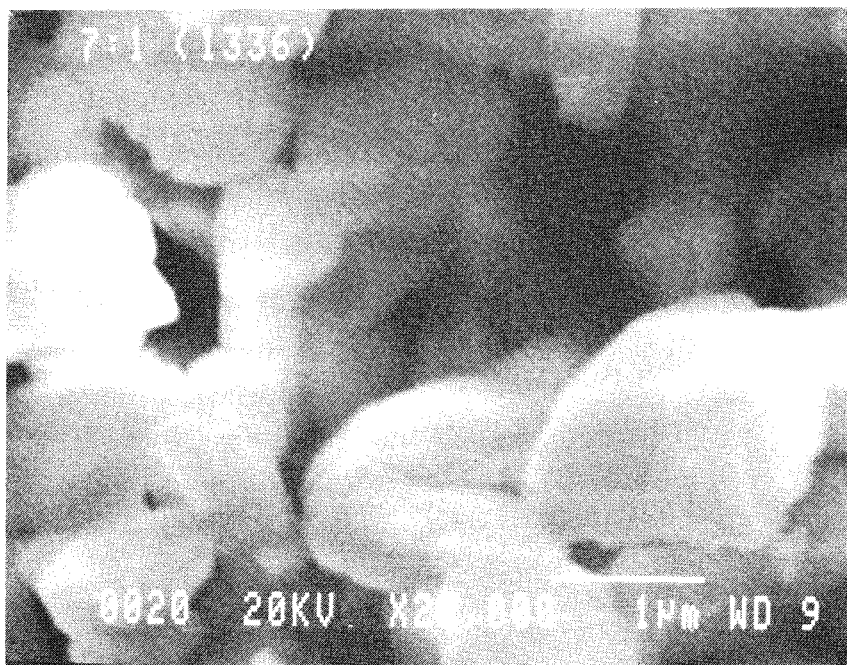
Fig 8. SEM photographs of the surface deposit.

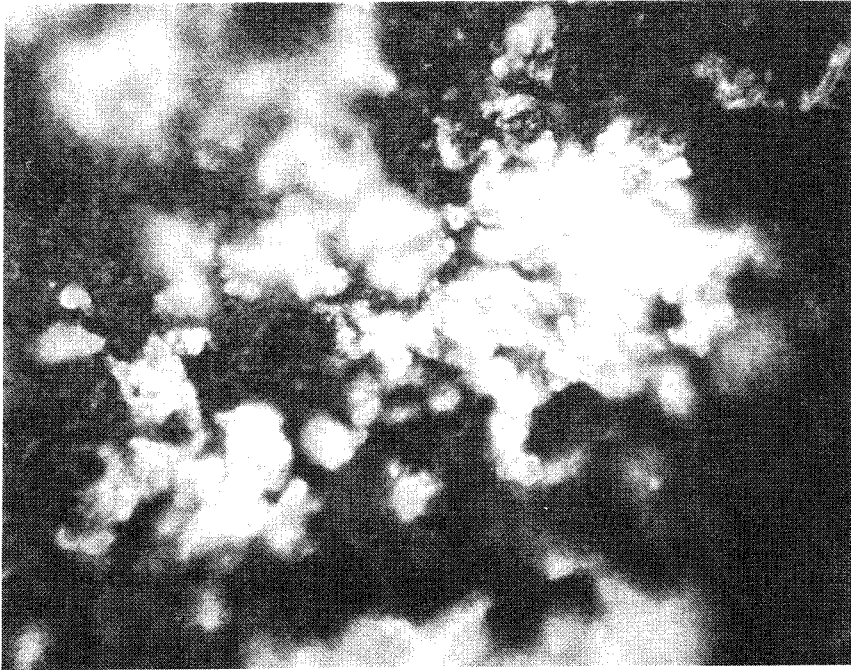
Fig 9. Appearance of the surface deposit in the optical microscope (x1000).

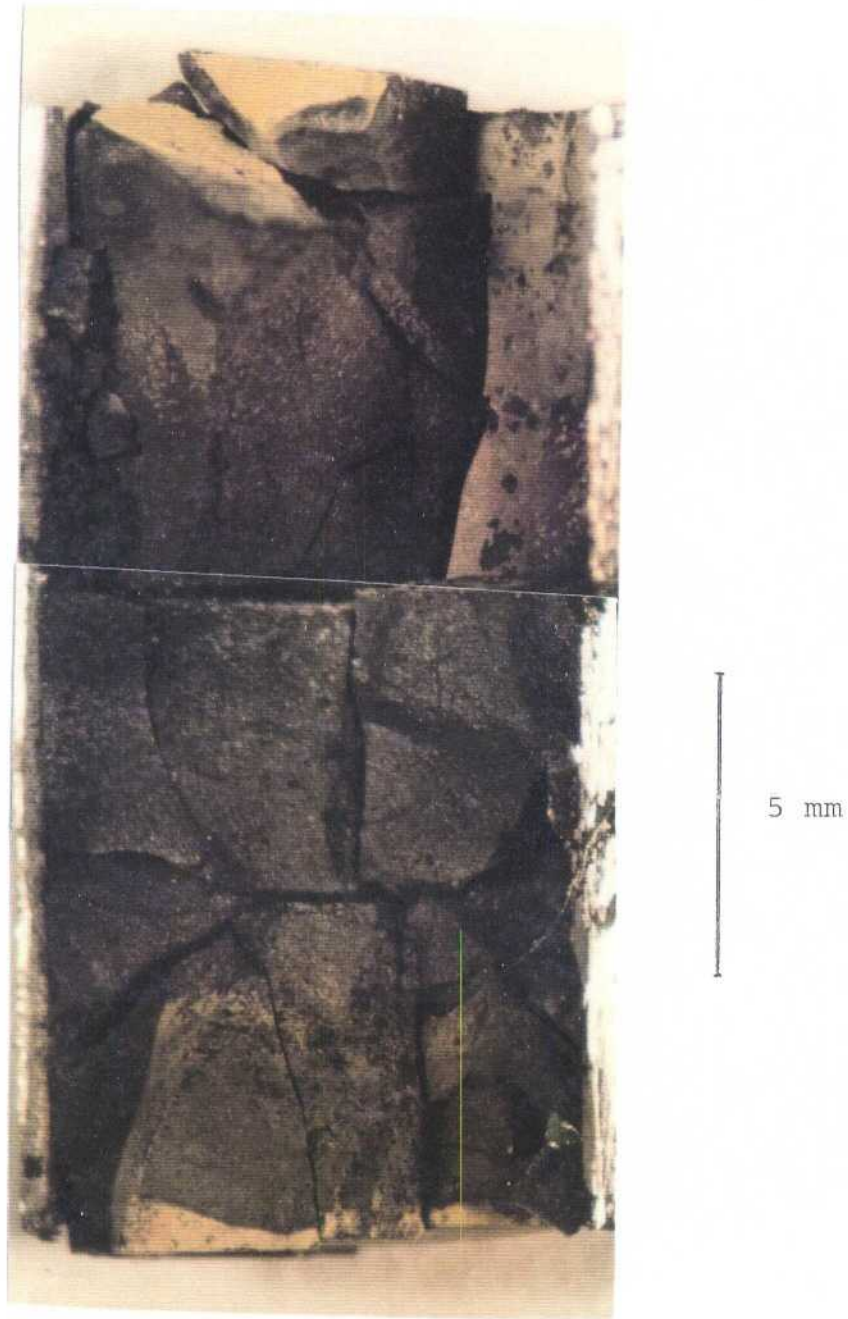
Fig 10. Fuel segment 7.1, clam-shelled to show distribution of yellow deposit.

As mentioned above, both open-end faces of specimen 7.1 were coated with the deposit. In order to determine whether or not all the fuel fragment surfaces were coated in the same way, specimen 7.1 was clam-shelled by cutting two longitudinal slits through the Zircaloy-4 clad. One of the clad halves, with adherent and loose fuel fragments, is shown in Fig. 10.

Perhaps rather surprisingly, it can be seen that the yellow deposit was predominantly located on the open-end surfaces, although some slight traces were seen on some fragment surfaces, and at the interpellet gap. (Fig. 11).

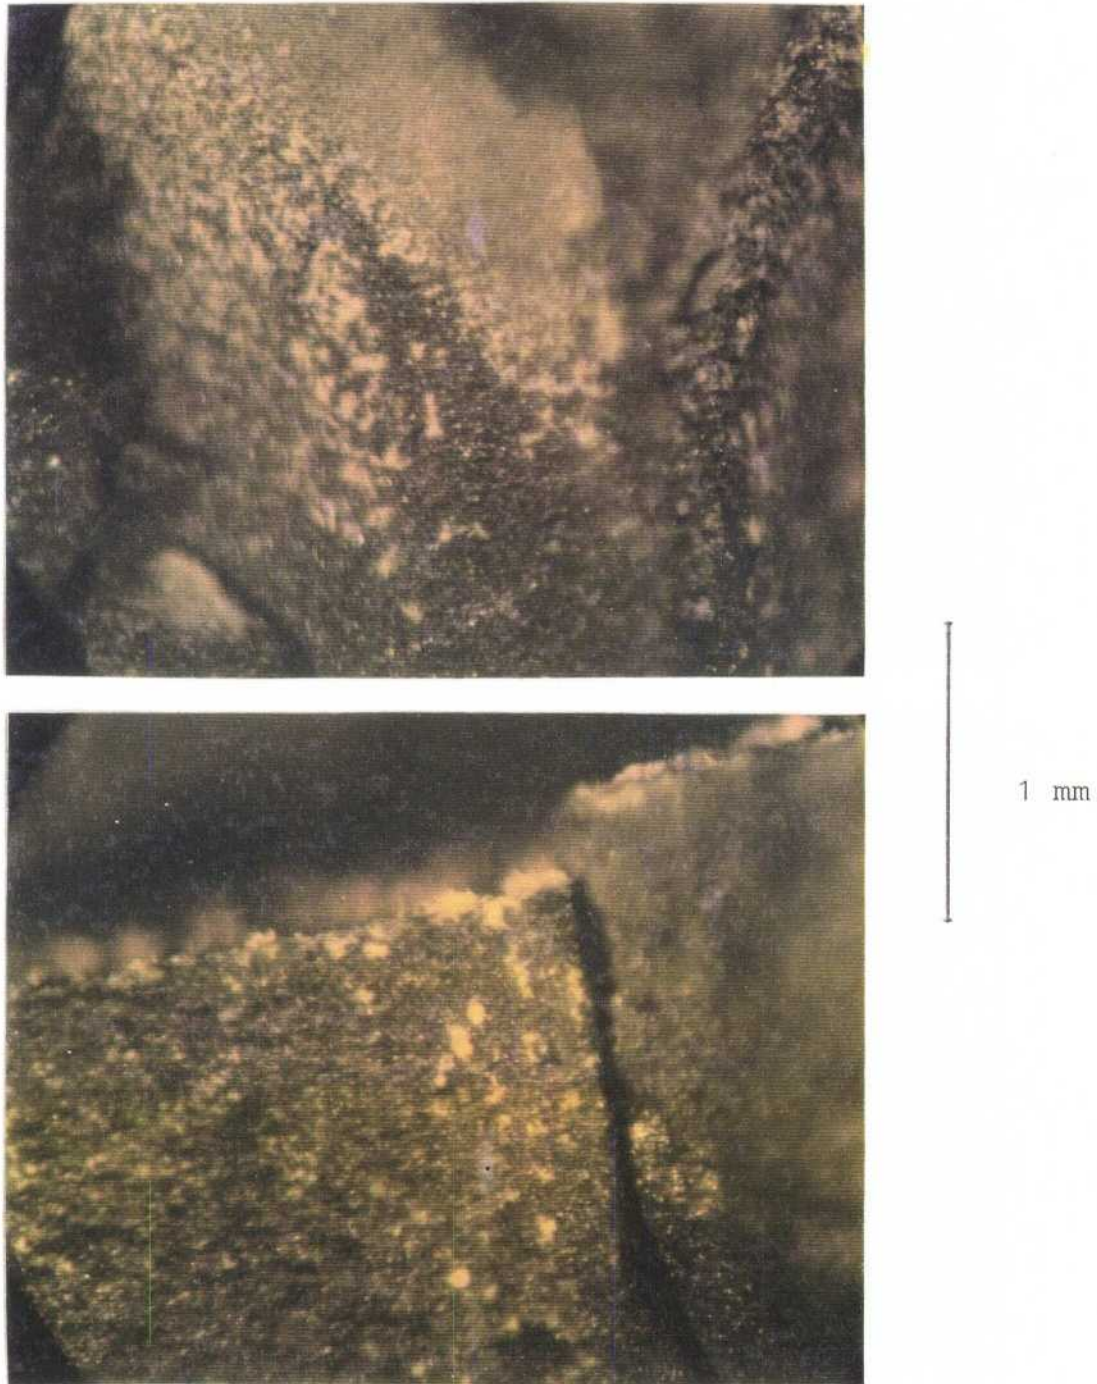
Fig 11. Yellow deposit on fragment (upper) and at edge of pellet dishing (lower).

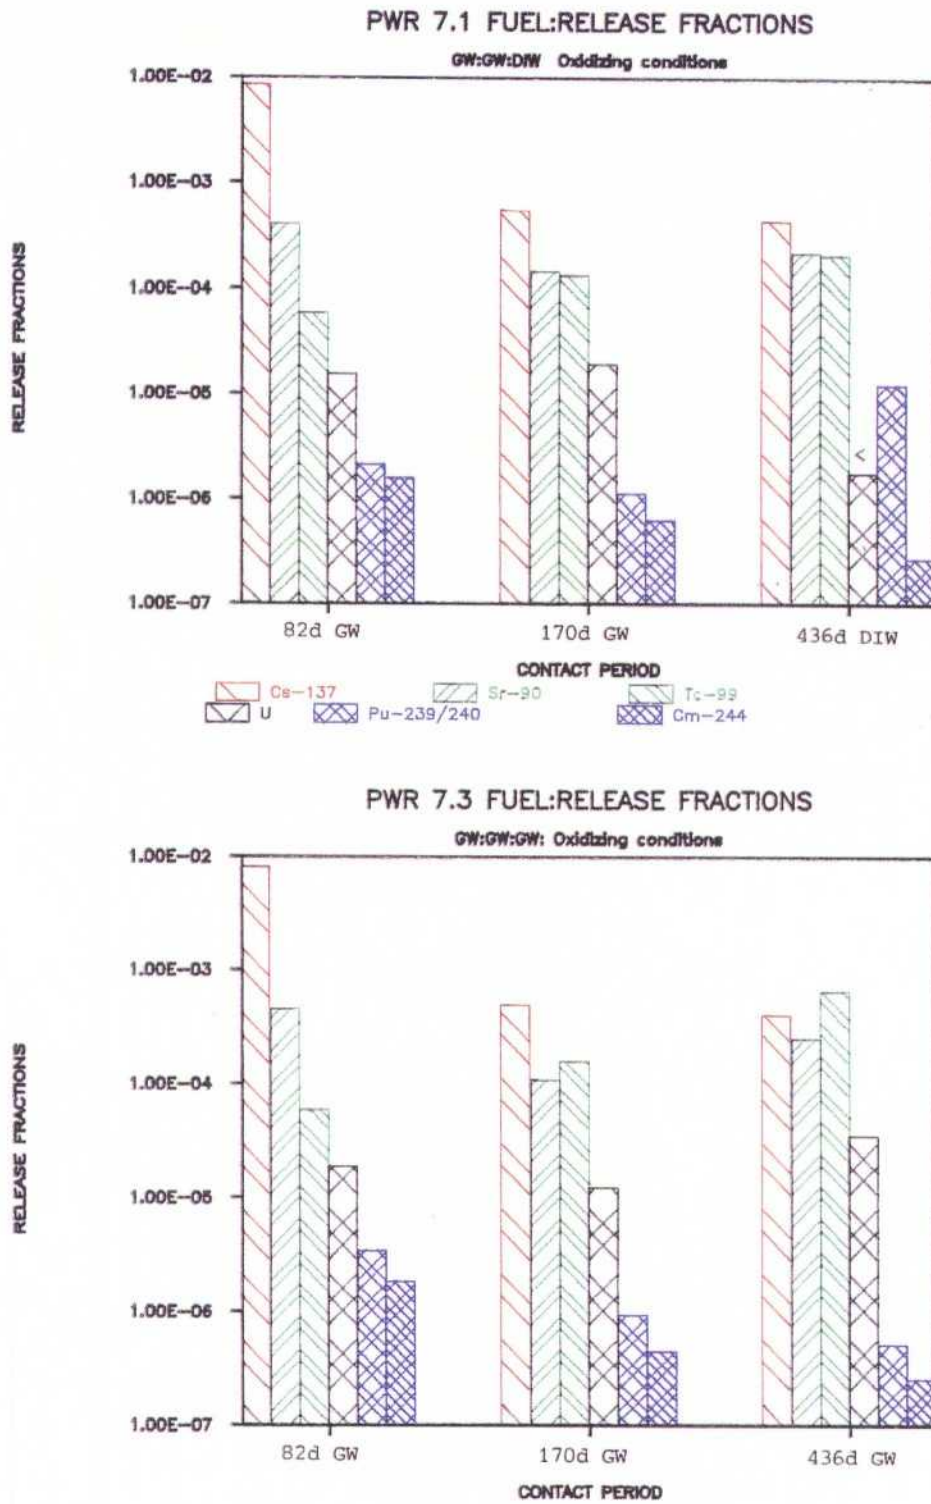
Fig 12. Comparison of release fractions between specimen 7.1 (final contact with DIW) and specimen 7.3 (all contacts with GW).

This effect is illustrated in Fig. 12 which presents the release fractions for uranium and some key fission product and actinide nuclides for the two specimens during their three contact periods. The release fraction for uranium plotted for the third DIW contact period for specimen 7.1 is a detection limit value. The correct value is probably at least an order of magnitude lower.

Inspection of the figure shows that the release fraction values for the two specimens were very similar during the first two groundwater contact periods. Even during the third contact, the release values for Cs-137 and Sr-90, often regarded as monitors of the on-going corrosion process, are essentially identical. The higher retention of plutonium in deionized water compared with groundwater has been established in previous work (3) and will not be discussed further here.
