Technical Report

TR-98-11

**Leaching of 90-year old
concrete mortar in contact
with stagnant water**

Swedish Cement and Concrete Research Institute

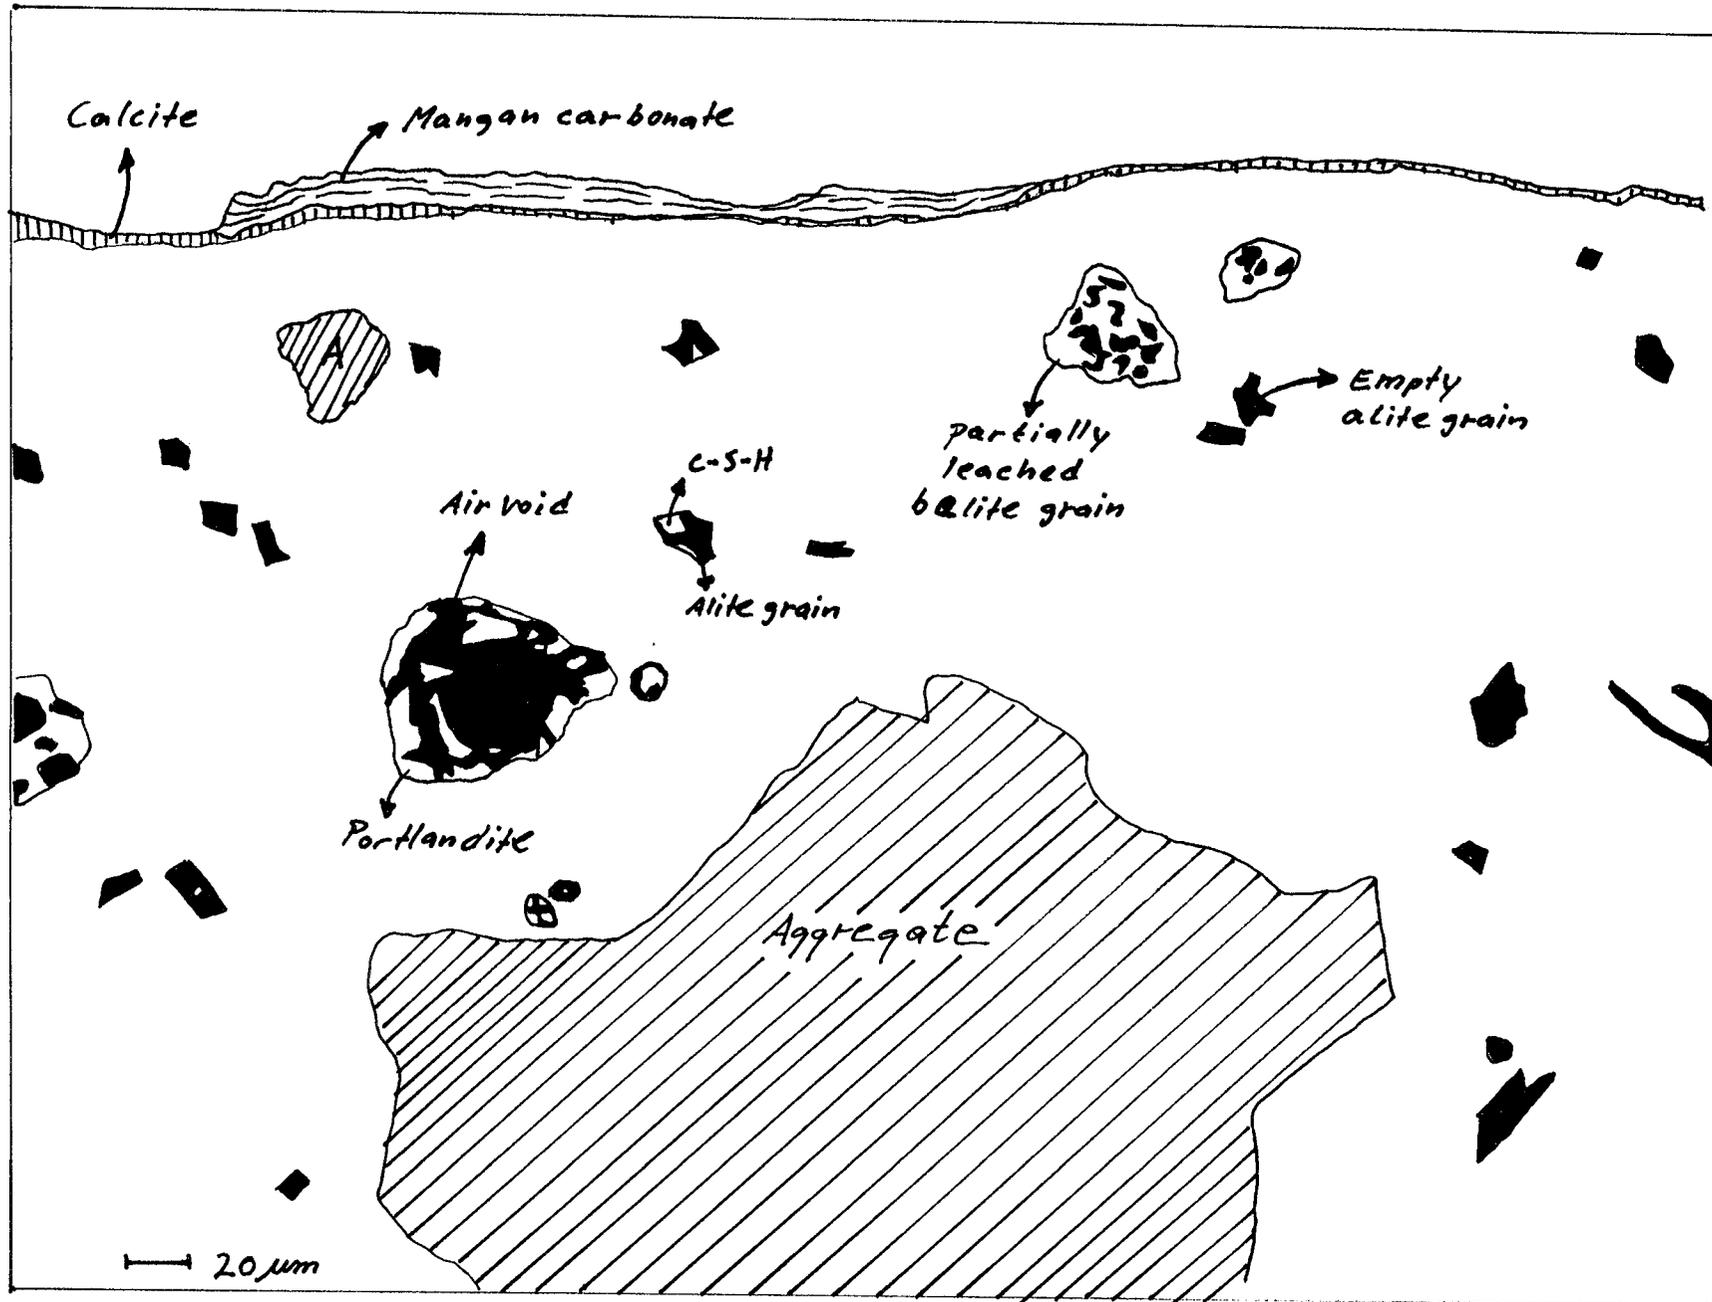
FIG. 2. Structural features in the outer zone (waterside) of the concrete mortar.

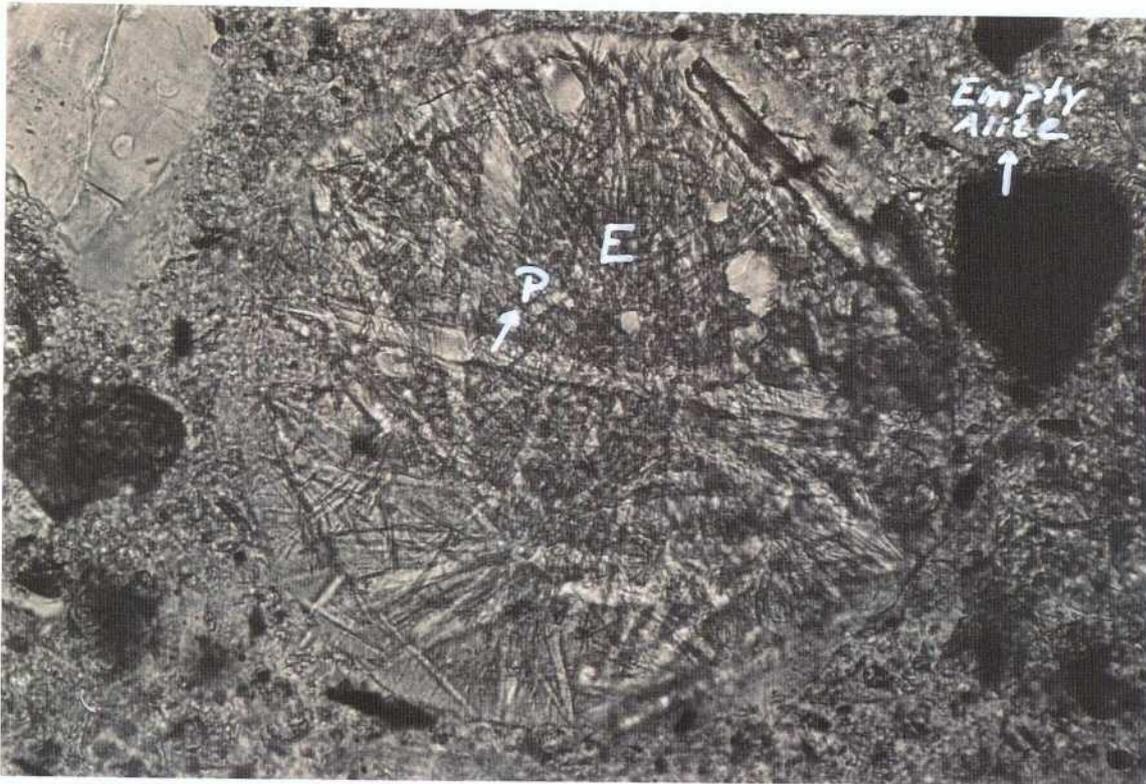
Fig 3. Air-void filled with platy portlandite crystals and needle-like ettringite crystals. Empty alite grain (leached) on the right side.

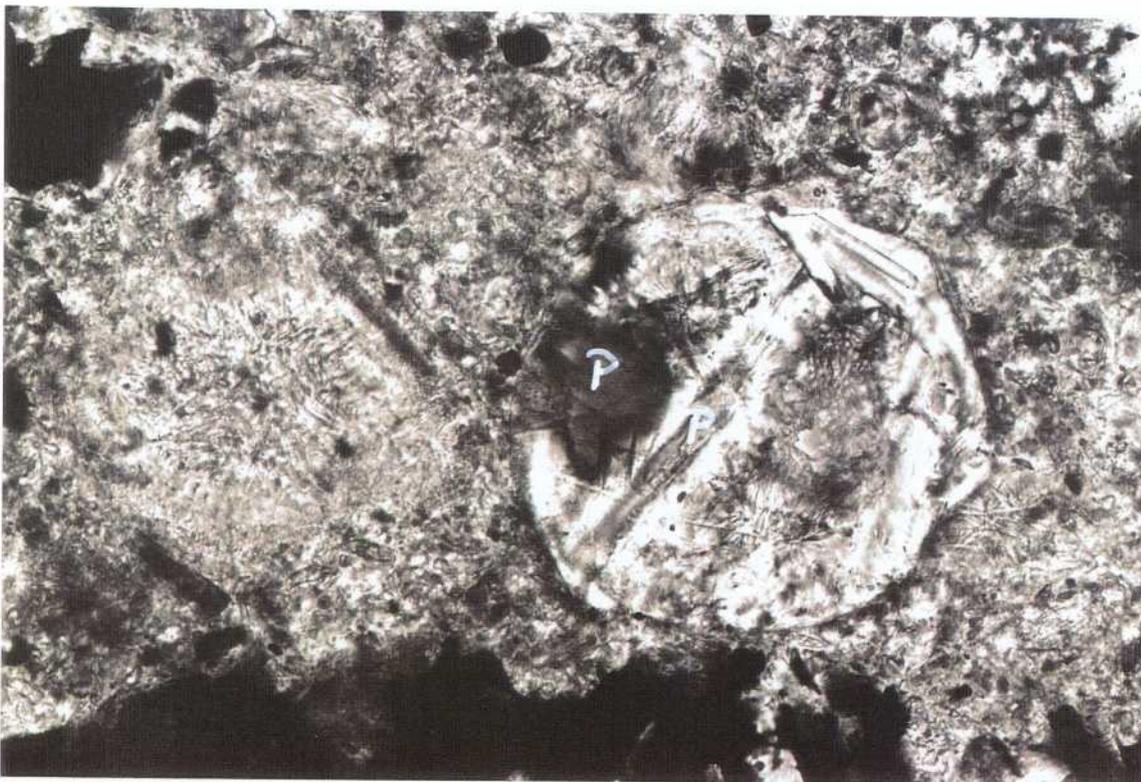
Fig 4. Air-void filled with portlandite.

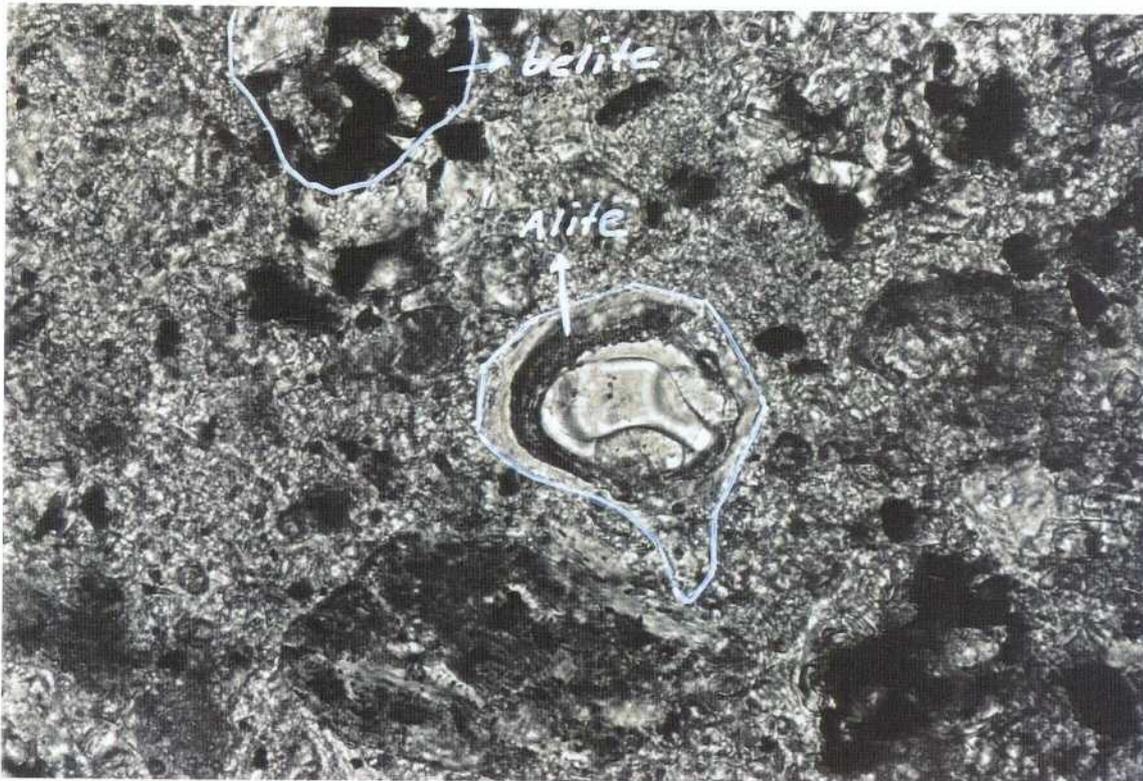
Fig 5. Half-filled alite grain and partially leached belite grain.

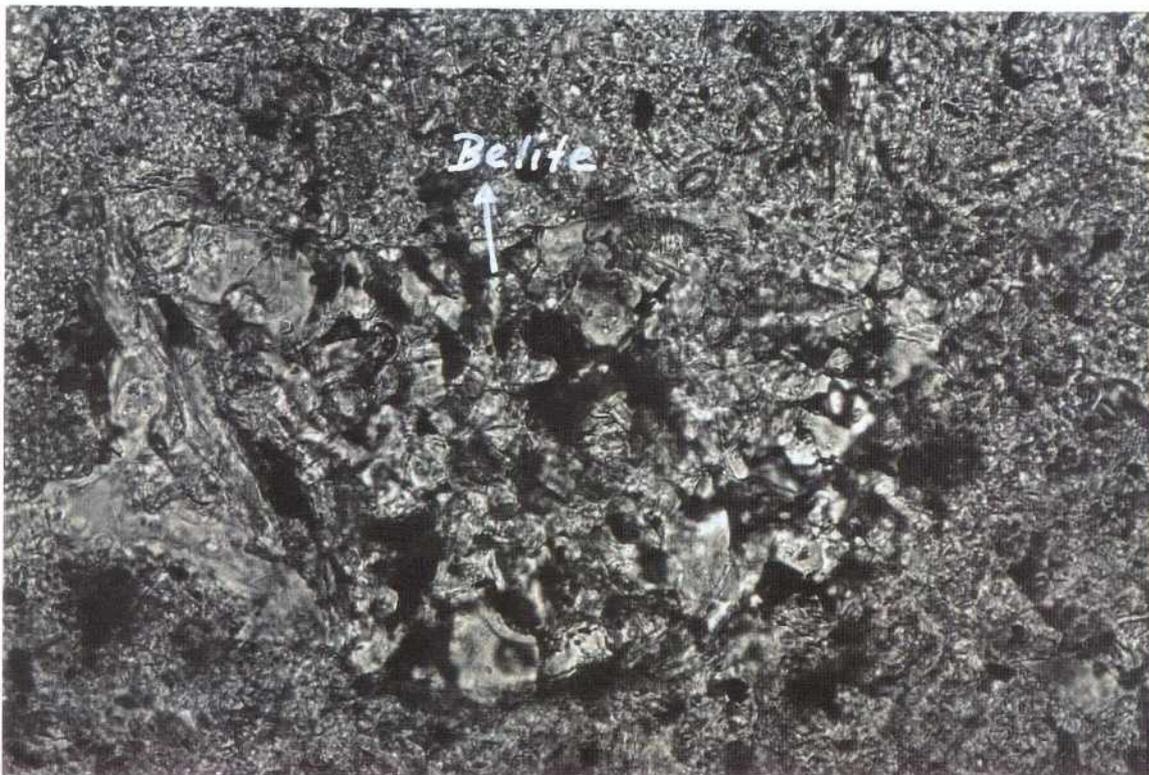
Fig 6. Partially leached belite grain.

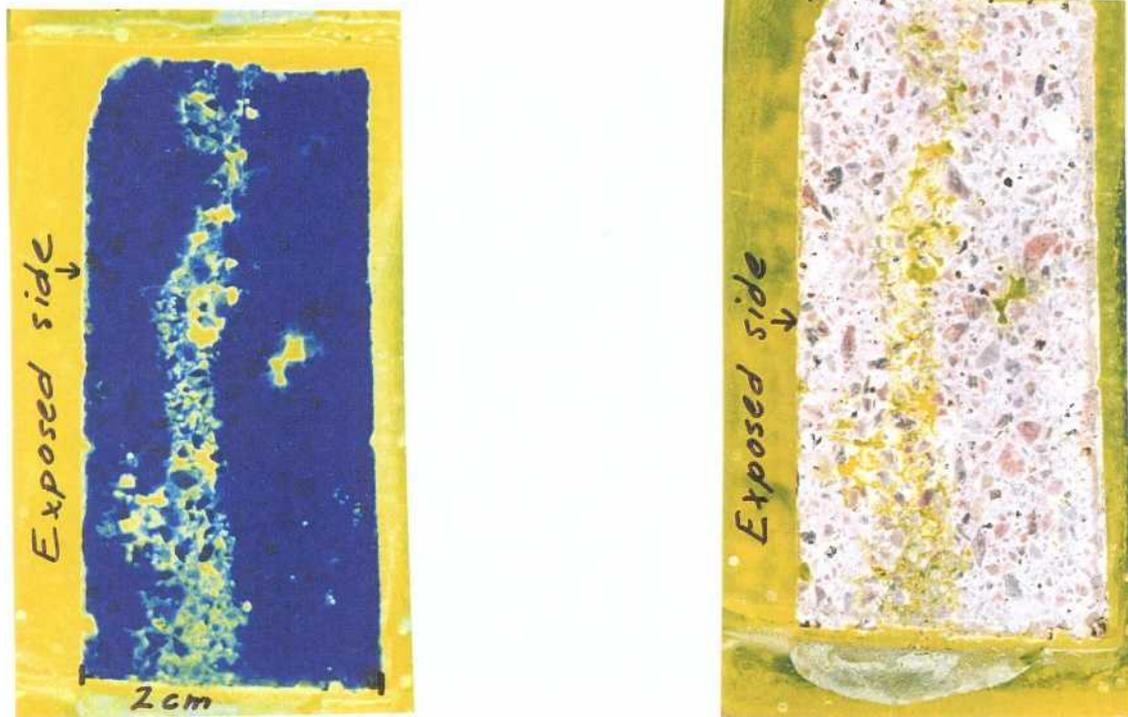
Fig 1. Polished crosssection of the concrete mortar in watertank. The sample is impregnated with epoxy with fluorescent dye which reveals the coarse porosity (yellow patches) under fluorescent light. Thin sections were made from the same piece.

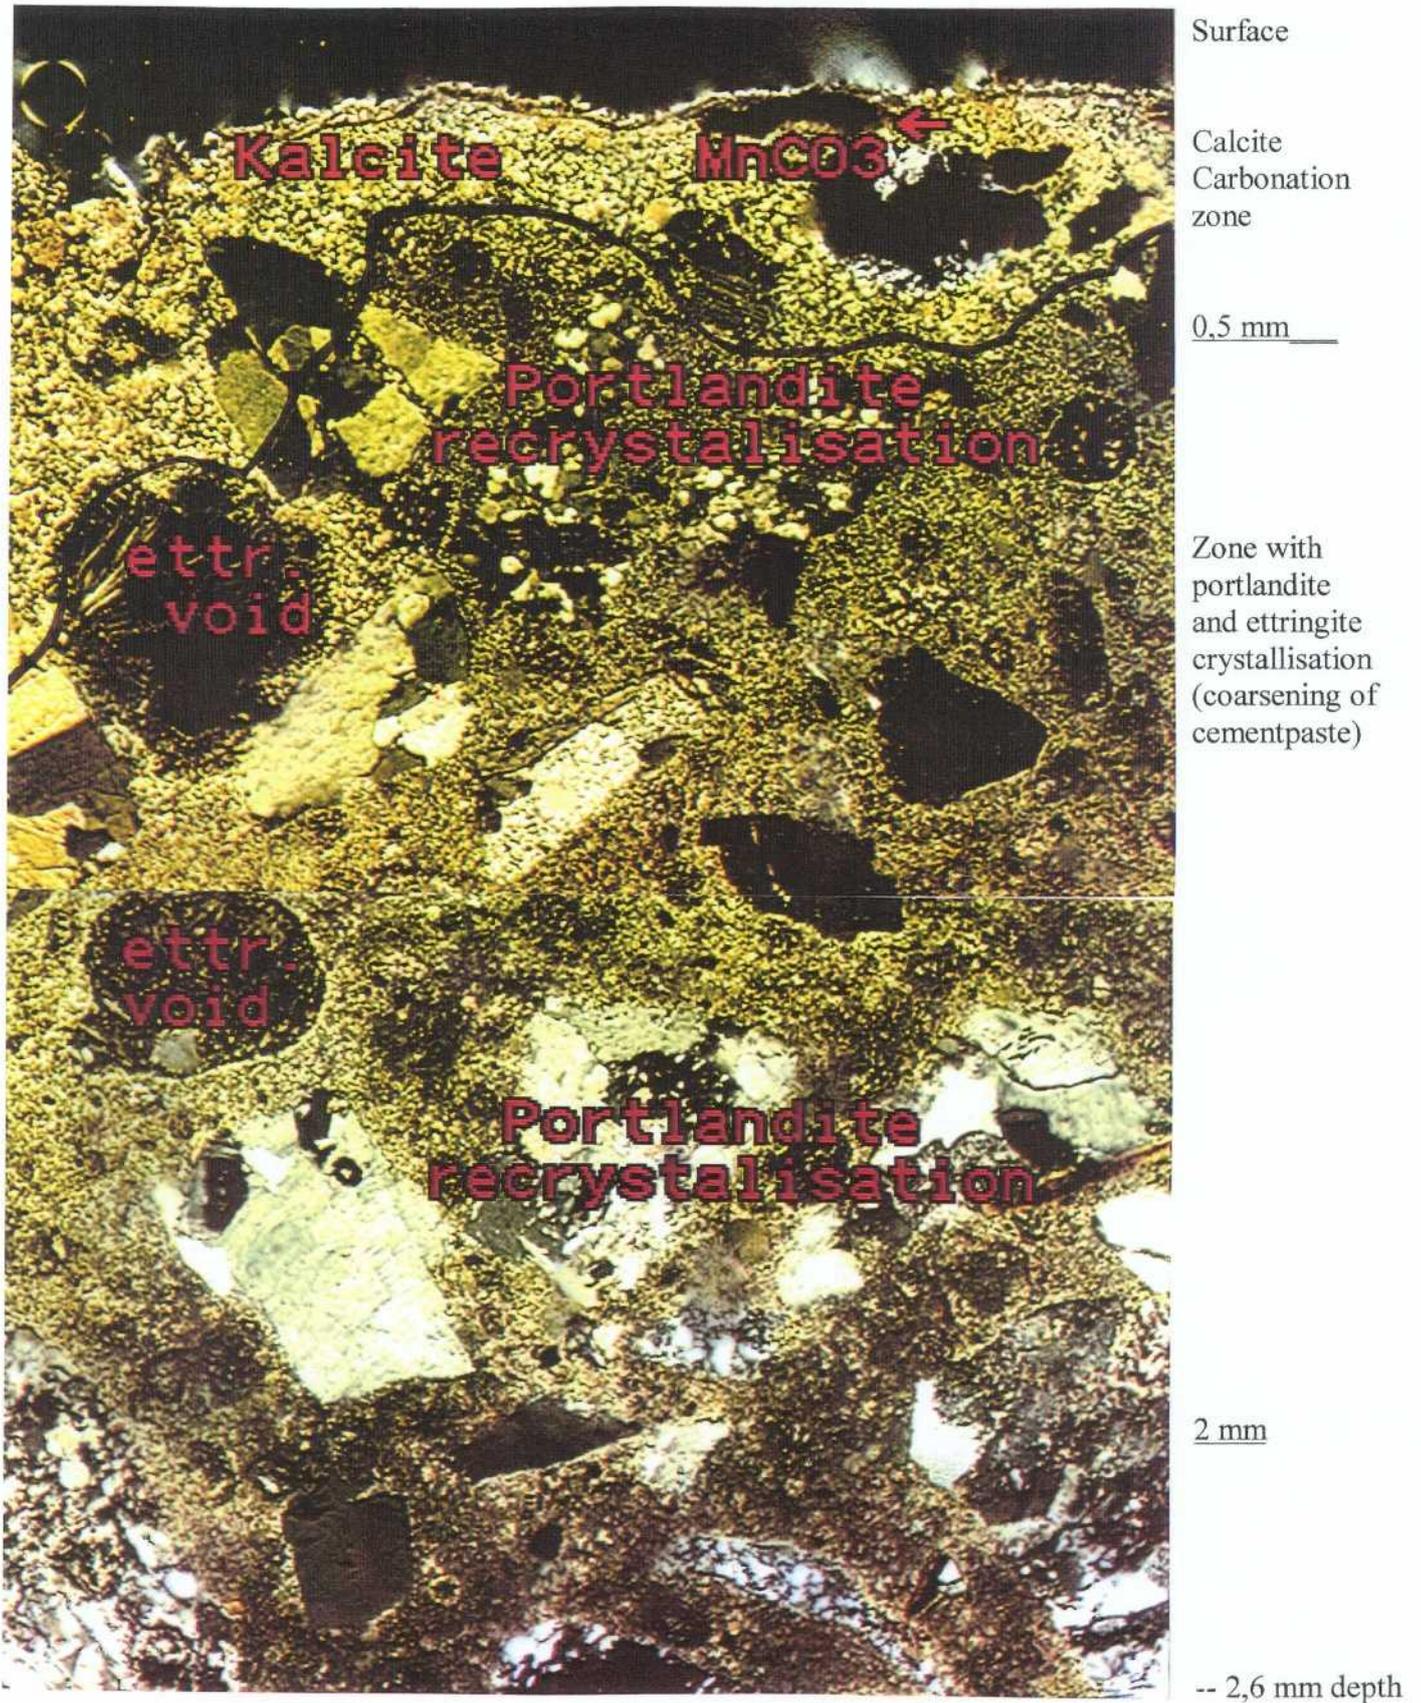
Photographs from thin sections: Level 0-2,6 mm.

Fig 2. Upper carbonated zone containing calcite, 0,5 – 1 mm thick. Abundant portlandite crystallisation from 0,5 mm – 3 mm depth. (Yellowish-grainy areas). Ettringite-filled circular air voids exist at about 1,5 mm depth.

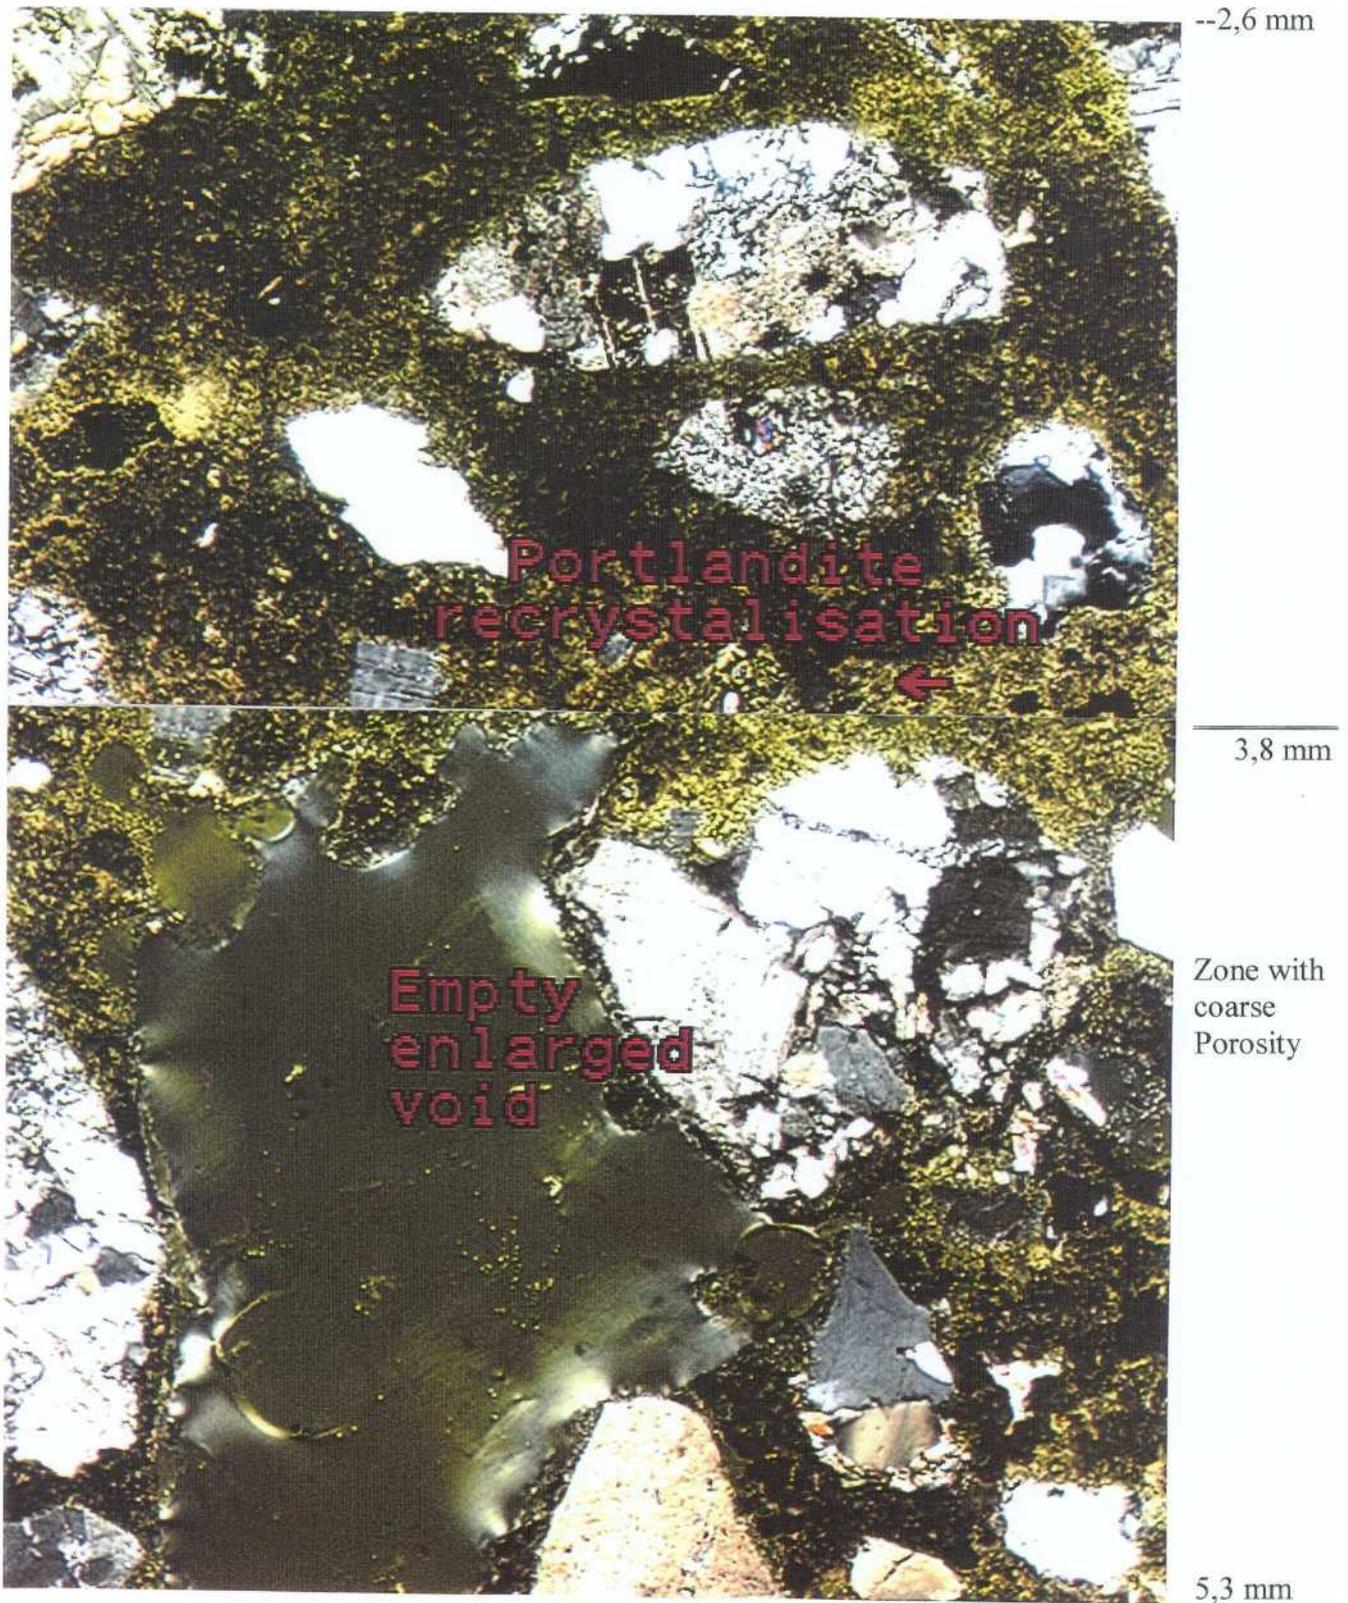
Level 2,6-5,3 mm

Fig 3. Portlandite crystallisation in patches indicated by "yellowish grainy" areas. At about 4,5 mm depth, a coarse porosity is observed shown by numerous enlarged and irregular air-voids.

The porosity variation of the coarser pore size range of 10-30 microns showed a marked increase between 4 and 7 mm defining the zone with heavy leaching and coarse pores which was also observed under the polarising light microscope (see Appendix 2, page 4).

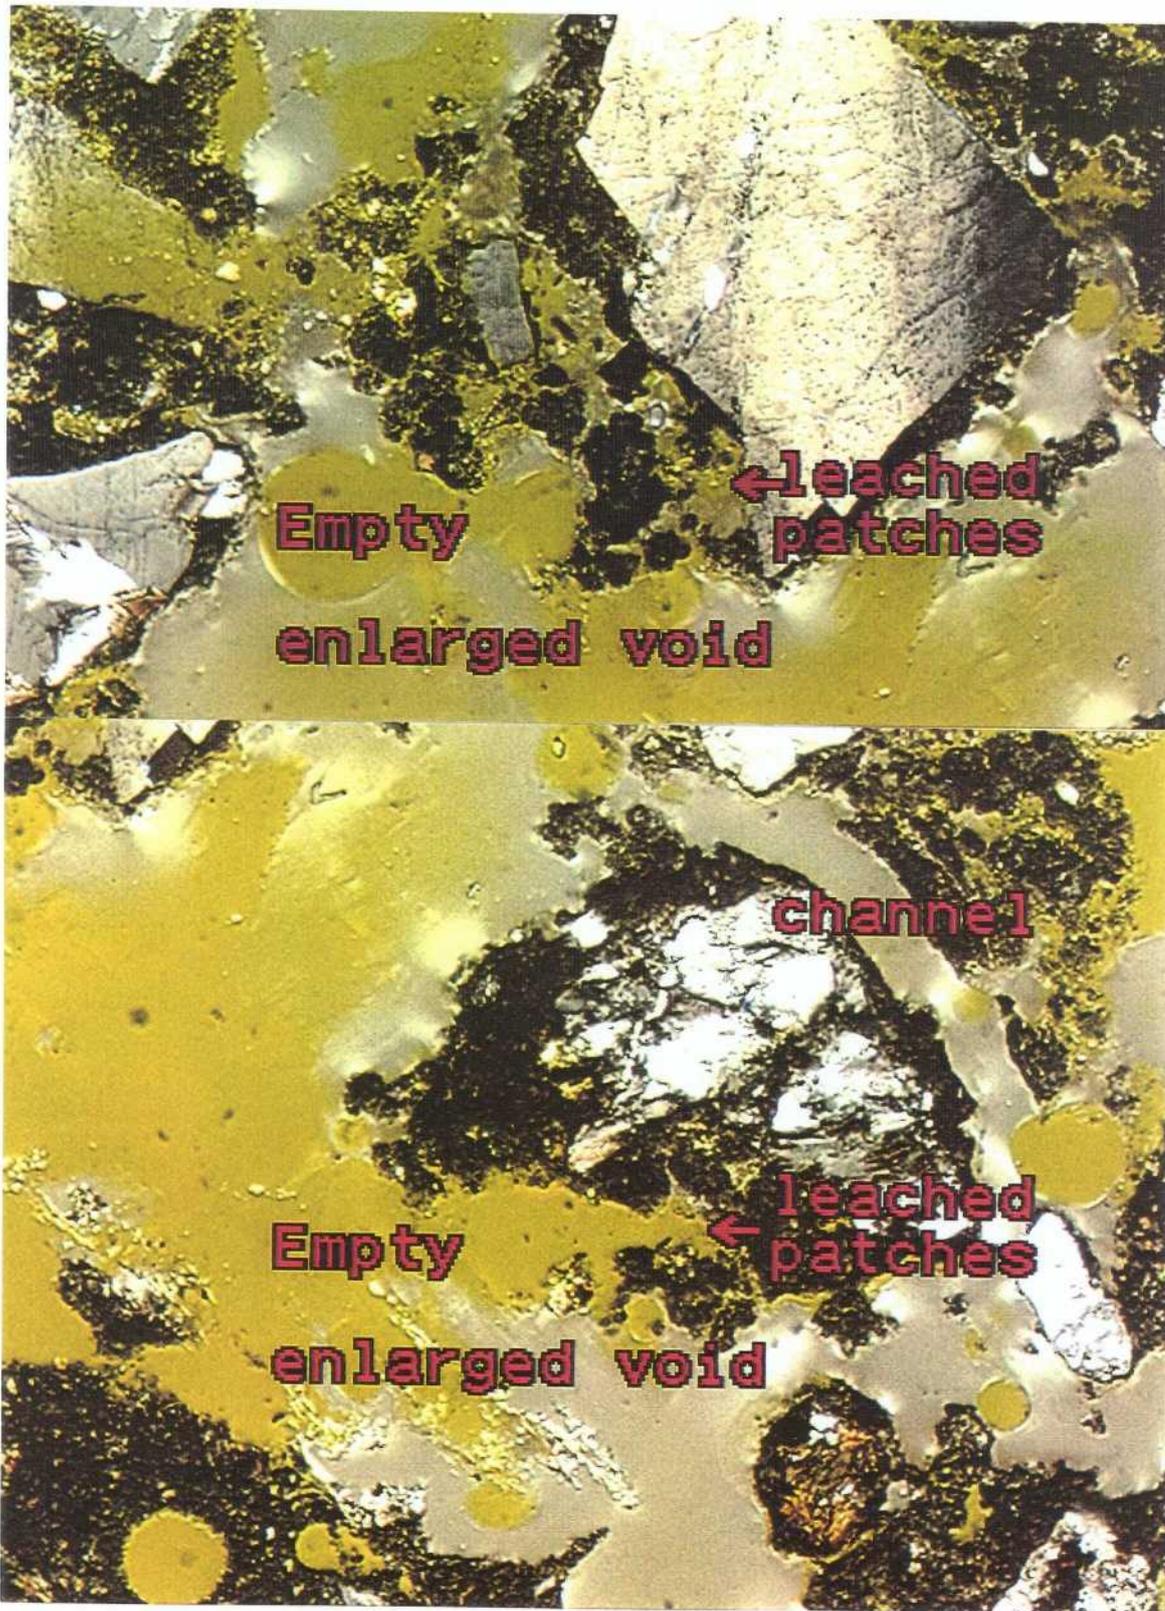
Level 5,3-7,8 mm

Zone with coarse Porosity and leached paste structure

Fig 4. Zone with coarse porosity shown by numerous enlarged and irregular air-voids. Leached patches in the cement paste exist at about 7 mm.

From about 4 mm to about 8 mm the cement paste has been heavily leached resulting in numerous large voids with irregular and "channel-like" shapes. This is shown in Appendix 2, page 3, 4 and 5. This zone can be interpreted as a leaching front.

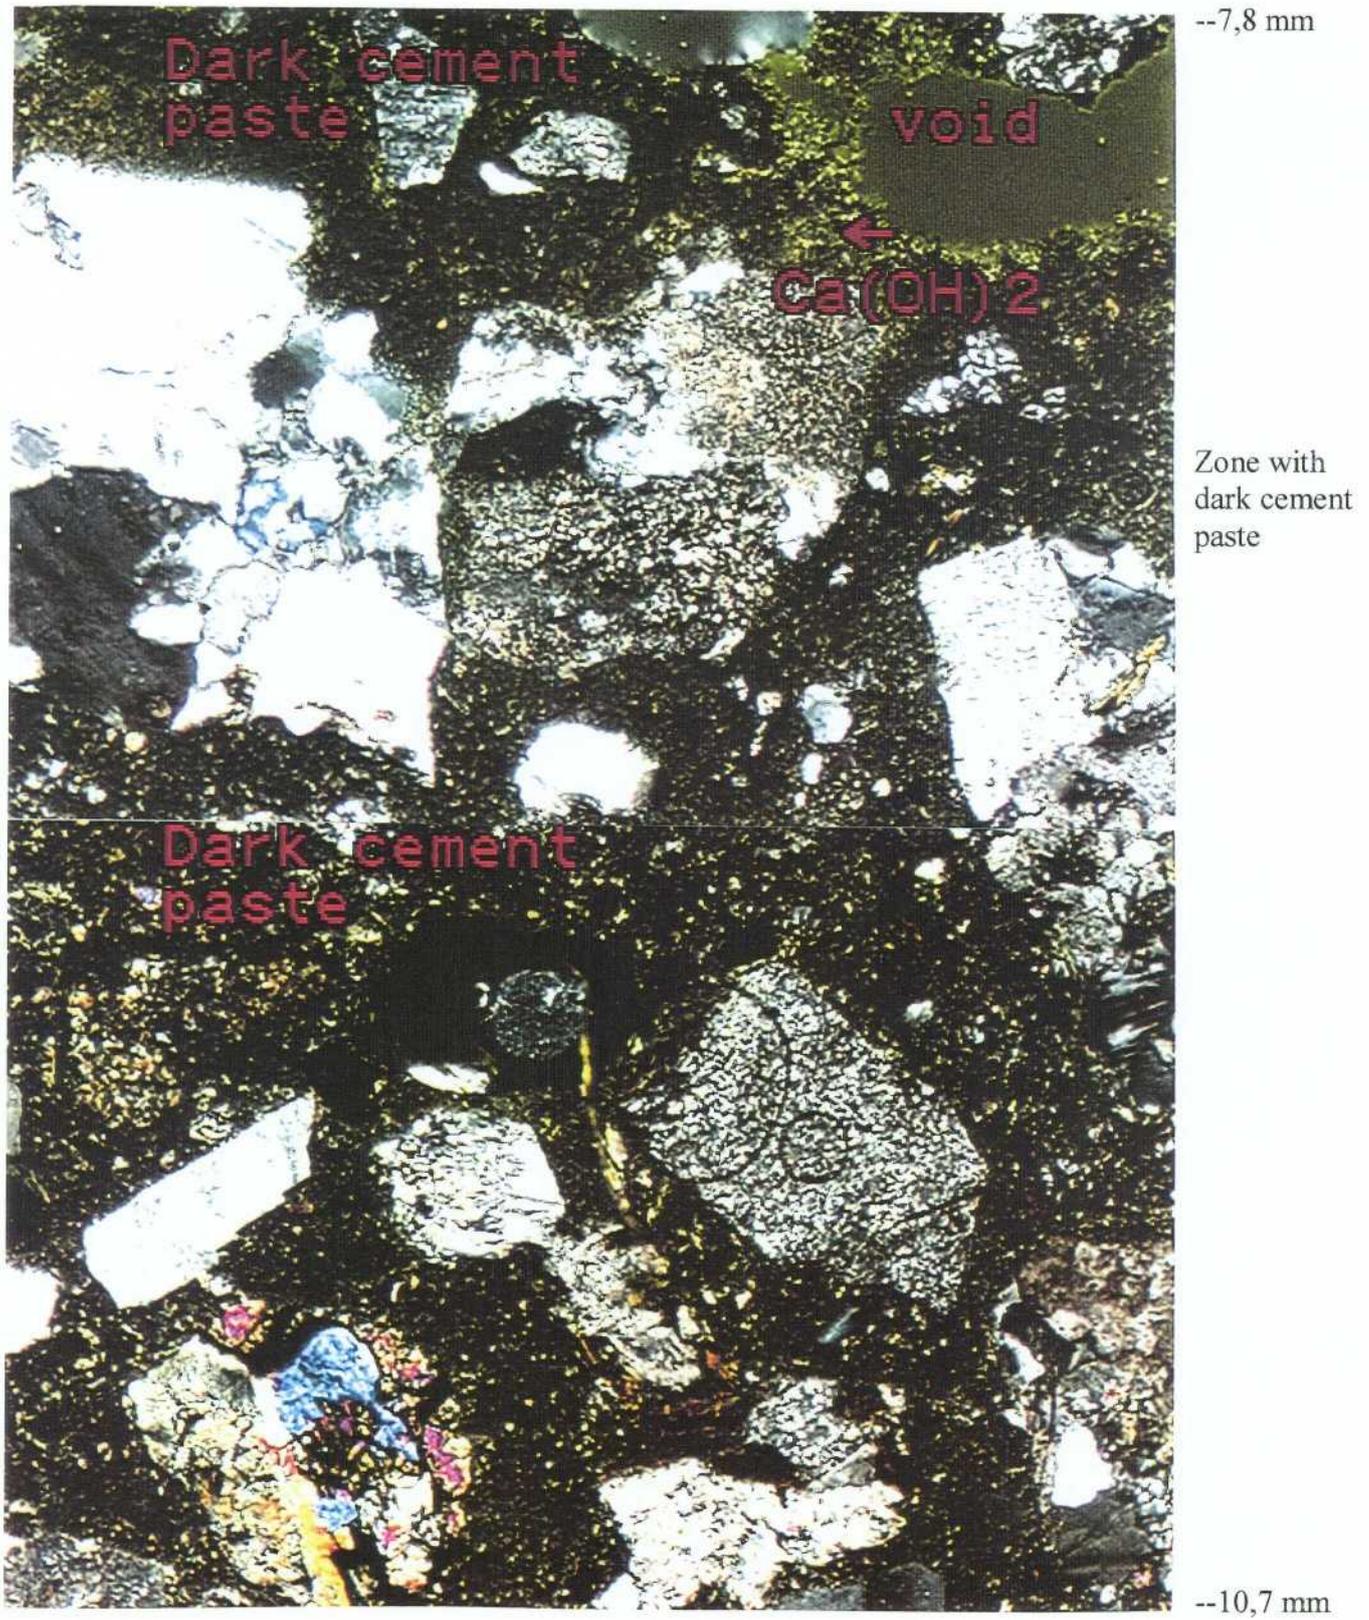
Level 7,8-10,7 mm

Fig 5. Zone with low porosity and dark cement paste. The structure of the cement paste is less affected by remobilisation and recrystallisation.

Behind this zone and to the steel confinement, the cement paste becomes denser which is indicated by the dark colour under the polarising microscope (see Appendix 2, page 5, 6 and 7). This also indicates that the cement paste in the inner part of the concrete mortar has been left, if not unaltered, at least much less altered by migrating fluids. This was supported by porosity measurements with a SEM-coupled image analyser shown in Appendix 3.

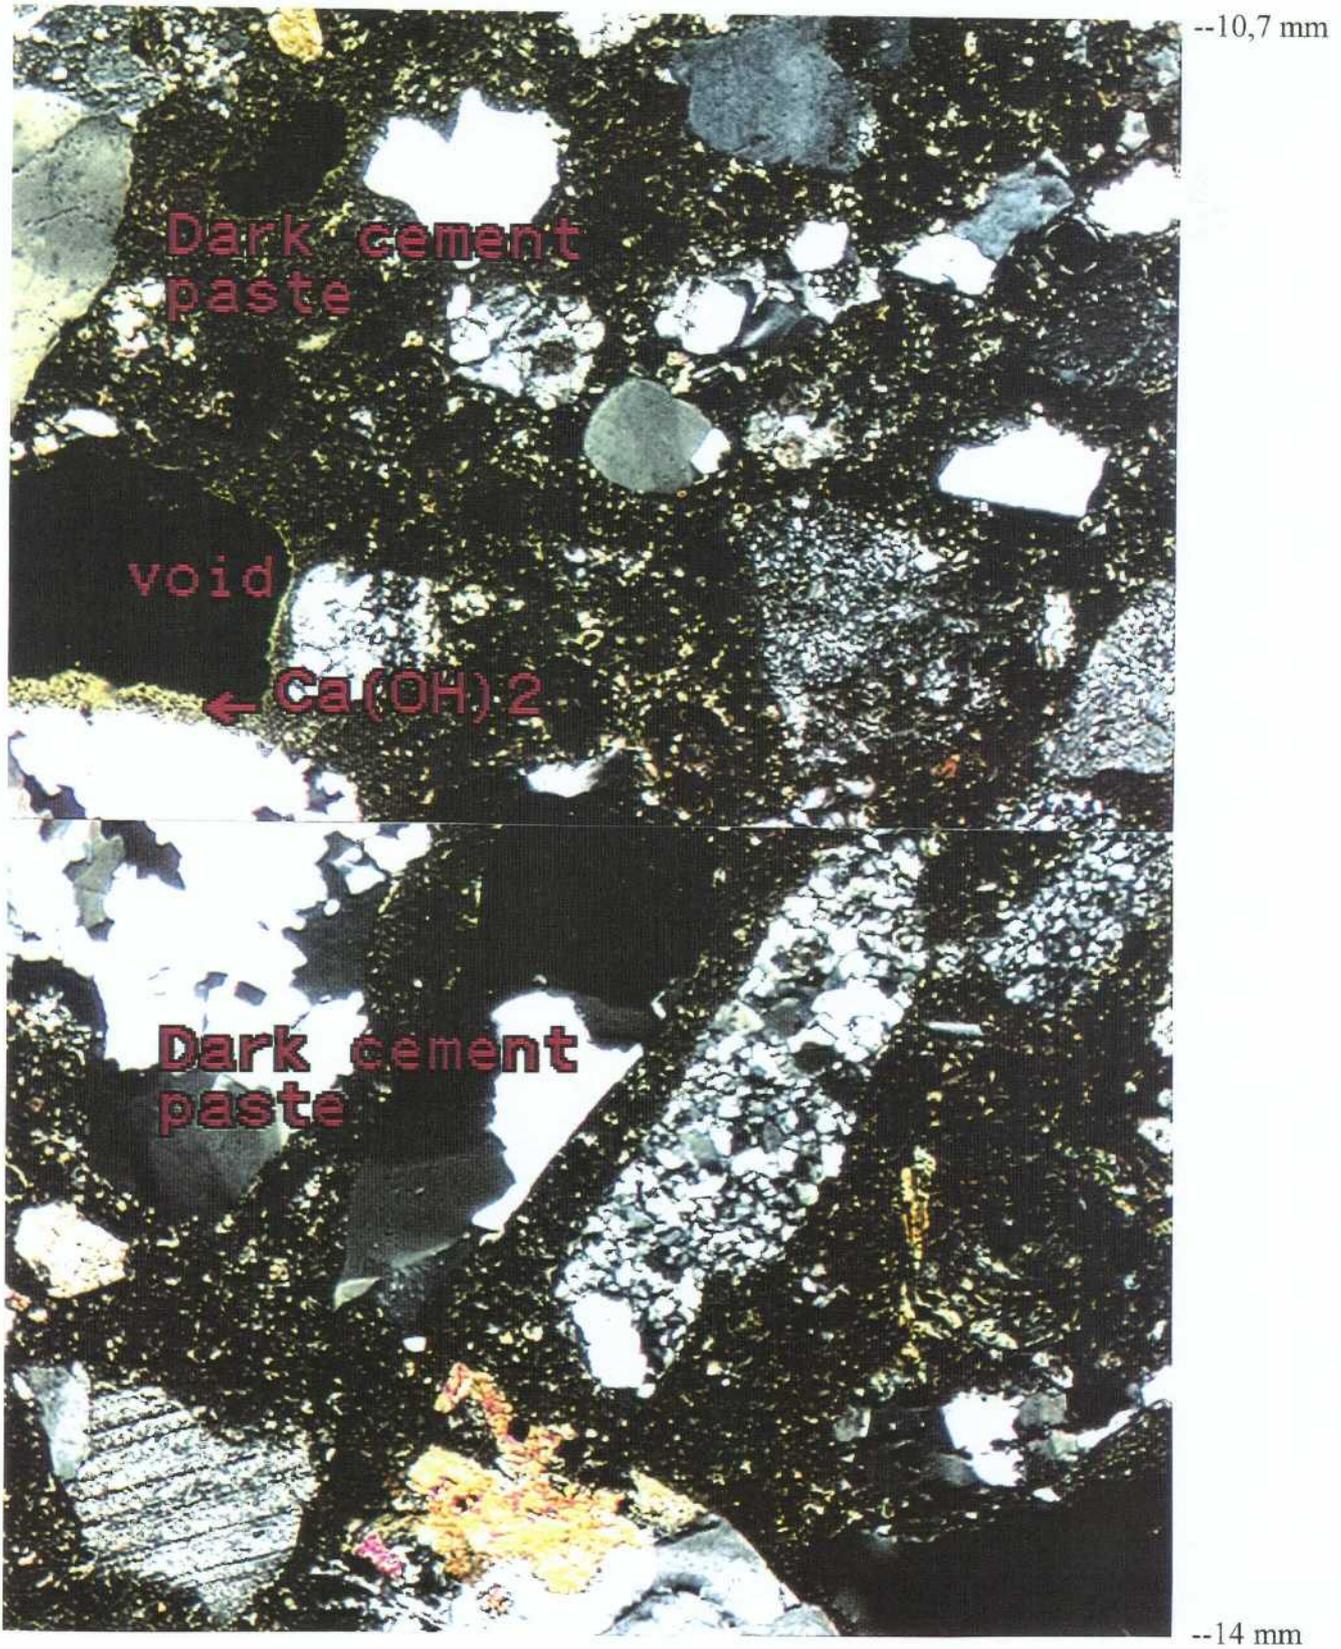
Level 10,7-14 mm

Fig 6. Zone with dark cement paste.

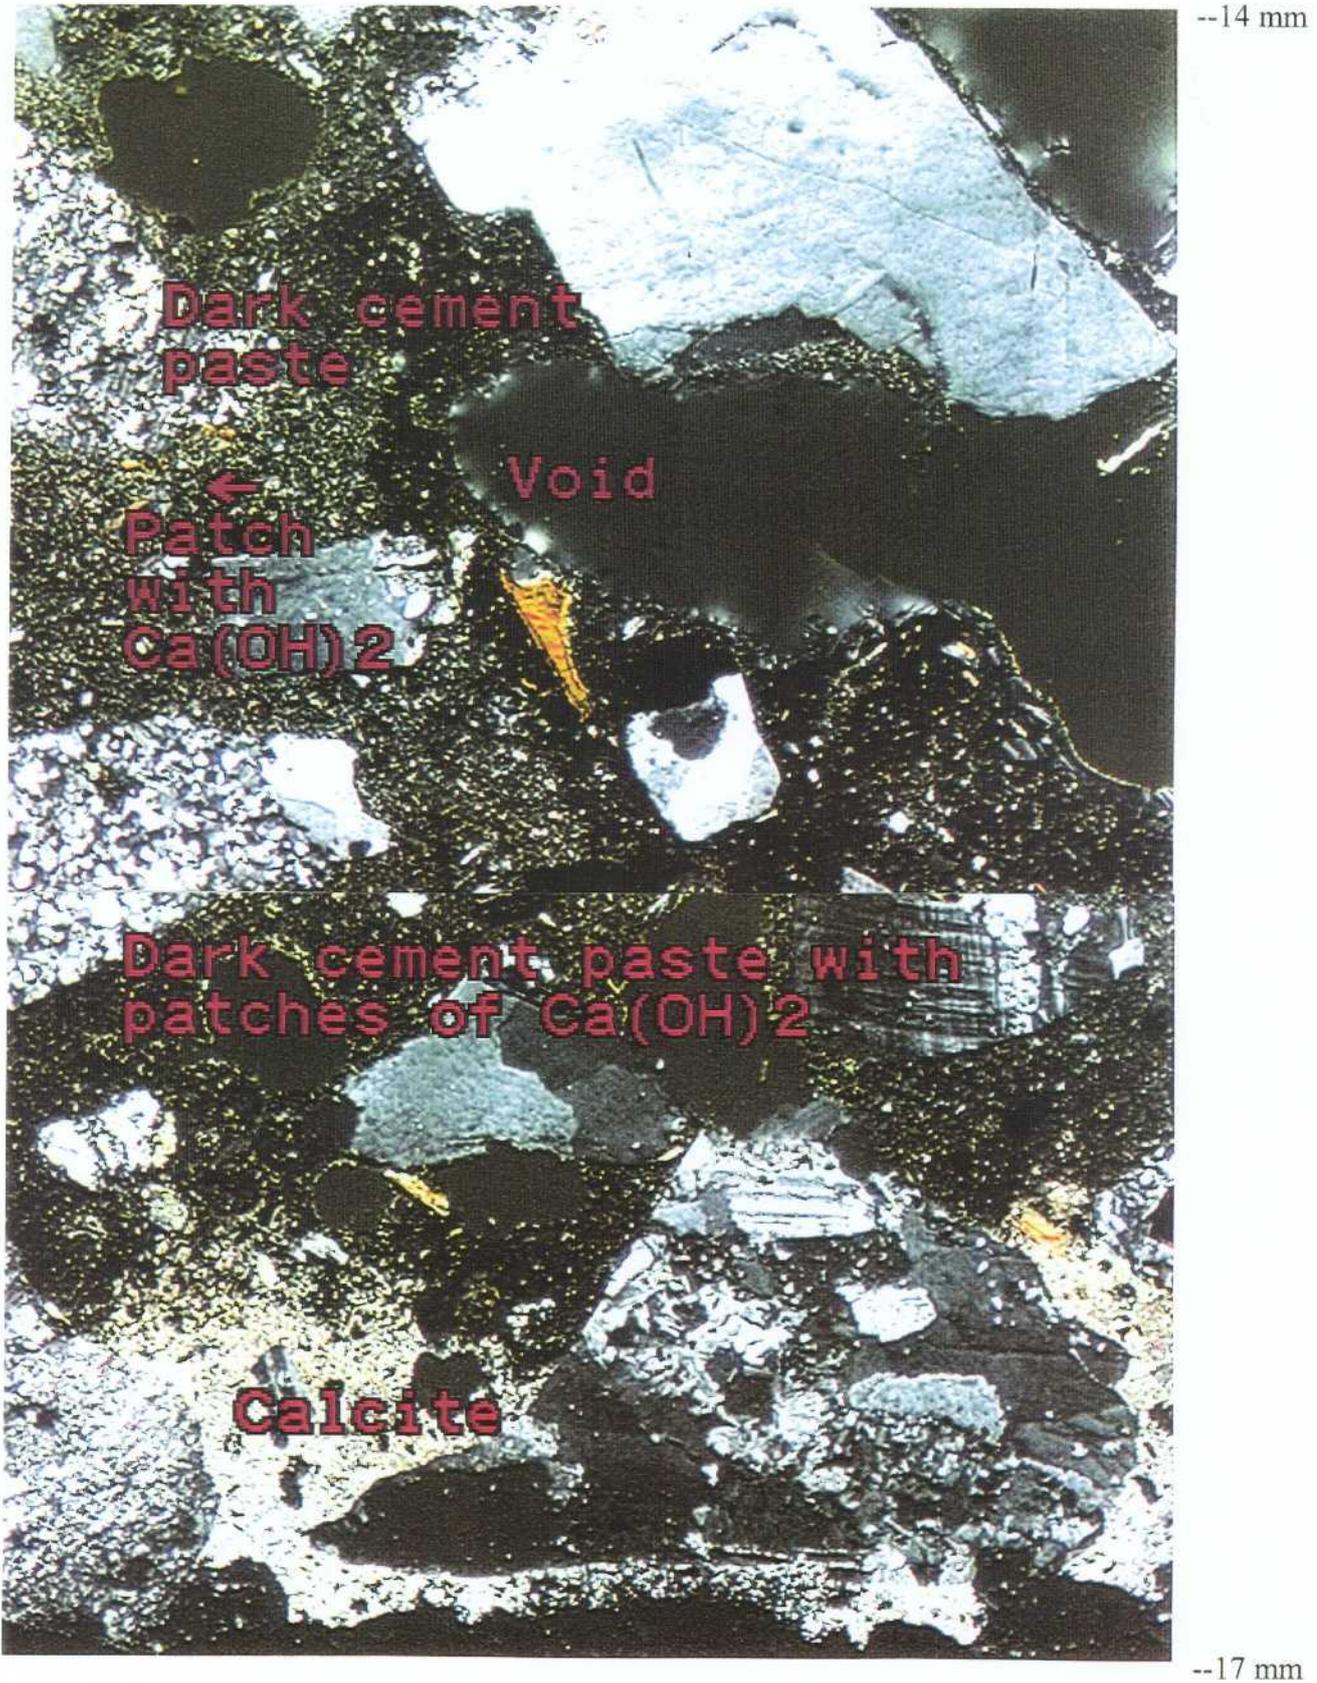
Level 14-17 mm

Fig 7. Zone with dark cement paste. Minor patches with portlandite crystallisation.

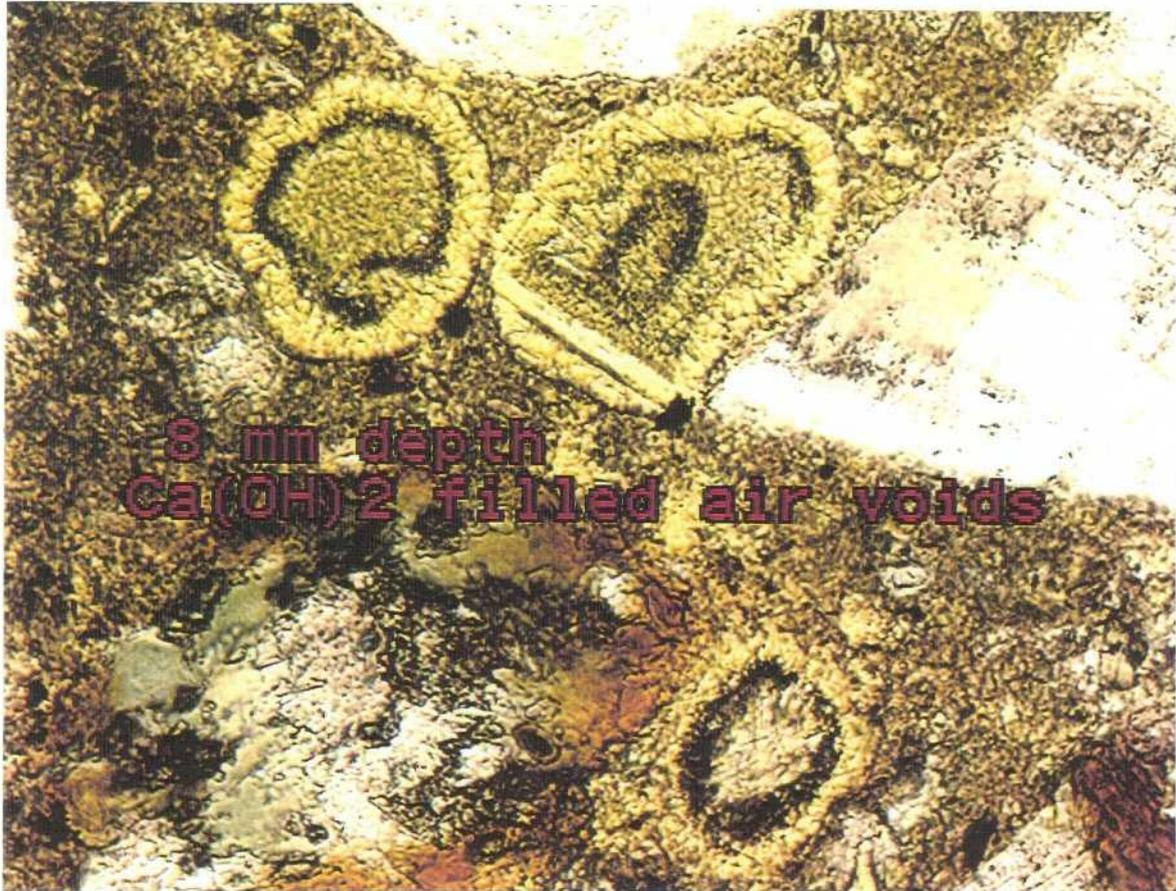
Zone with ring structures between zones with portlandite crystallisation and coarse porosity at about 8 mm depth.

Fig 8. In and just above the zone which is dominated by coarse porosity, numerous portlandite and ettringite-filled air-voids exist. These indicate strong remobilisation of calcium and sulfates. Note the "ring structures" which indicate different episodes of precipitation. Dark rings represent ettringite/monosulfate crystals and light-yellowish rings consist of portlandite.

At about 8-9 mm, marking the end of the leaching front, numerous "ring-structures" exist in former air-voids. The rings consist of alternating portlandite and ettringite crystallisation, which marks changes in fluid composition and episodes of precipitation. Precipitation started along the walls of the air-voids and the initial precipitates always consist of portlandite. Portlandite crystallisation was followed by a thin layer of ettringite crystallisation. After these two fairly pure and differentiated zones an inner core with mixed portlandite and ettringite crystallisation exists which sometimes was followed by one more ettringite layer. At the most, up to 5-6 layers were observed. Evidence of "ring-structures" at 8 mm depth is shown in Appendix 2, page 8.
