Technical Report

TR-98-11

**Leaching of 90-year old
concrete mortar in contact
with stagnant water**

Swedish Cement and Concrete Research Institute

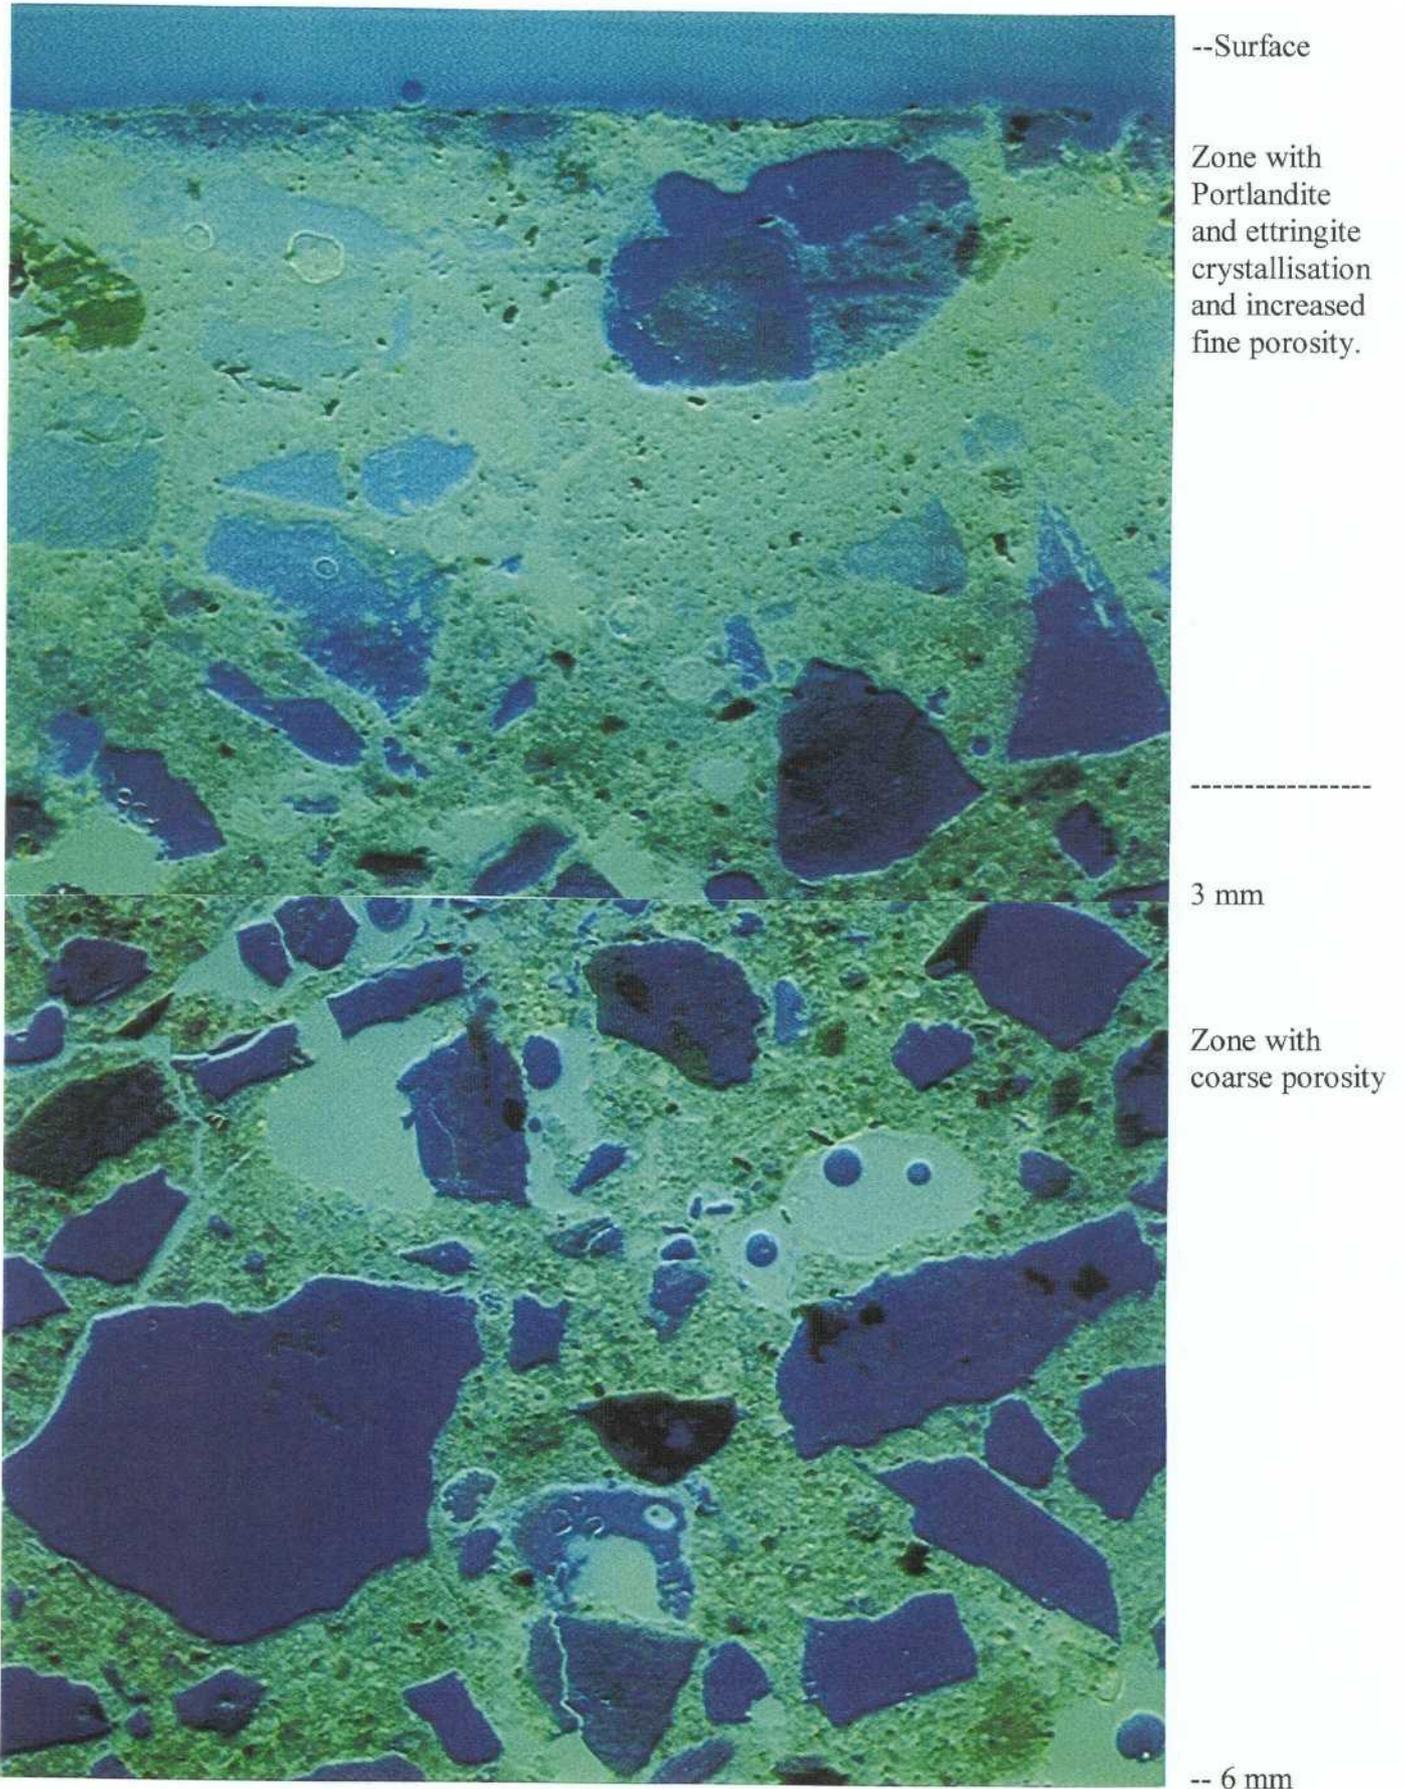
Porosity: Level 0-6 mm.
Thin section

Fig 1. Porosity shown by fluorescent light under the microscope. Light areas indicate voids.

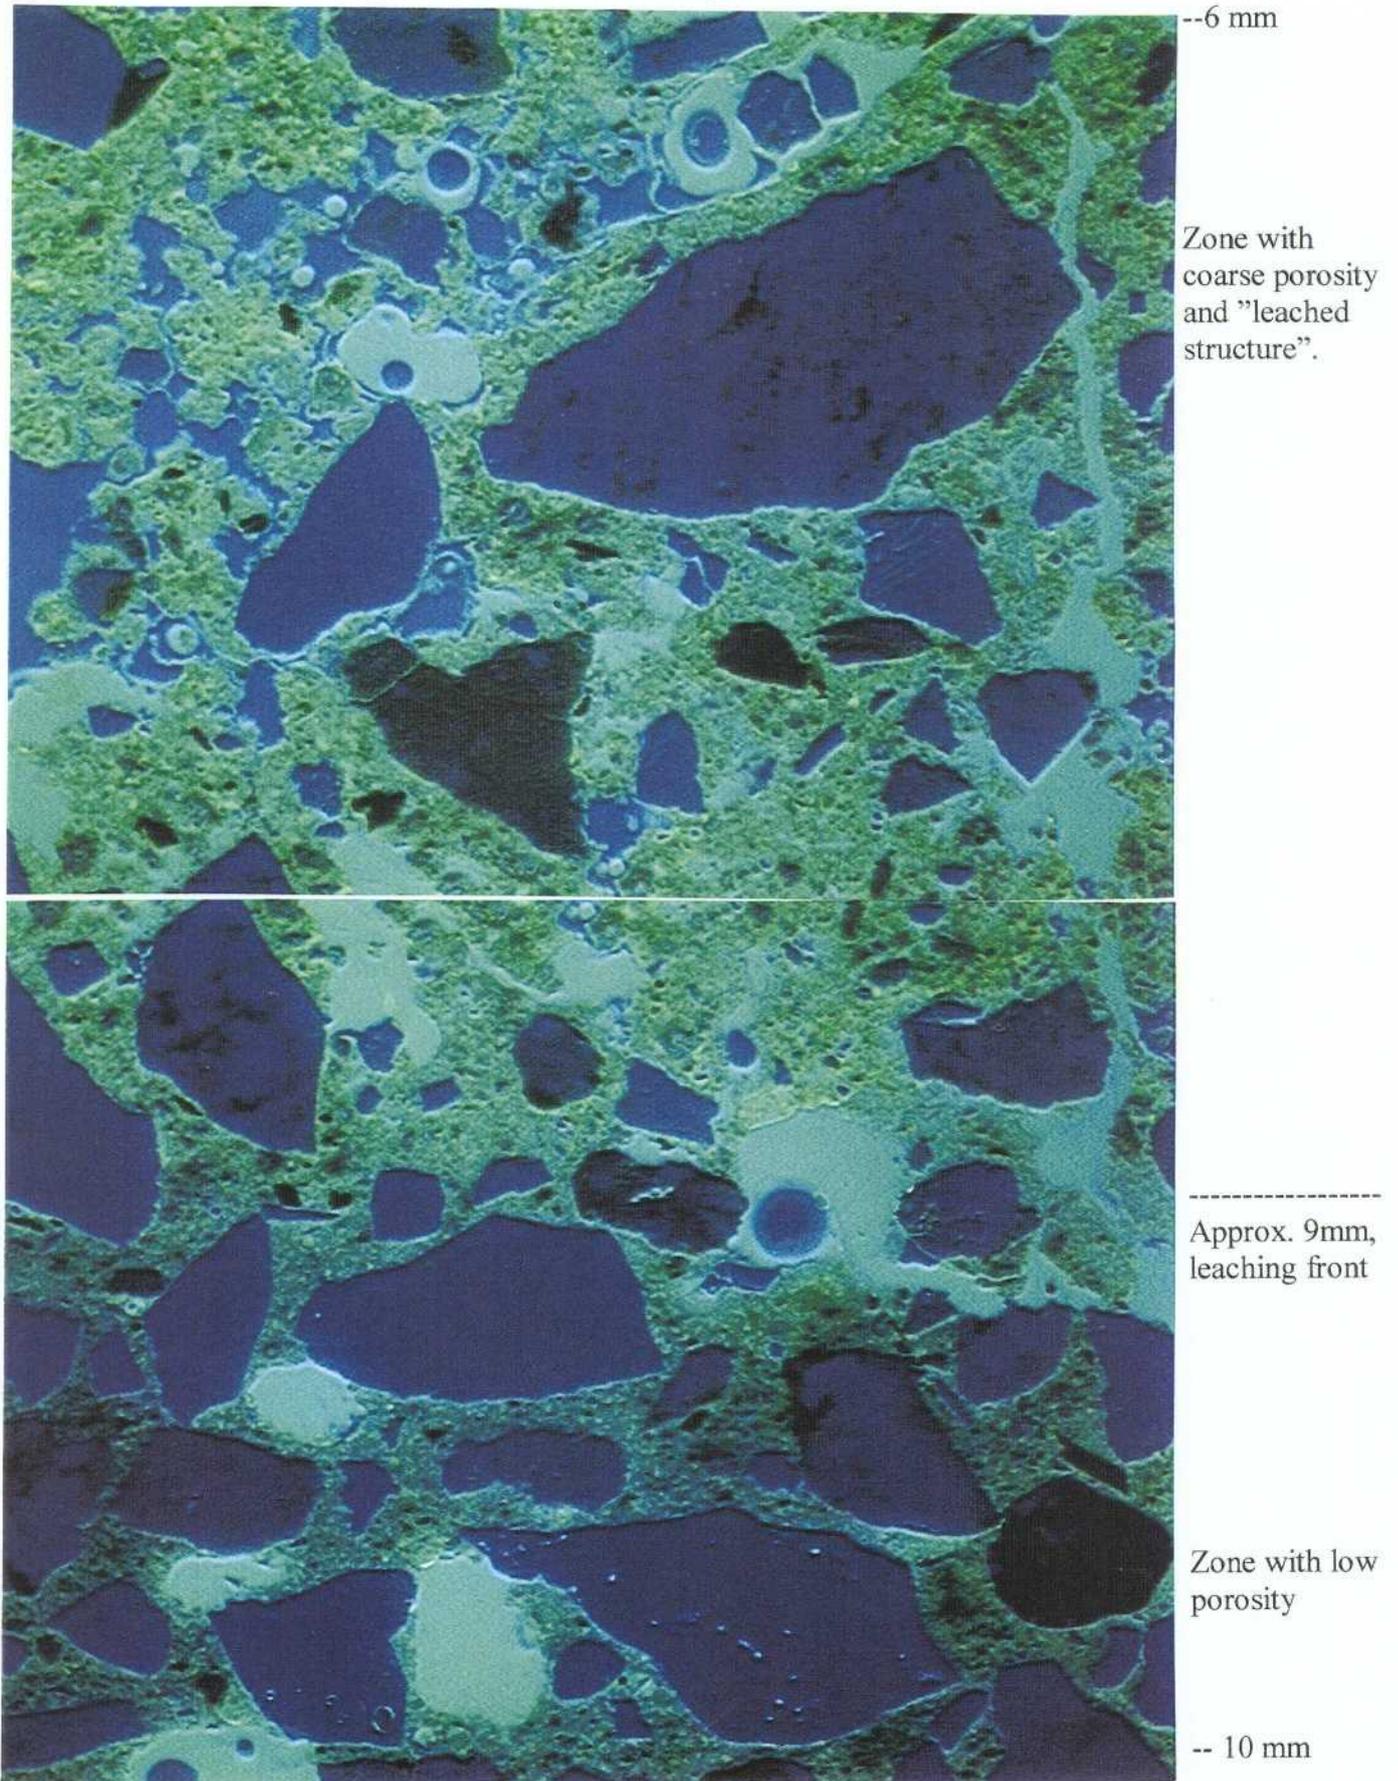
Porosity: Level 6-10 mm.

Fig 2. Irregular and "channel-like" voids indicate strong leaching. Note the sharp boundary between zones with coarse porosity and low porosity at about 9 mm.

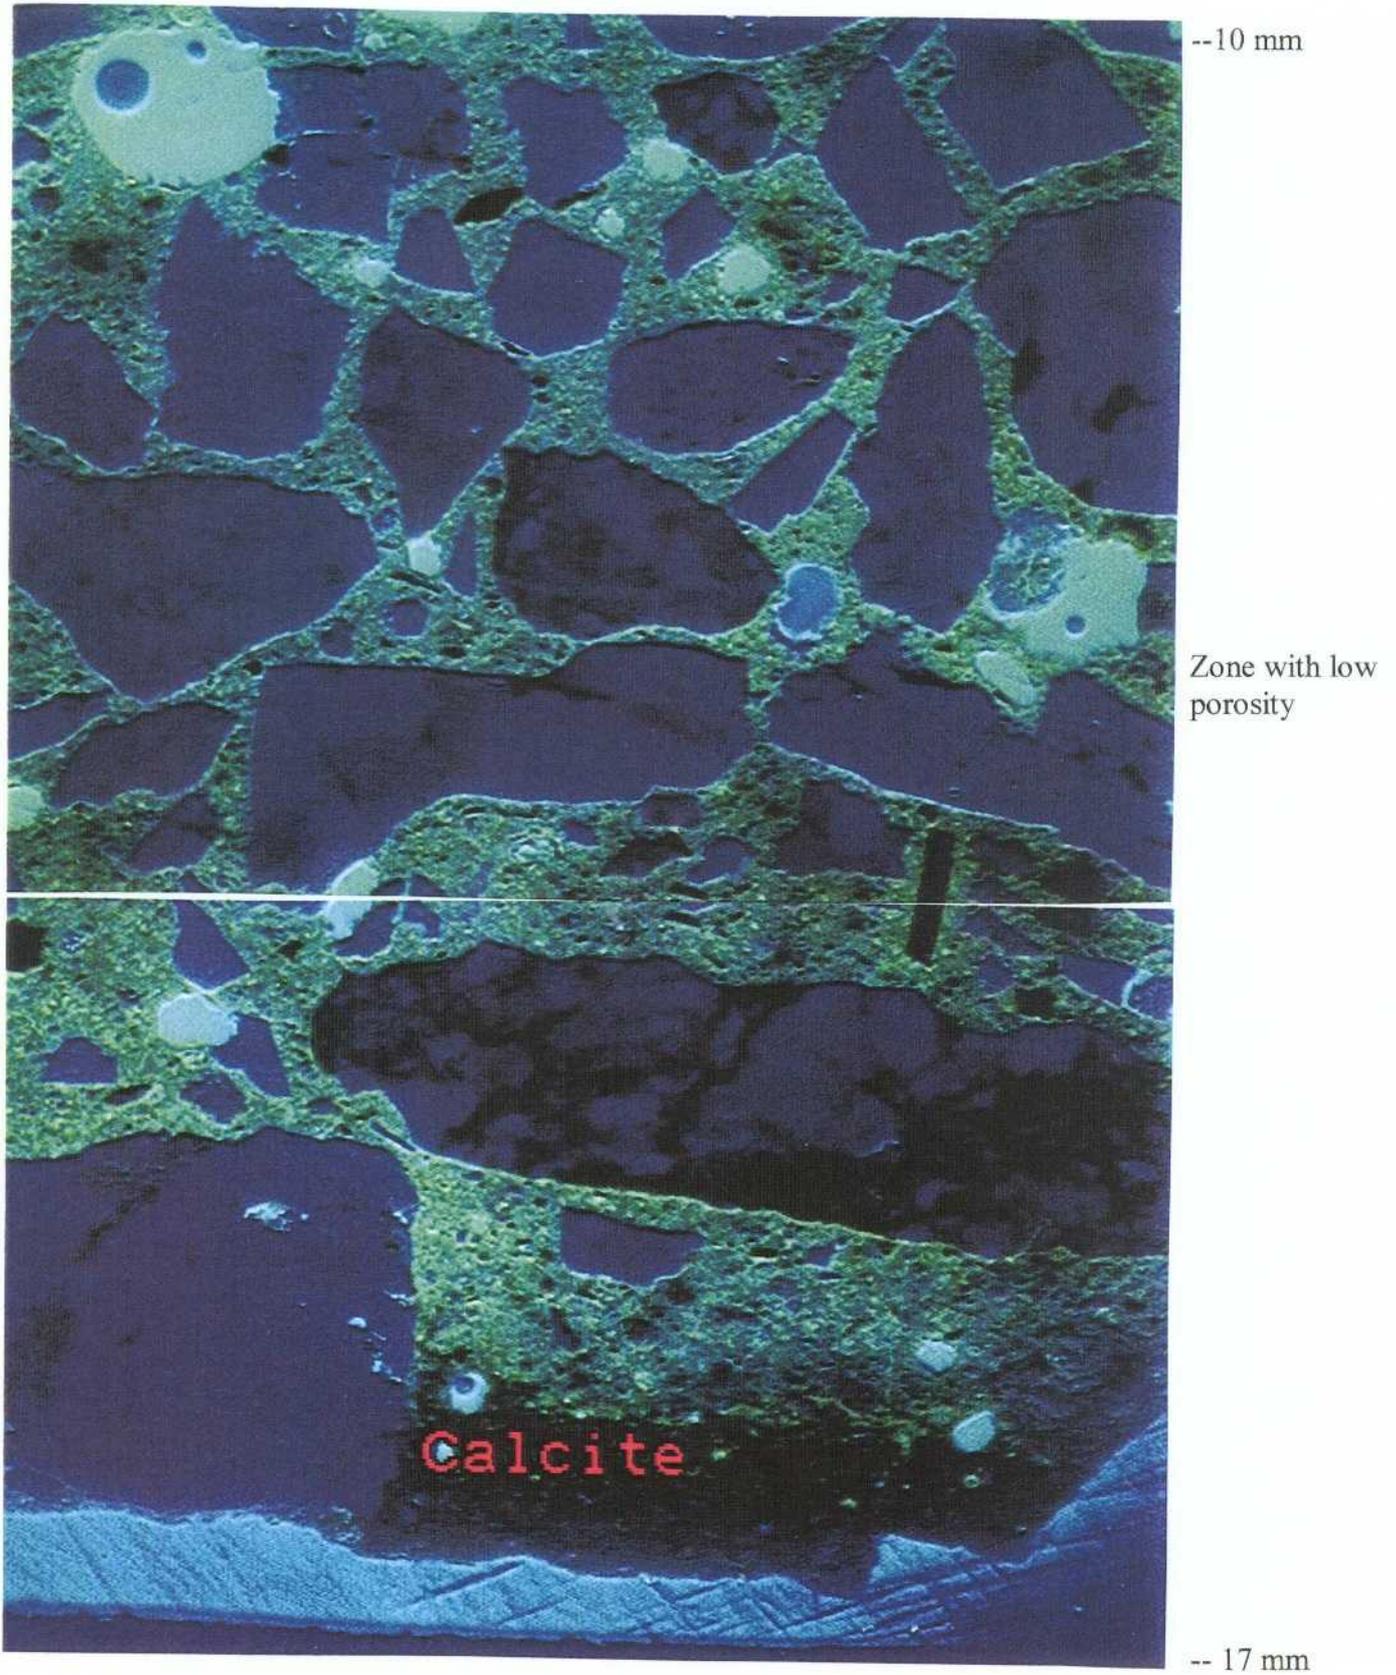
Porosity: Level 10-17 mm.

Fig 3. Zone with low porosity indicated by dark cement paste. Carbonation and calcite formation close to the steel confinement

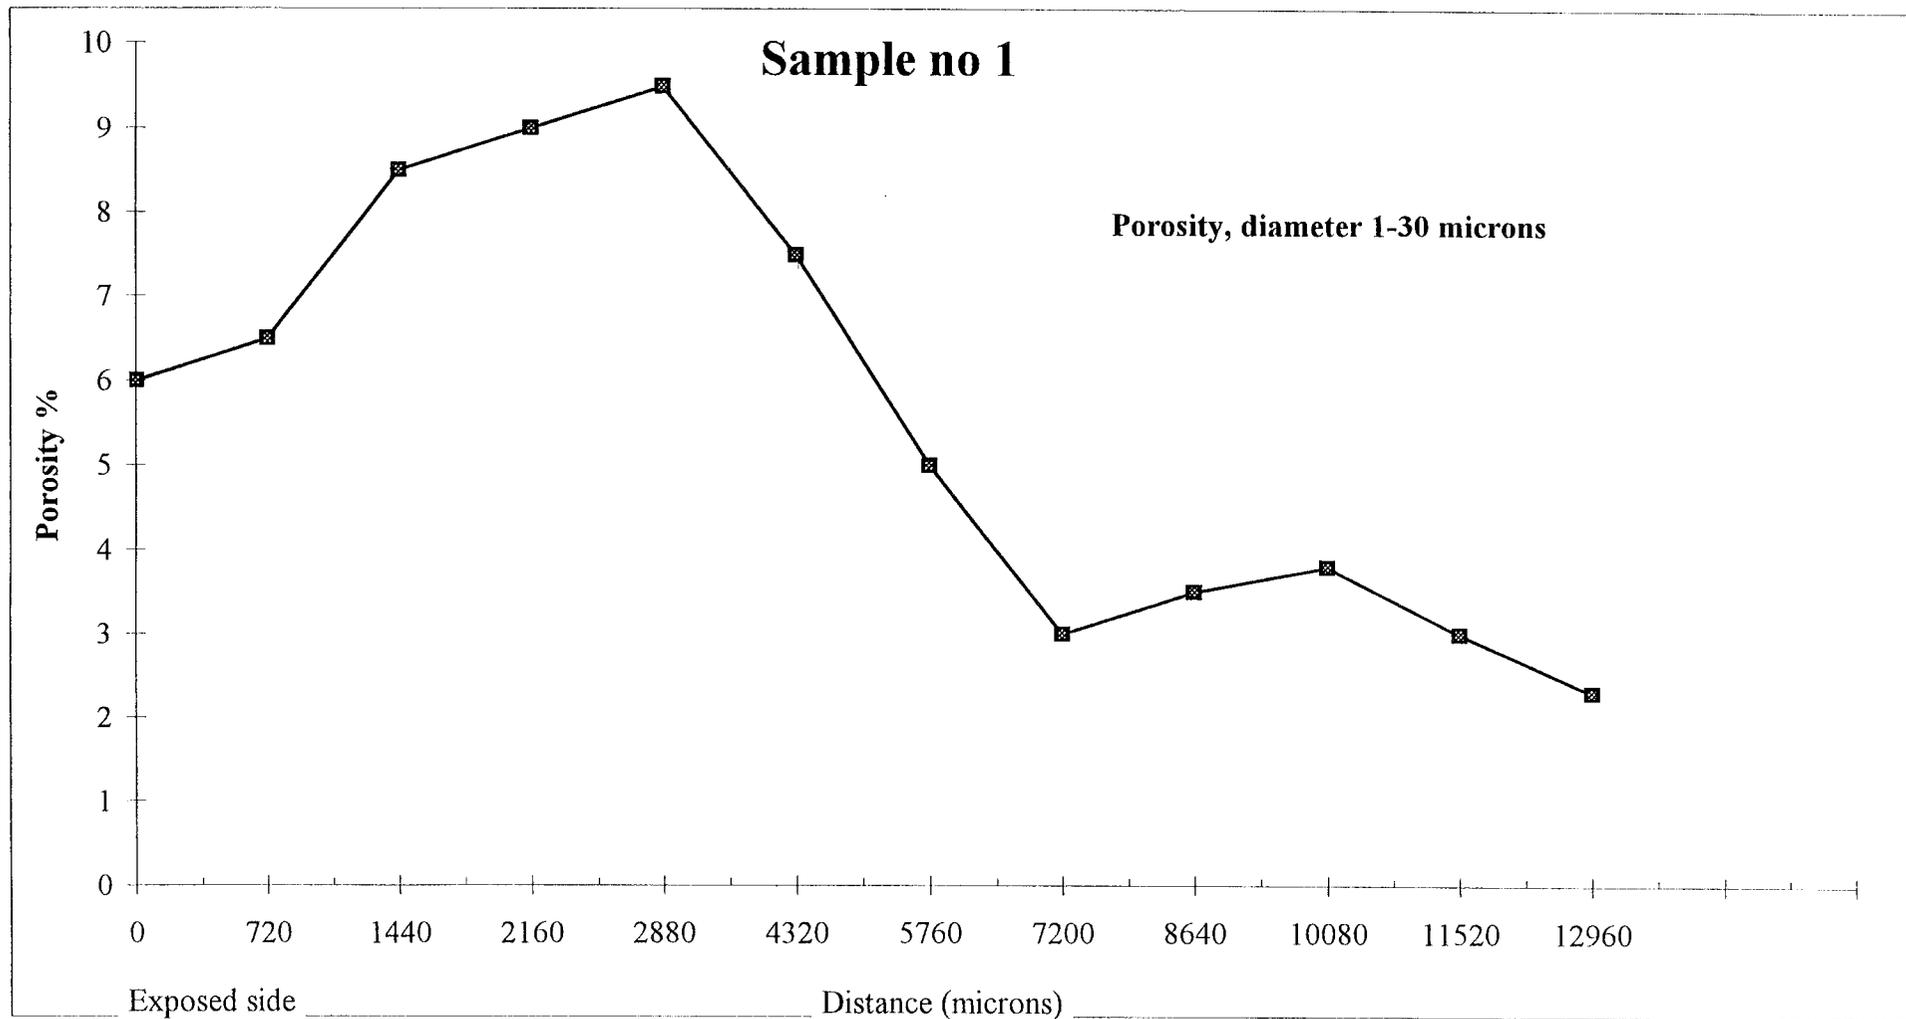
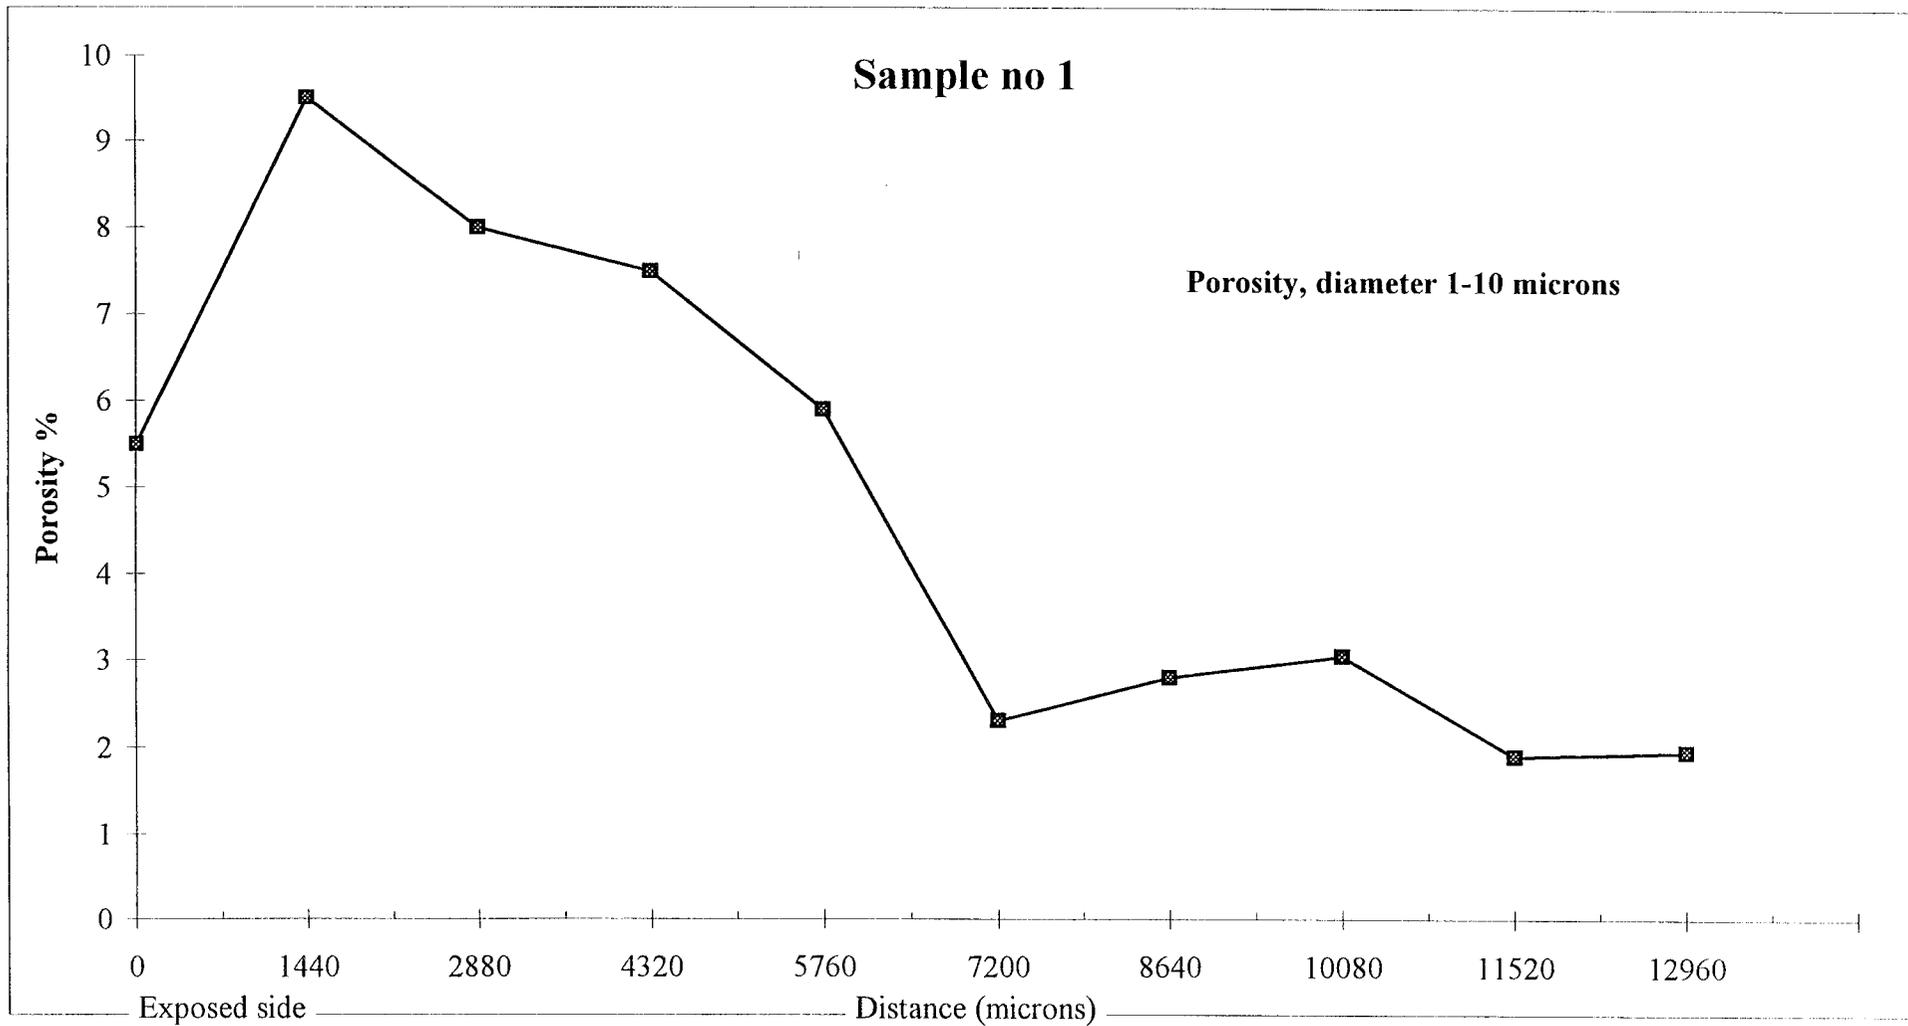
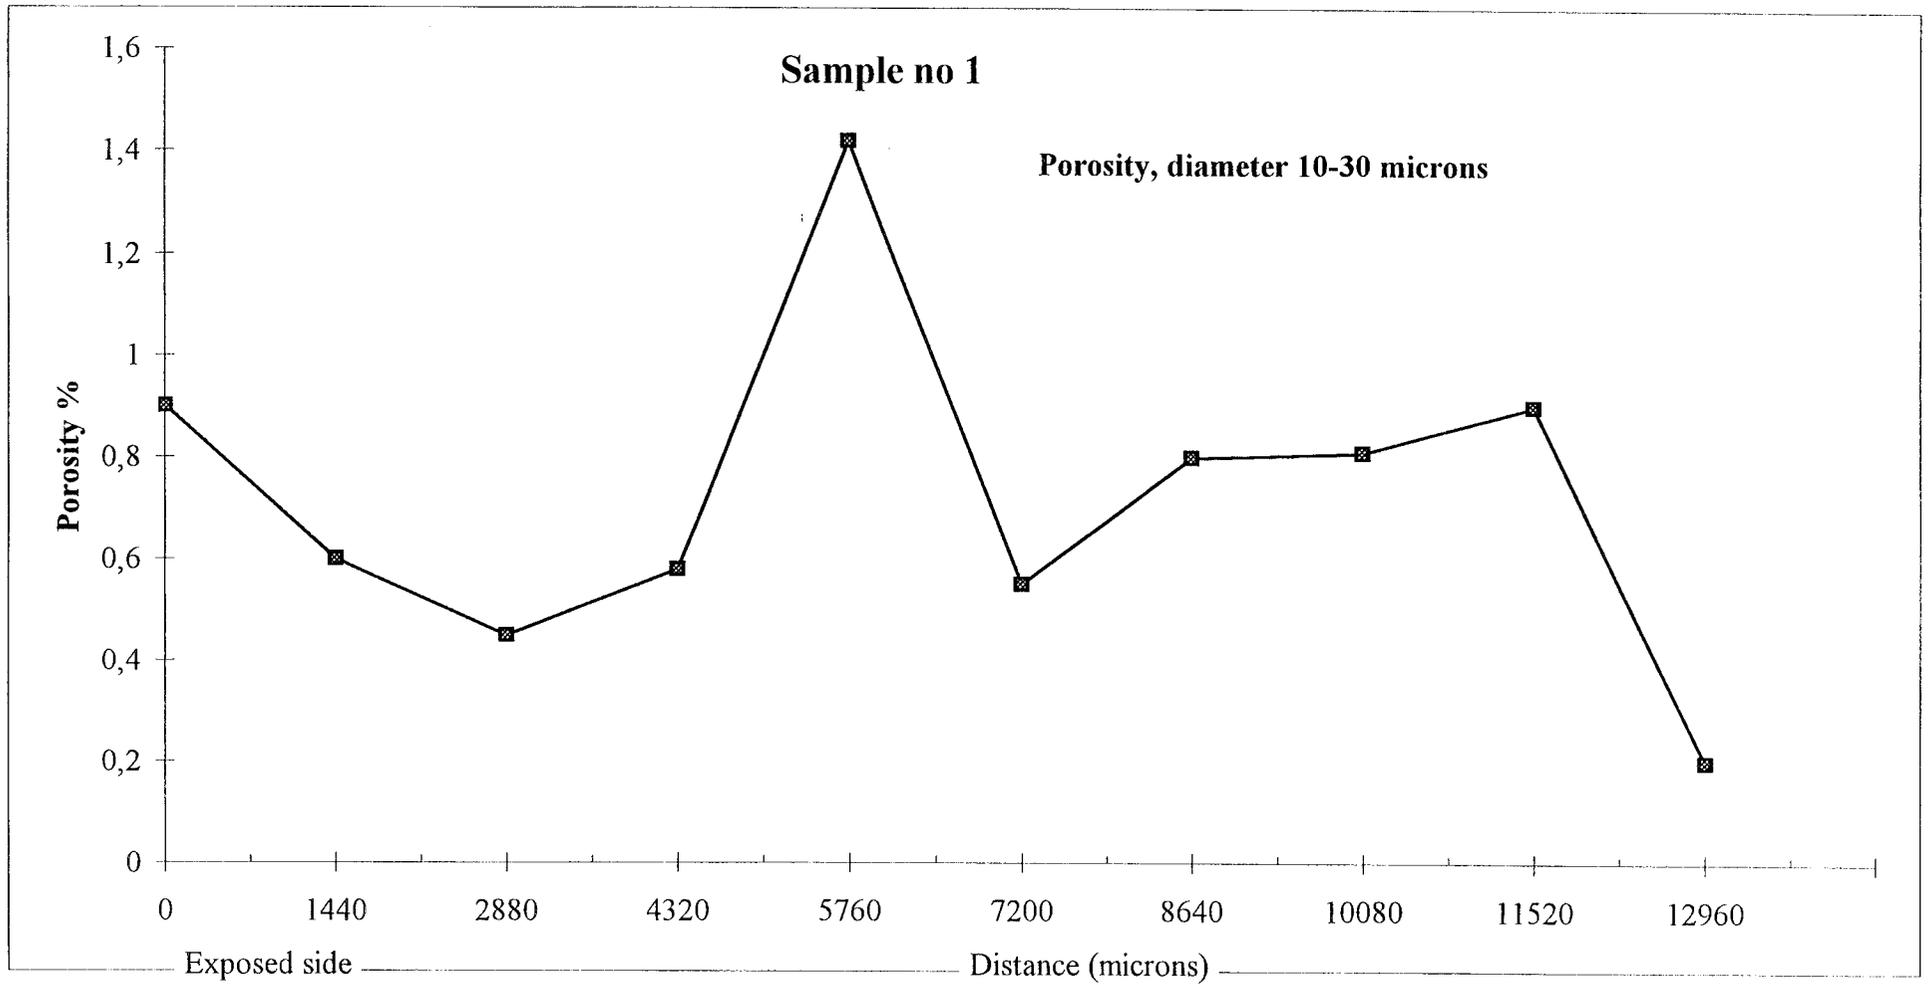
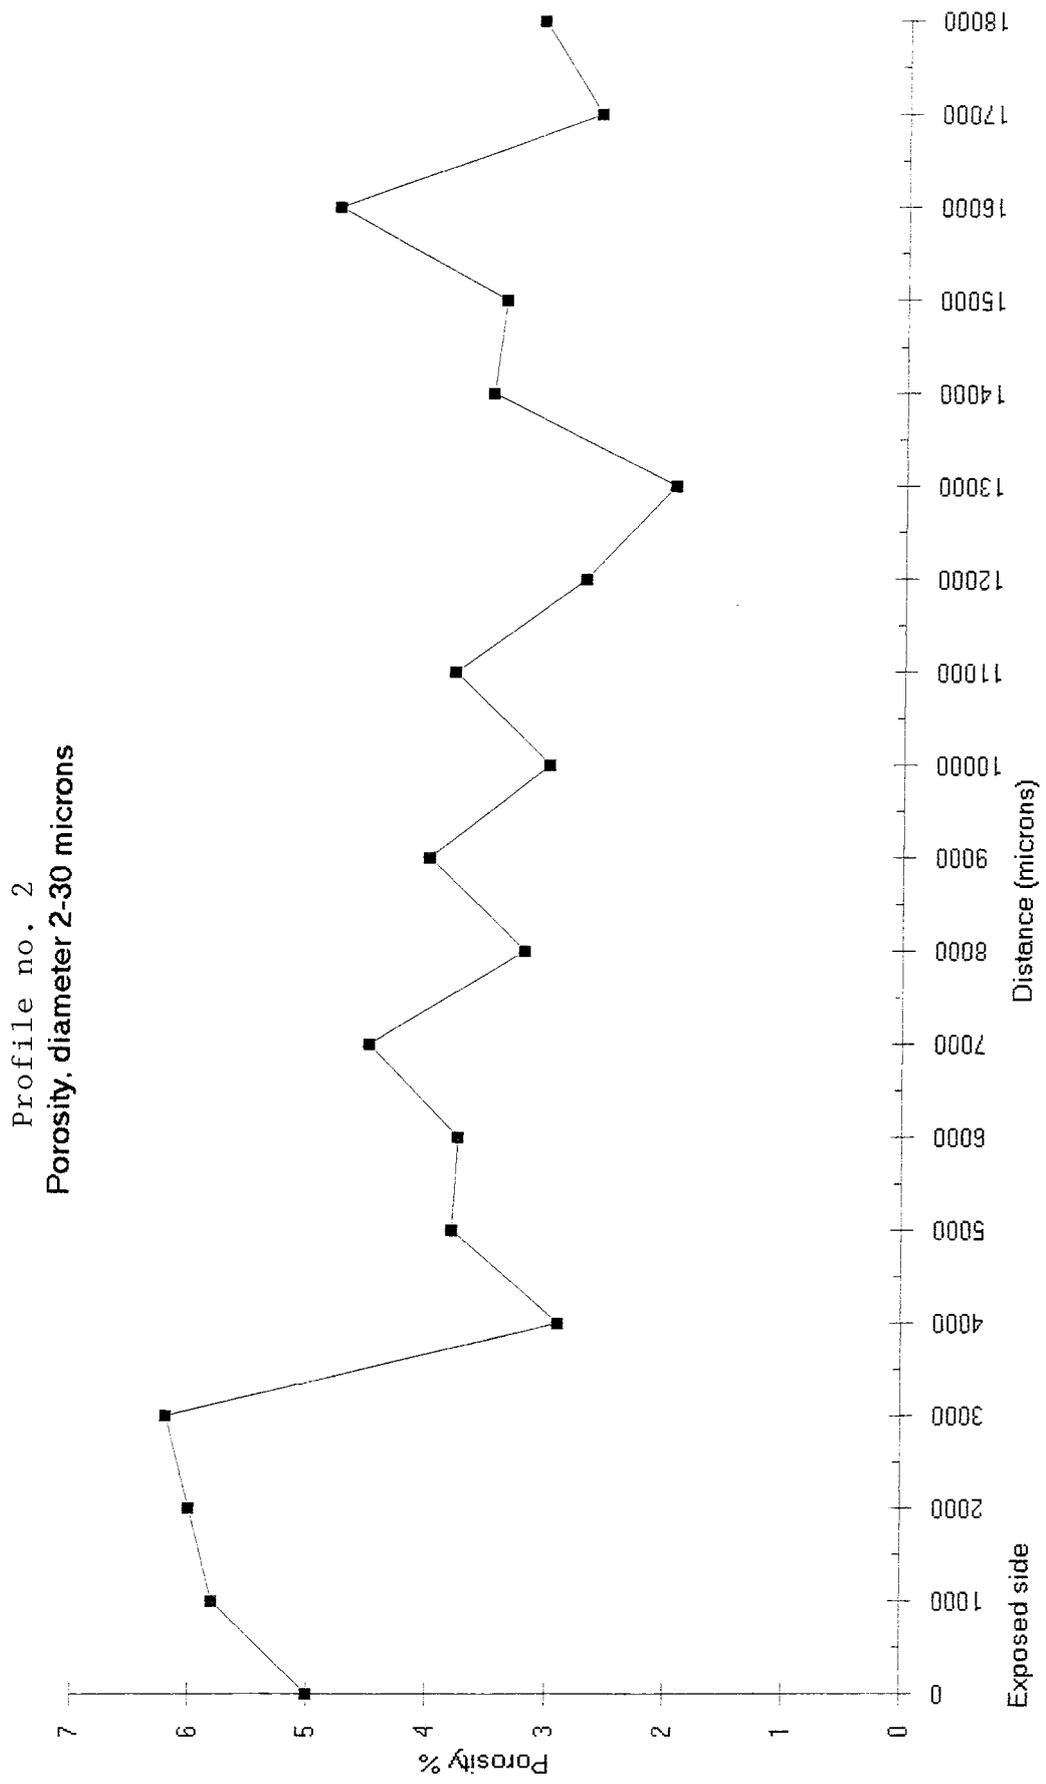
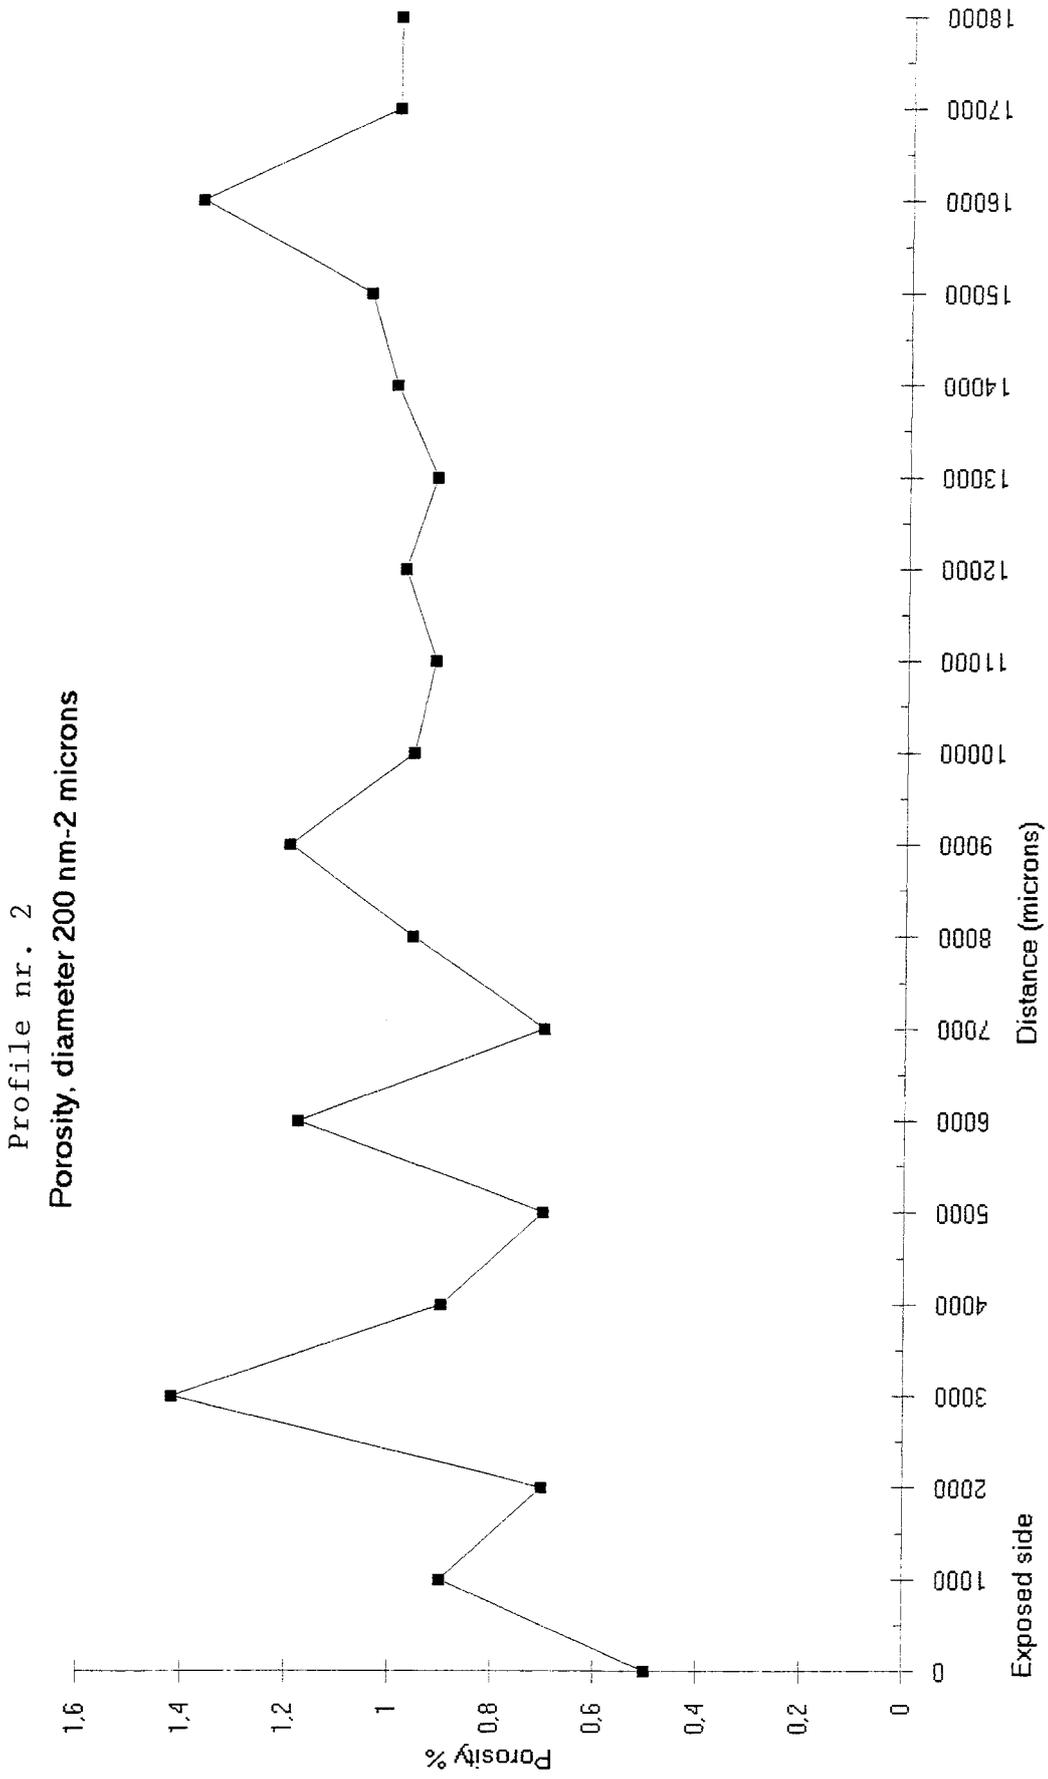
SEM, Image Analysis

Results from porosity measurements by SEM-coupled image analysis are shown in Appendix 3, page 4-8. Three different porosity measurements were made in profile 1 and two in profile 2. The size of the analysed field and the magnification was changed between the measurements in order to detect the variation of different pore size ranges.

- Porosity measurements with a SEM-coupled image analyser showed an increased fine porosity behind the carbonated zone to about 7 mm depth in profile 1 and about 4 mm in profile 2. This is in accordance with the marked calcium depletion/leaching front found by SEM-EDS analysis. The carbonated zone showed a lower porosity.
