Technical Report

TR-98-11

**Leaching of 90-year old
concrete mortar in contact
with stagnant water**

Swedish Cement and Concrete Research Institute

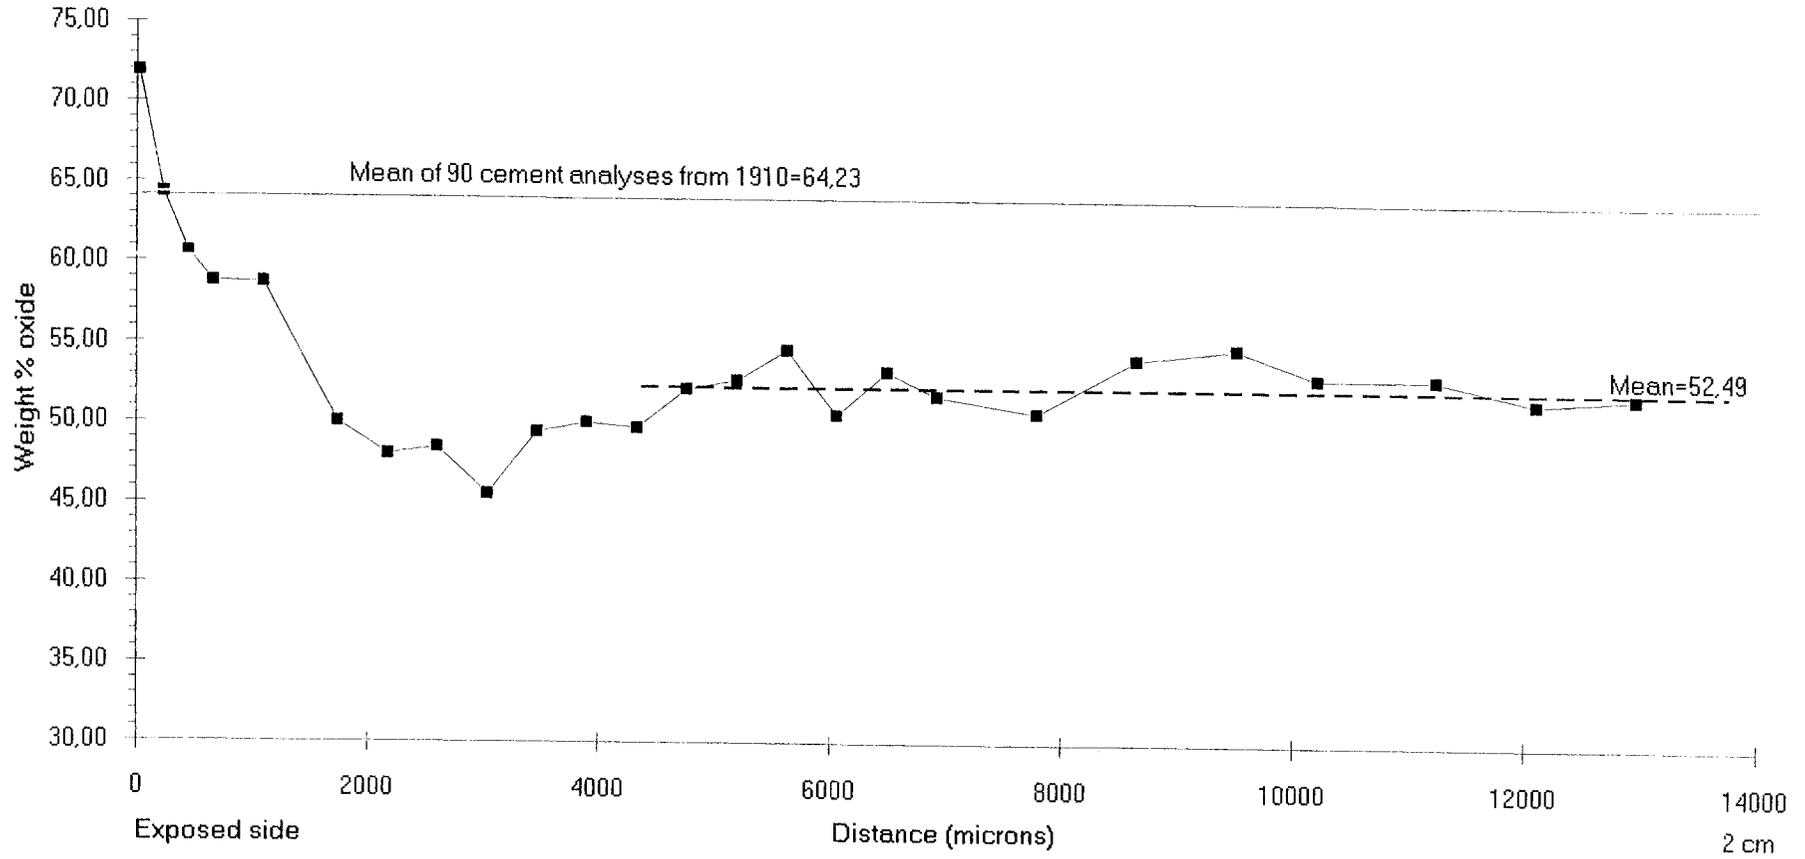
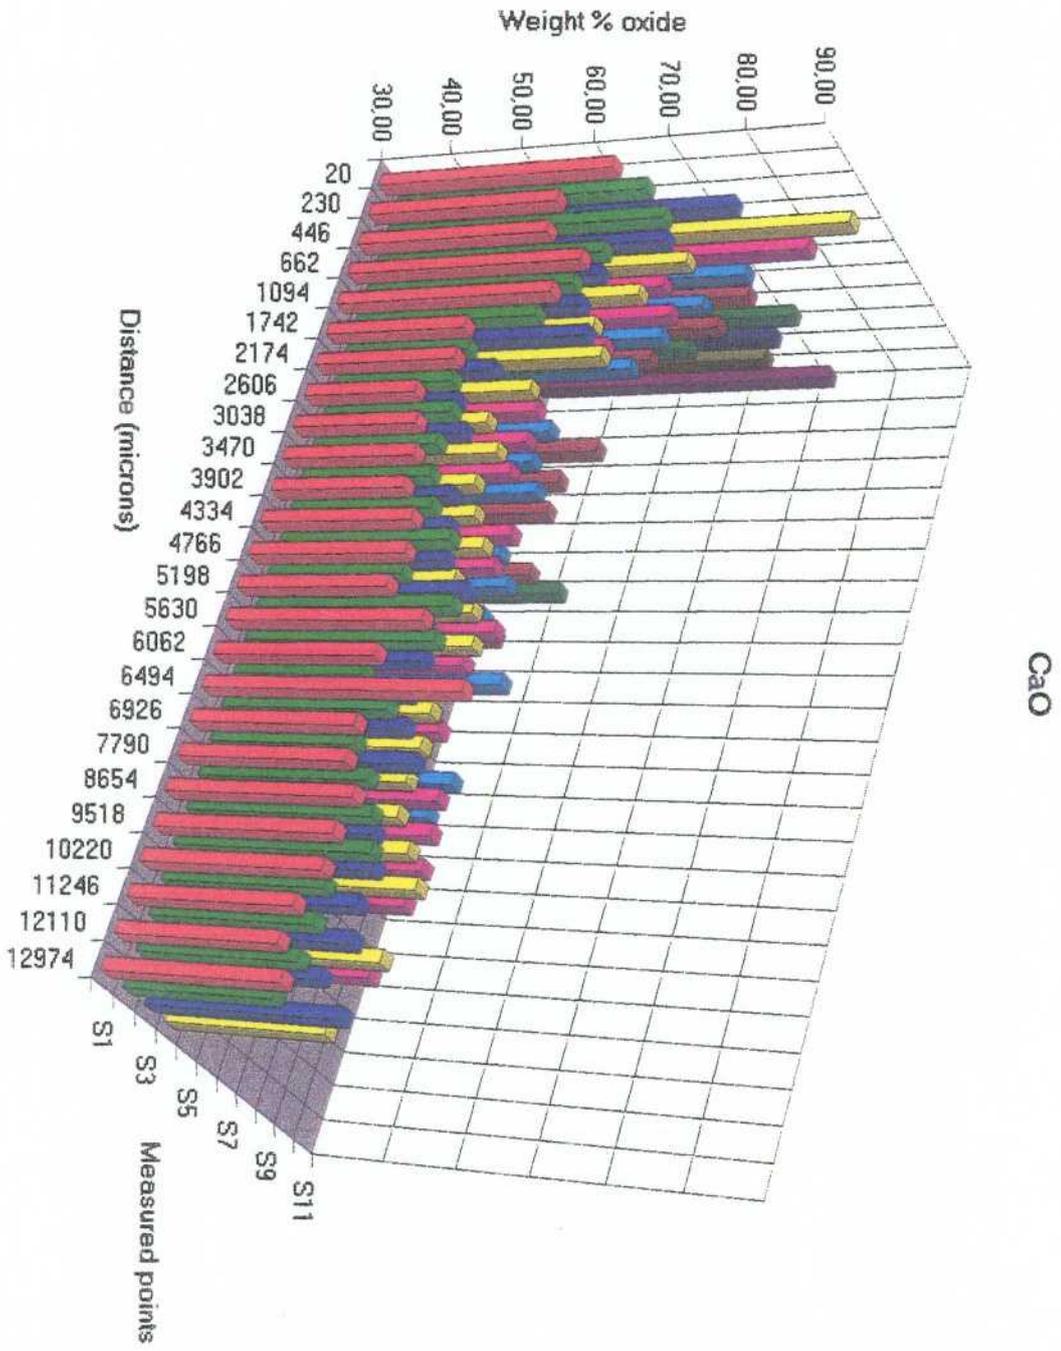
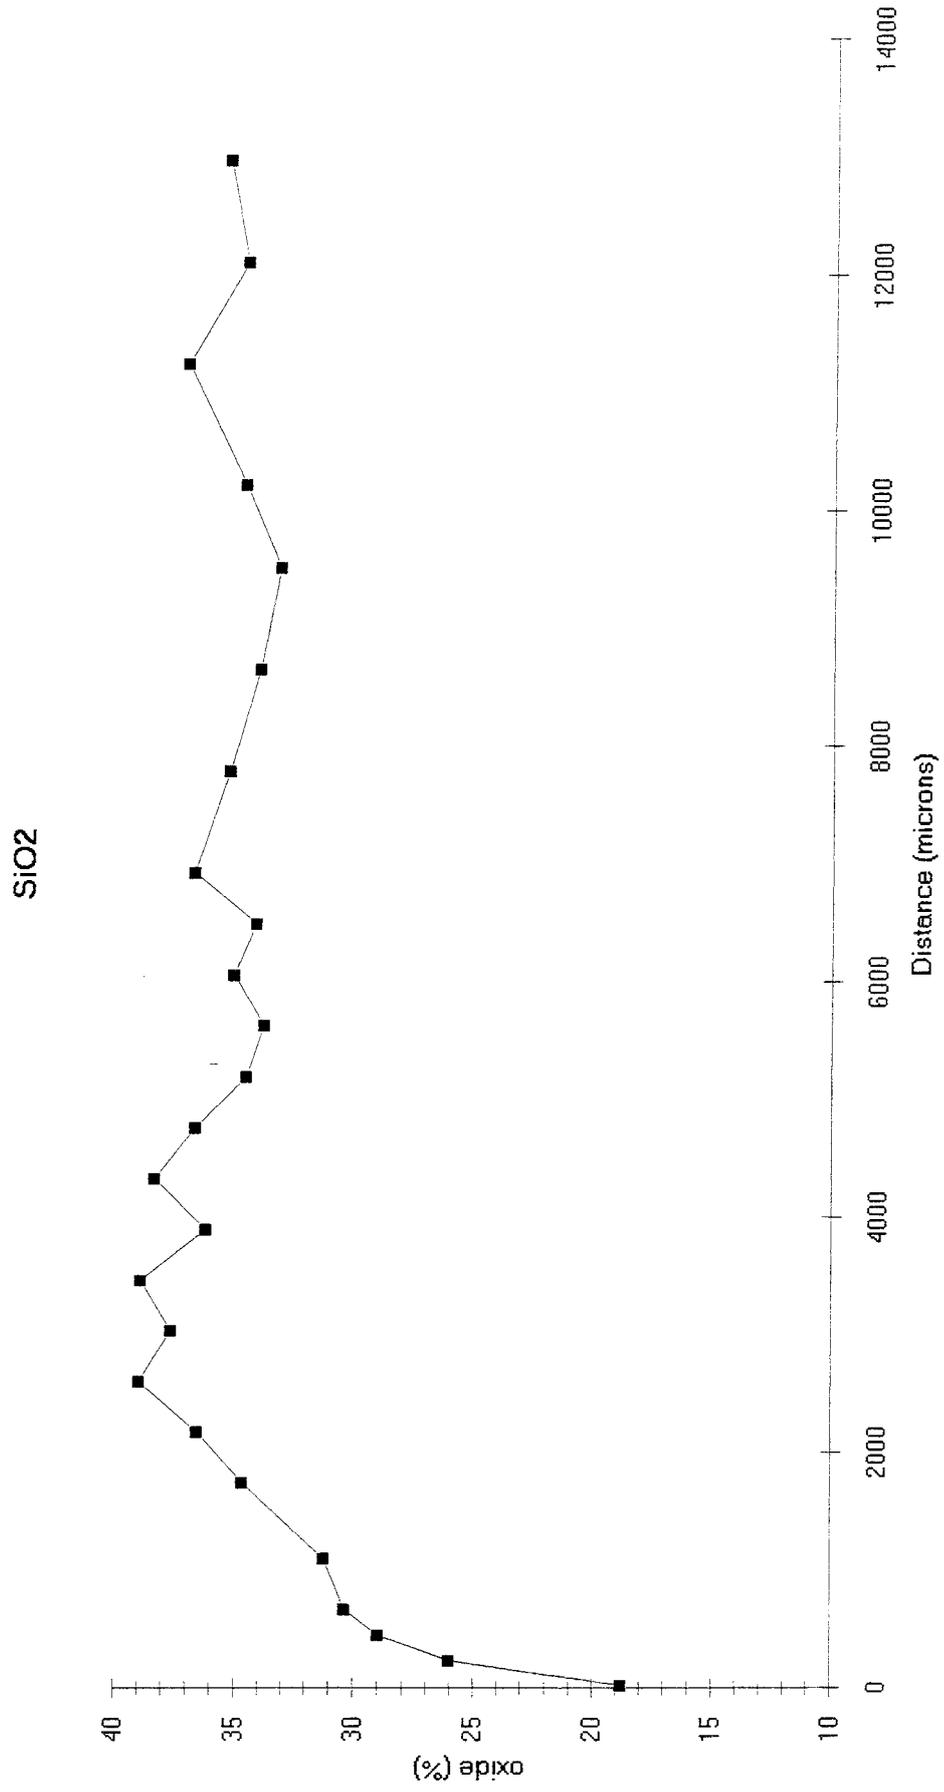
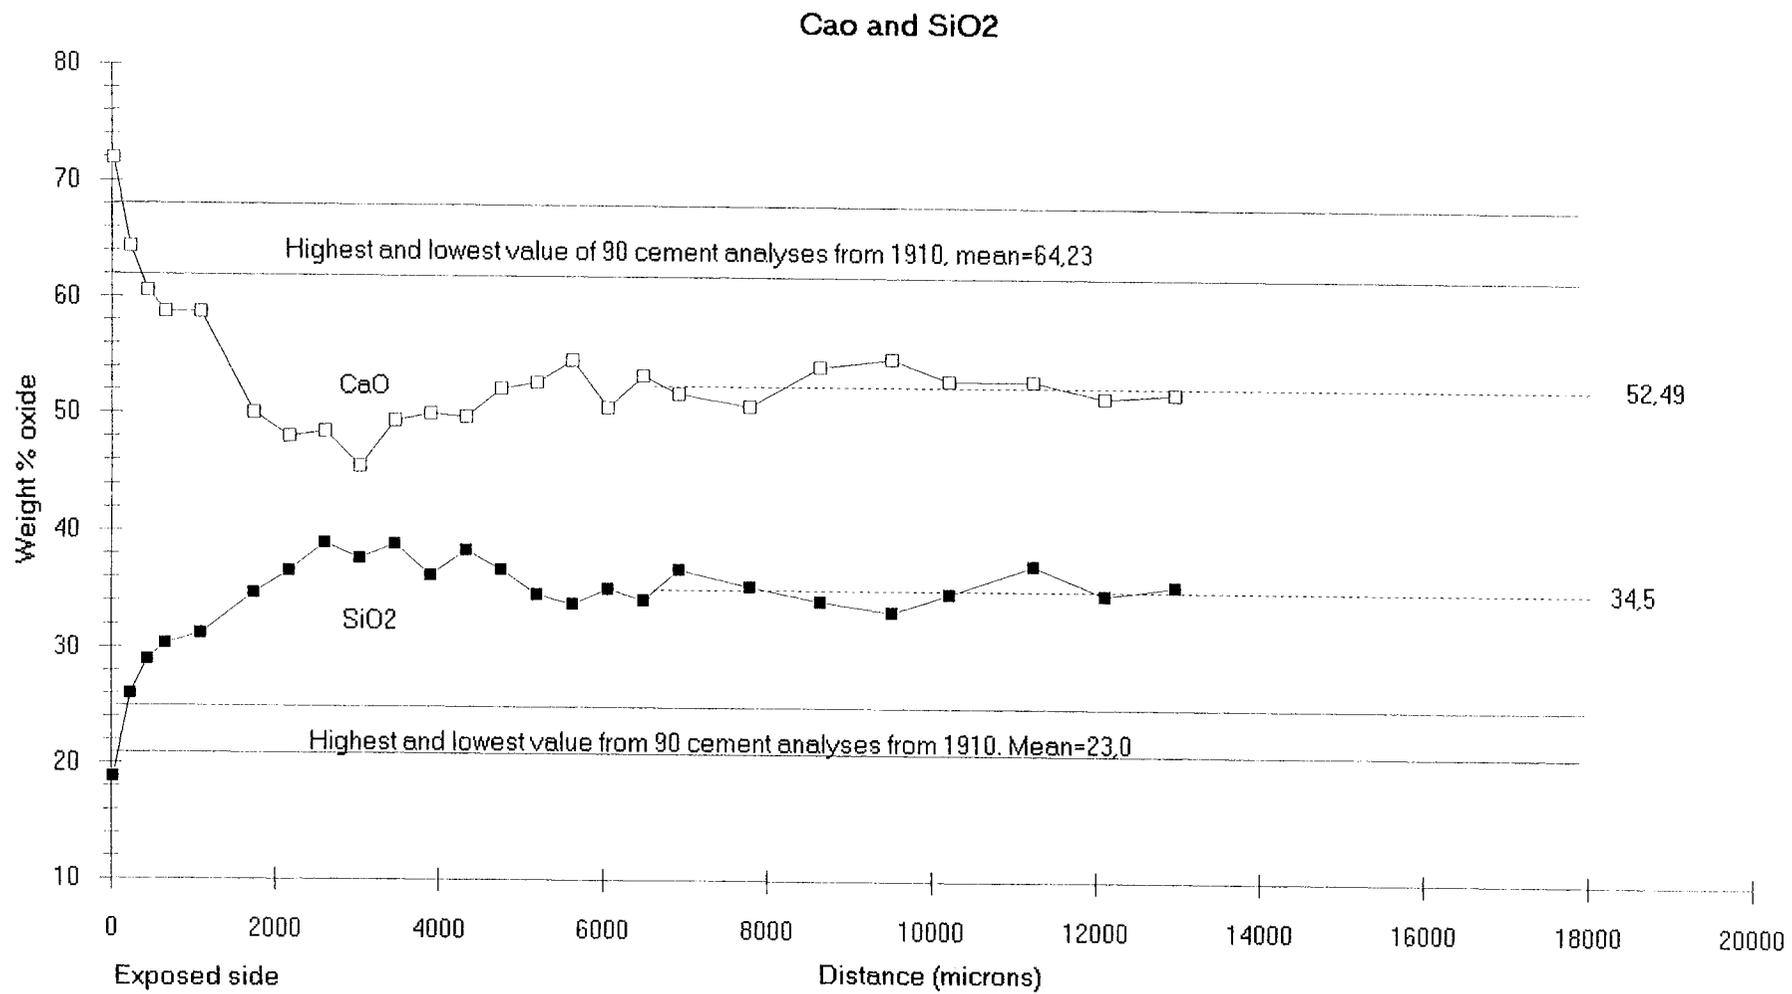
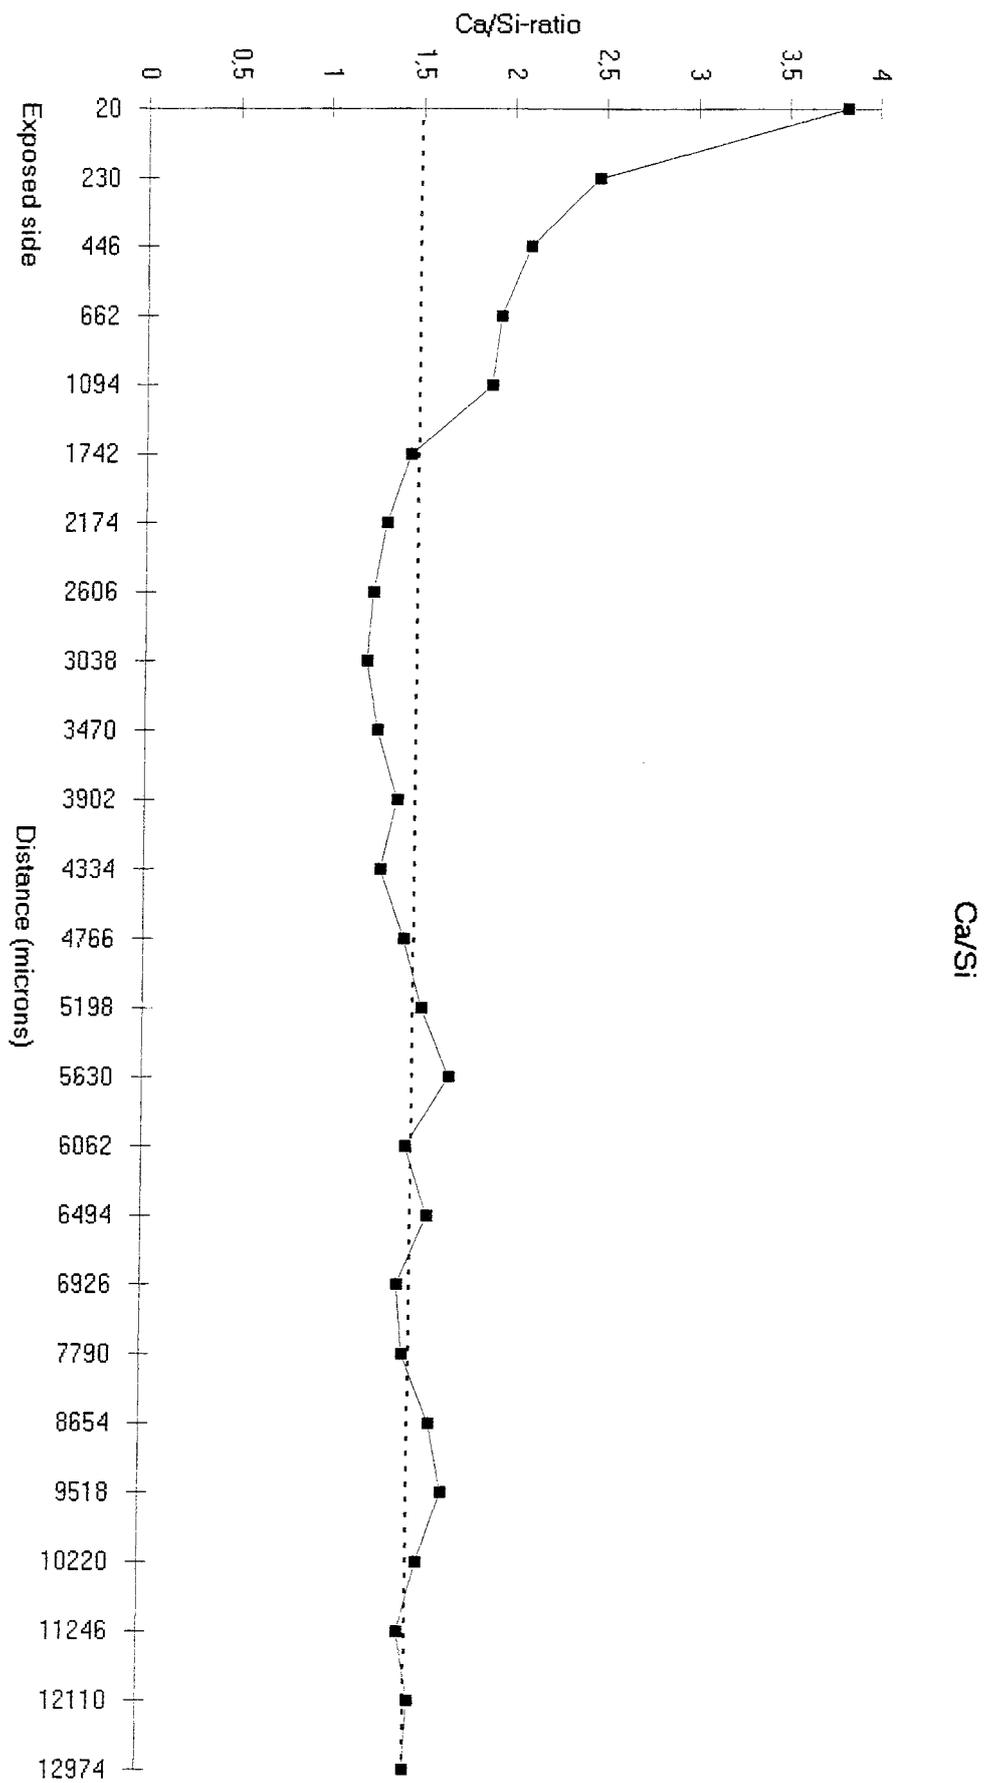
From the water-exposed surface and to about 0.5 mm depth, an excess of calcium compared to normal calcium values in cement at this time was recorded. This zone corresponds to the carbonated zone consisting mostly of calcite. After about 0.5 mm depth, the calcium content gradually decreases and reaches a minimum at about 3-4 mm depth. From this depth an increase takes place and at about 5- 7 mm depth the calcium content stabilises and reaches a constant level (see Appendix 4, page 2, 3, 5, 6, 16 and 18).

In profile 1, the calcium content behind 5 mm depth was about 10 wt. % CaO lower compared with the mean value of 90 cement analyses from 1910. In profile 2, the mean calcium content at these depths was approximately the same as in the cement analysis from 1910. In profile 1, the minimum value in the outer zone (0-7 mm) was about 45 wt. % CaO and the mean value in the inner zone (8-13 mm) about 52 wt. %. In profile 2, the minimum value in the outer zone (0-7 mm) was about 50 wt. % and the mean value in the inner zone (8-18 mm) about 60 wt. %.

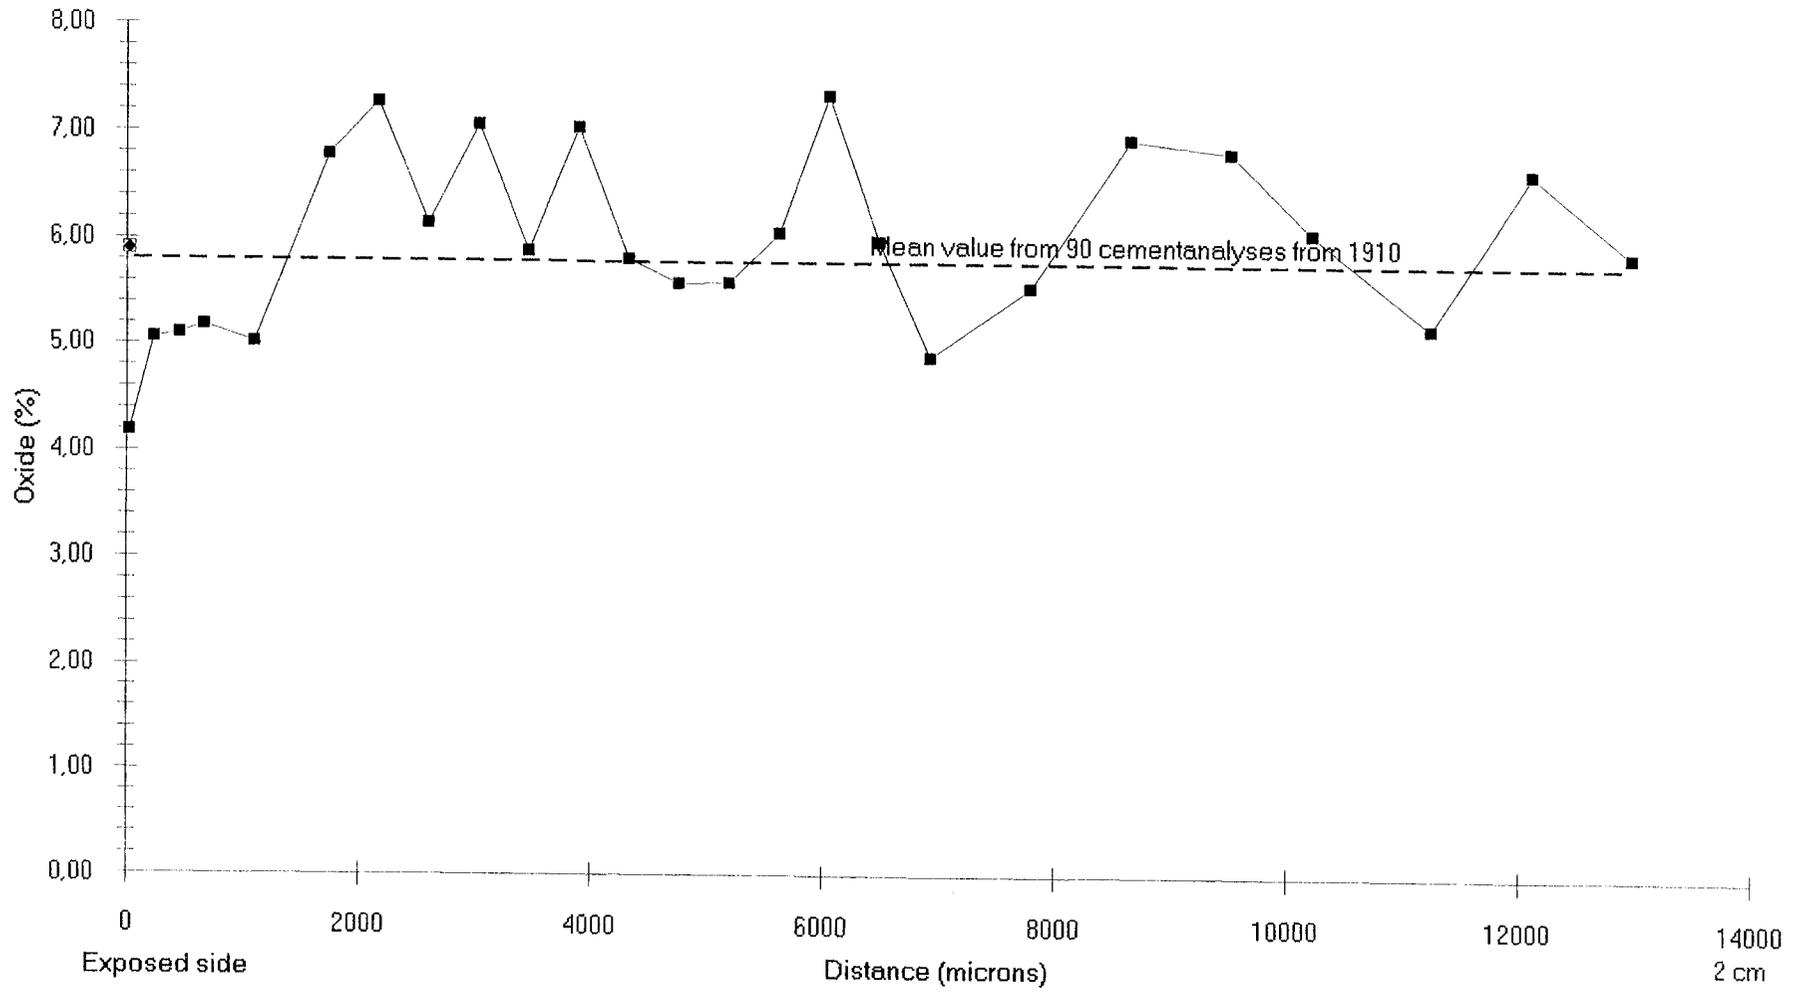
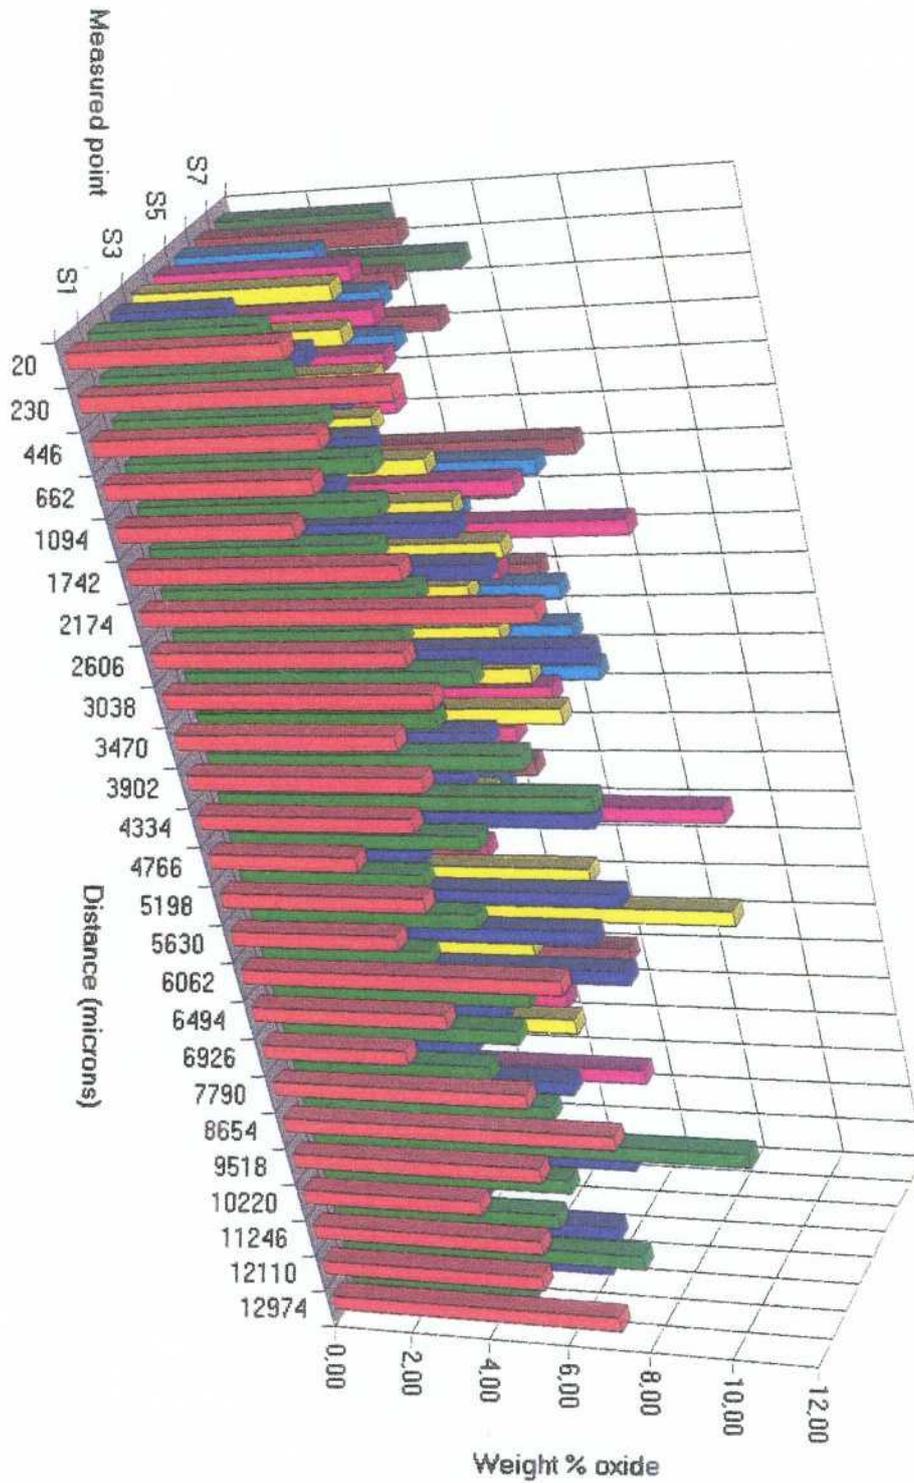
Al₂O₃

From the surface and to about 1 mm depth the aluminium concentration was low. This zone is the carbonated zone dominated by secondary calcite formation. From 1-2 mm depth, aluminium had a peak in both profiles indicating ettringite formation. After 2 mm depth in profile 1, aluminium fluctuates with highs and lows around the mean value given by the cement analyses from 1910. A combination of high concentrations in both aluminium and sulphate indicate ettringite and probably thaumasite formation.

The variation of the aluminium concentration is shown in Appendix 4, page 7, 8 and 19.

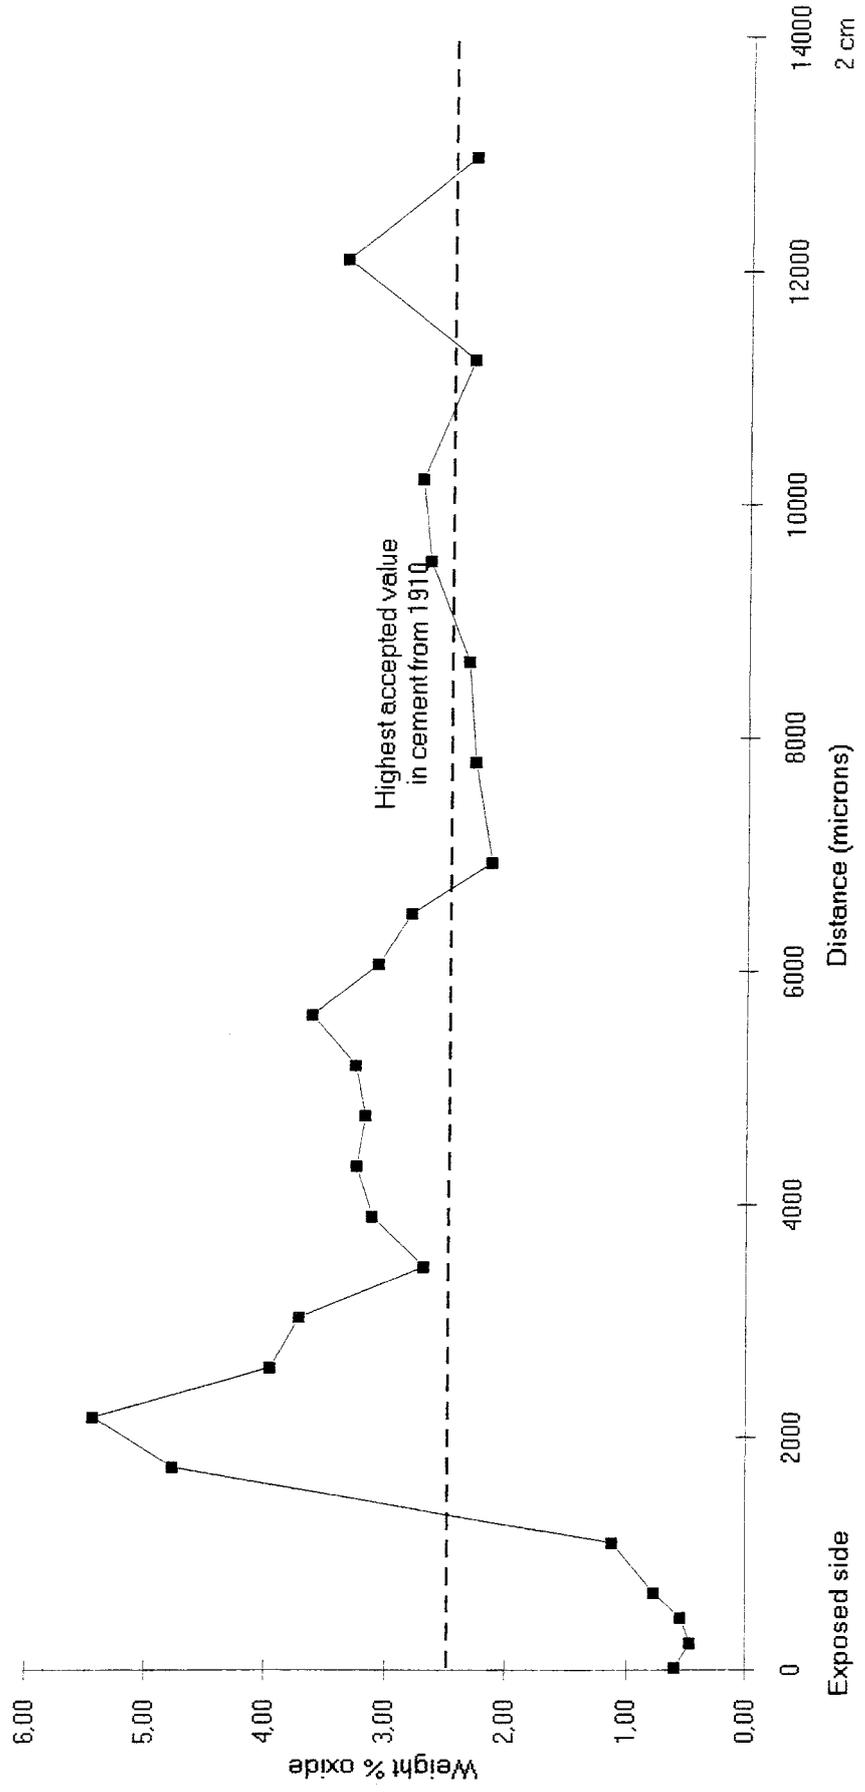
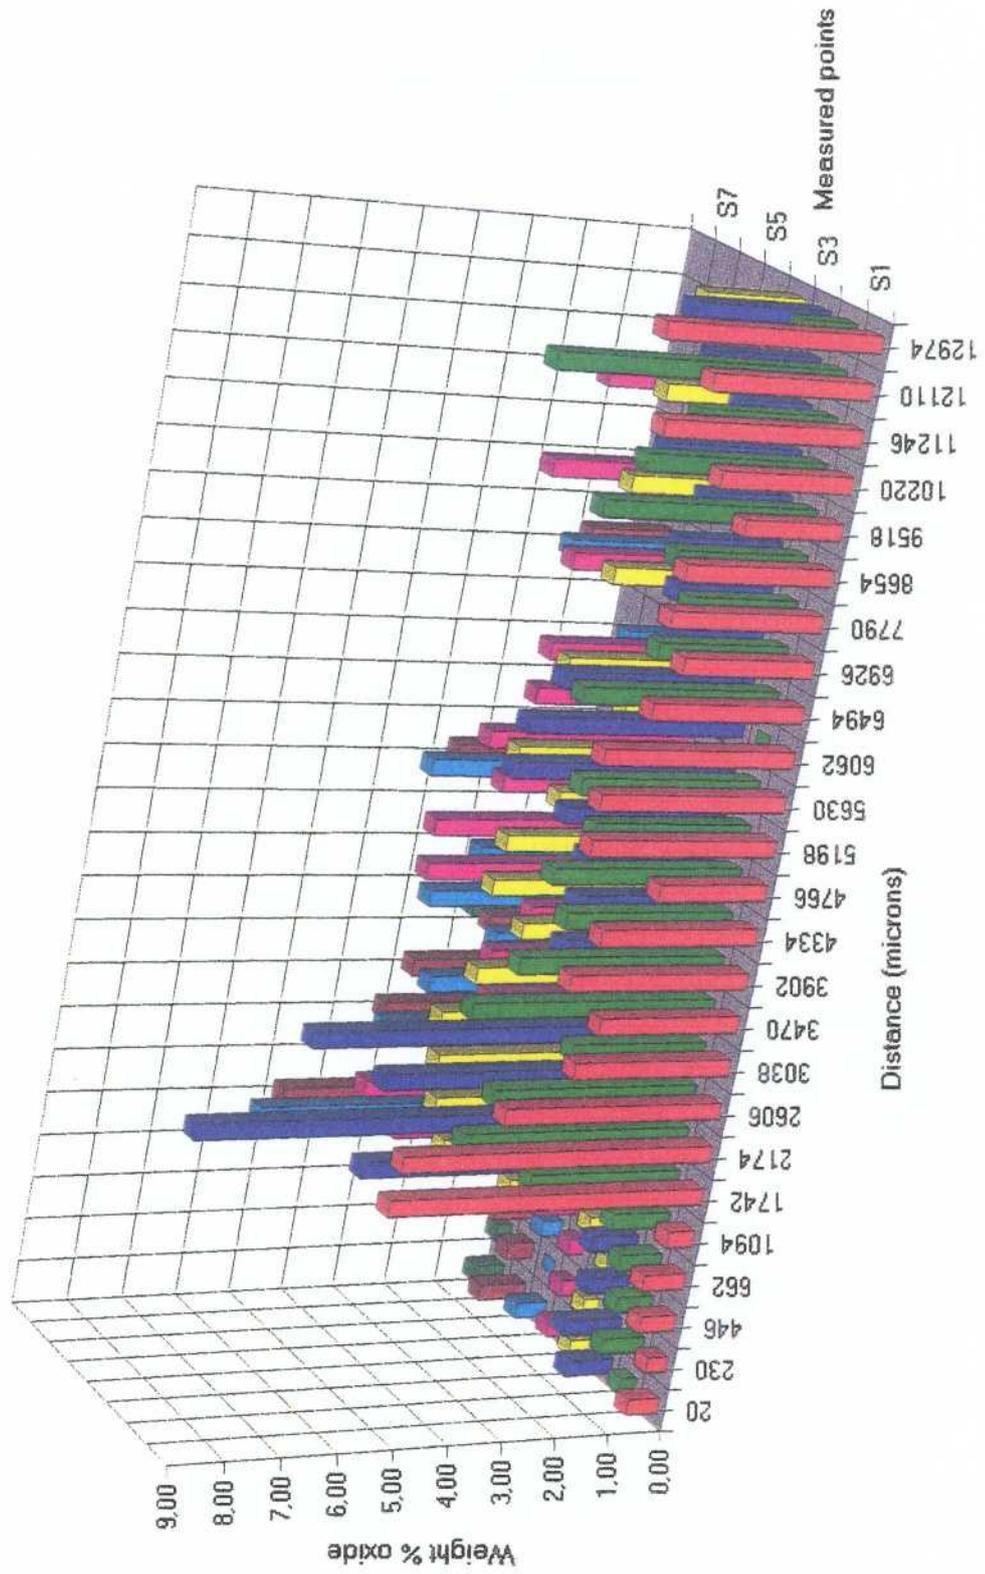
SO₃

Similar to the aluminium variation, the sulphate concentration was low in the carbonated zone and had a peak at about 2 mm depth. In both profiles, the sulphate concentration dropped to about the same level as the highest acceptable value in cement from 1910 at about 7 mm depth, which corresponds to the approximate boundary between the outer and inner zones. As previously mentioned, this suggests that there is a clear correlation between calcium depletion (Appendix 4, page 4 and 16) and high concentrations of sulphates and aluminium (page 7, 9, 19 and 20). Redistribution of sulphates and aluminium in calcium depleted areas lead to secondary formation of ettringite, monosulfate and probably thaumasite. These minerals consist primarily of Ca, Al and SO₄²⁻. Some iron may also substitute for aluminium in ettringite phases. The existence of ettringite was confirmed by electron microscopy.

The variation in sulphate concentration is shown in Appendix 4, page 9, 10 and 20
